# 2024 Routine Bridge Inspection Report - District 4-0

BMS ID: 63 1002 0230 0739  
BRKEY: 35588  
Feature Carried: SR 1002  
Feature Under: Delaware River

**2024 ROUTINE BRIDGE INSPECTION REPORT  
SR 1002 over DELAWARE RIVER**

**BMS No. 63 1002 0230 0739**

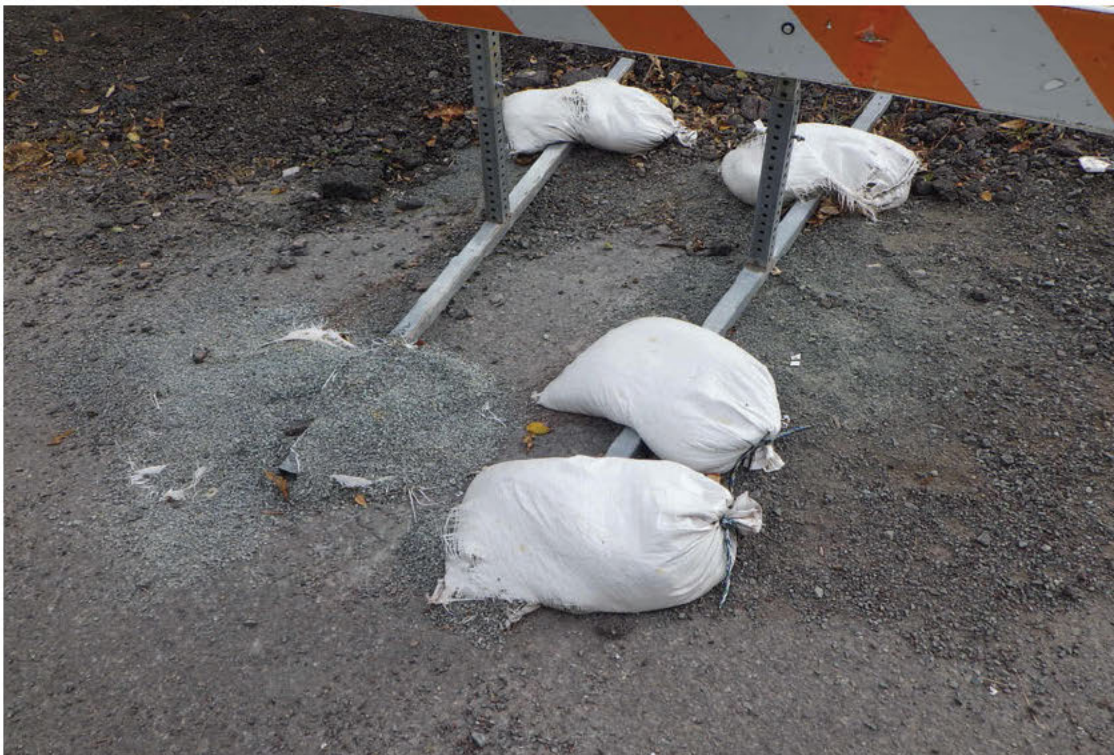
8. Damaged gravel bag at the near approach.

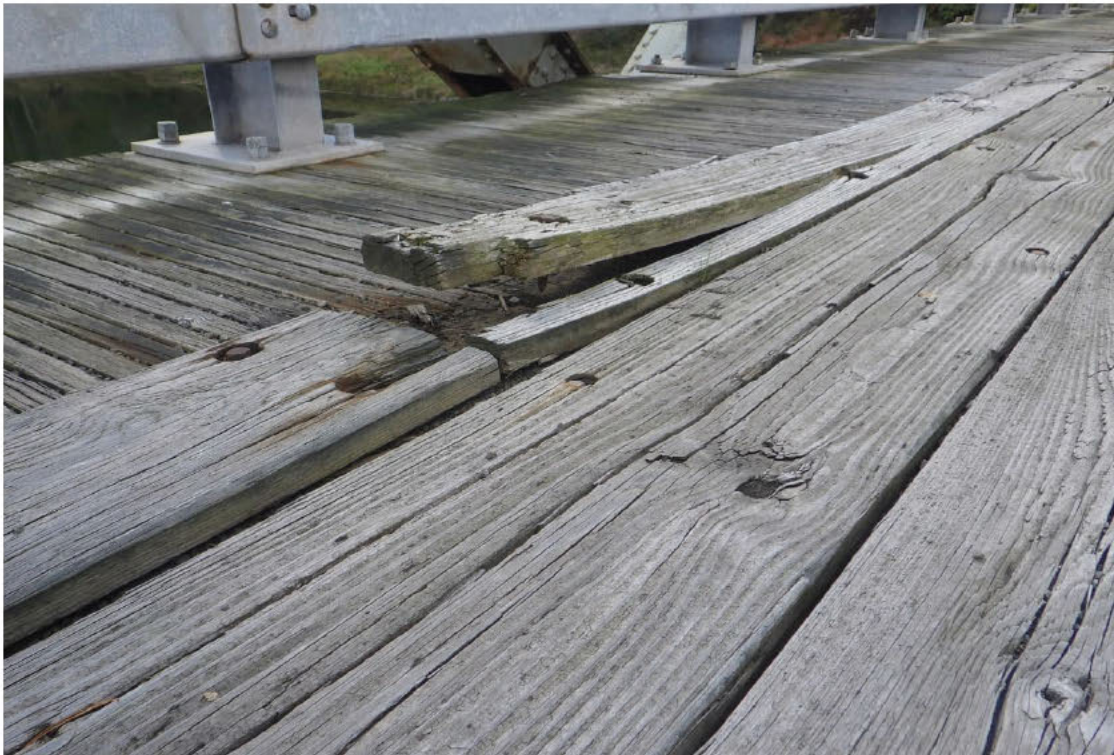
12. Typical warped running plank with missing fasteners.

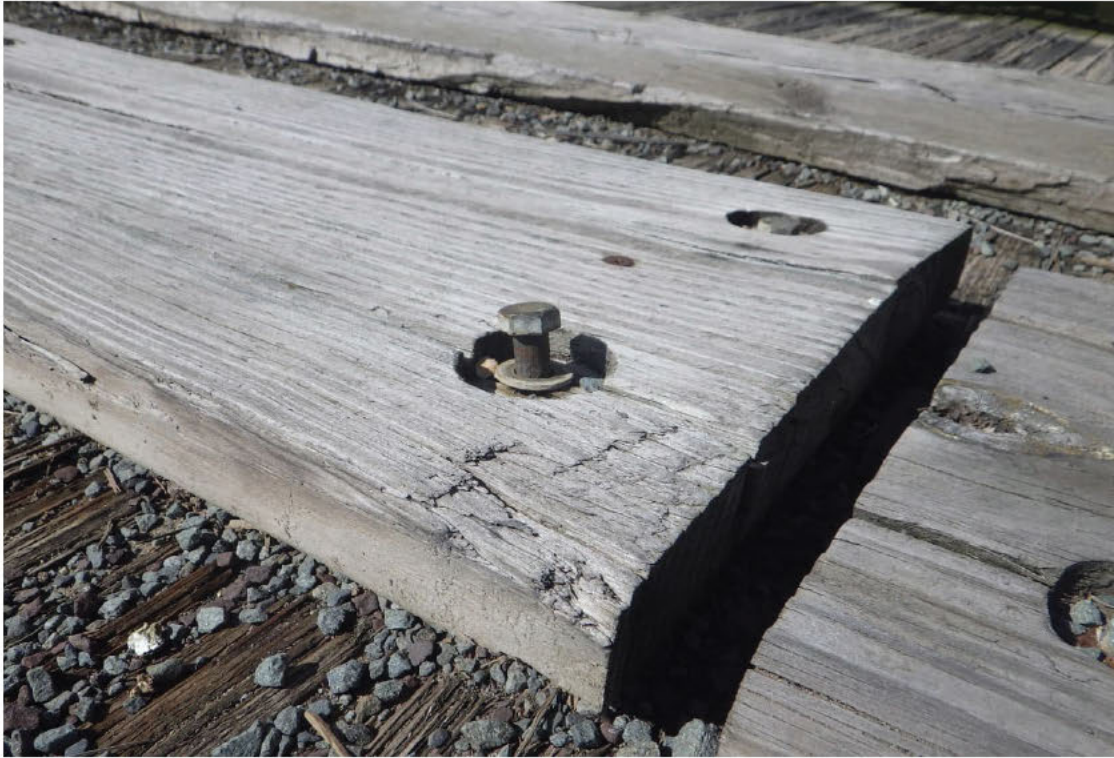
13. Typical loose fasteners protruding from the running planks.

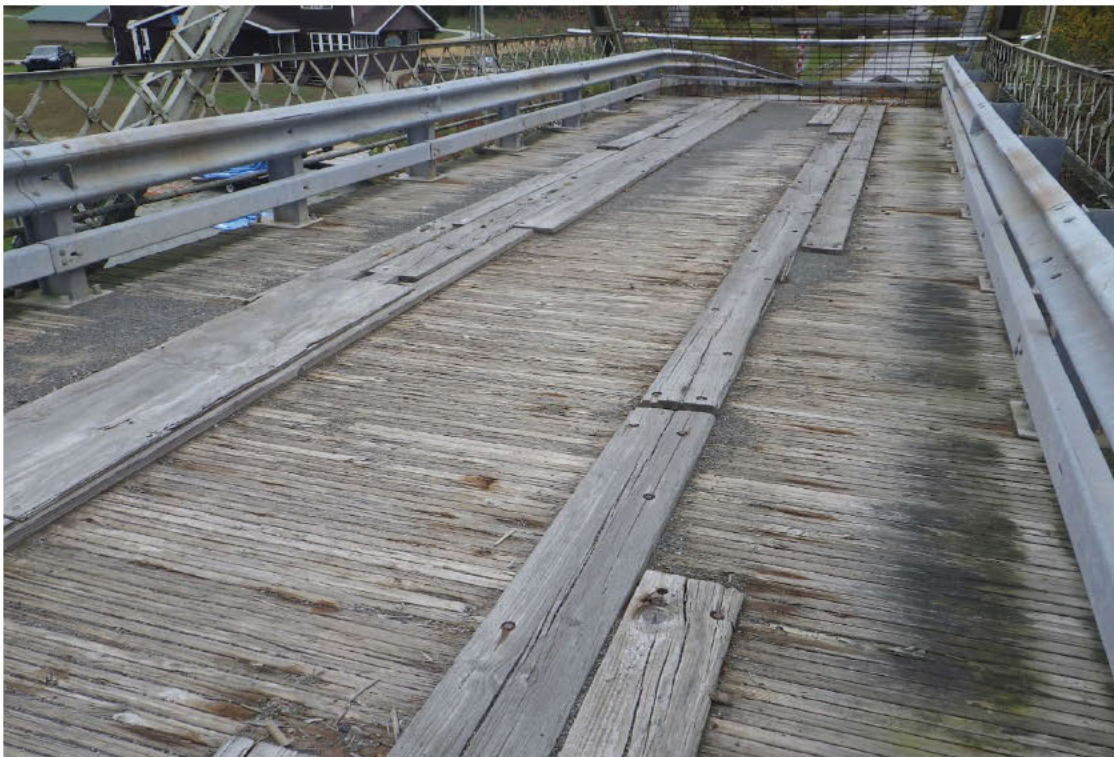
14. Typical missing running planks in Span 2.

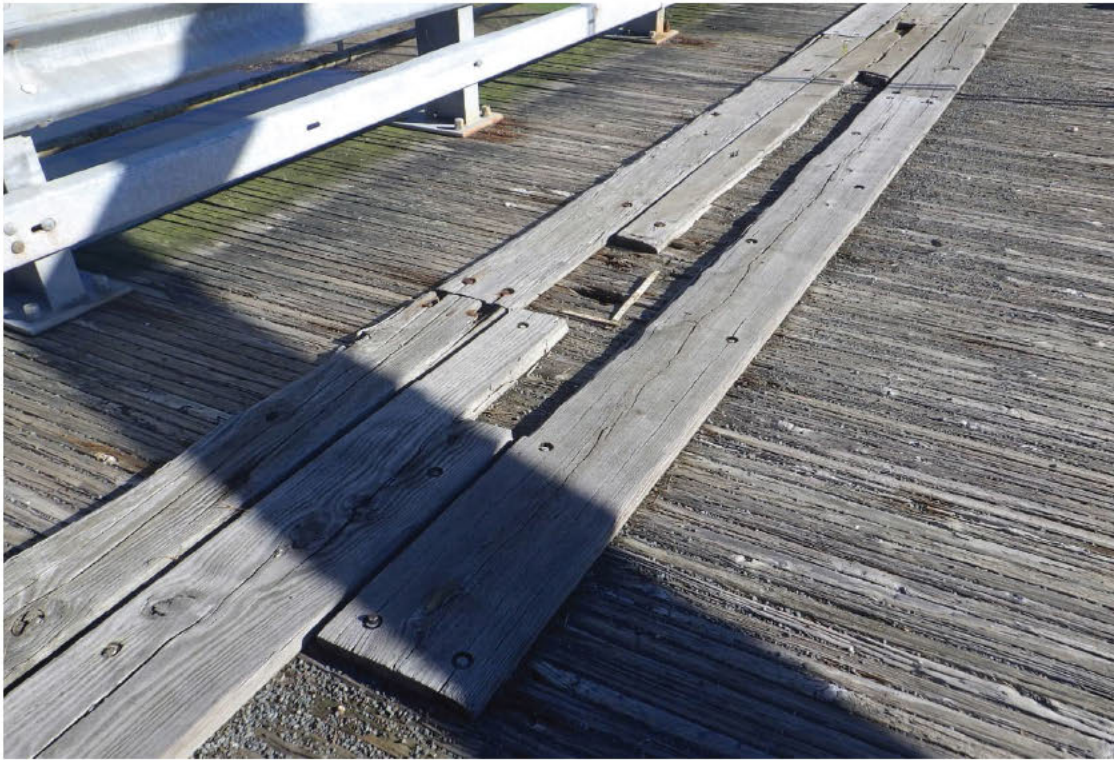
15. Missing running planks with severe decay to below to laminated deck boards in Span 2.

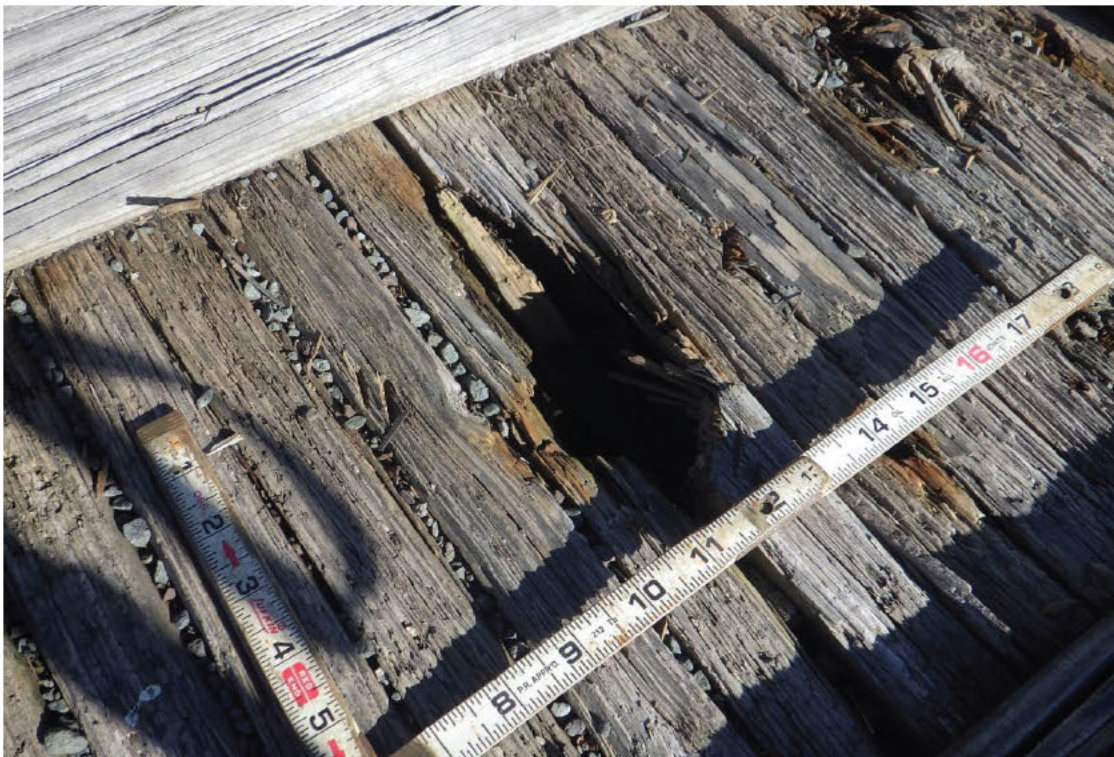
16. Close-up of previous photo showing severe decay to deck boards.

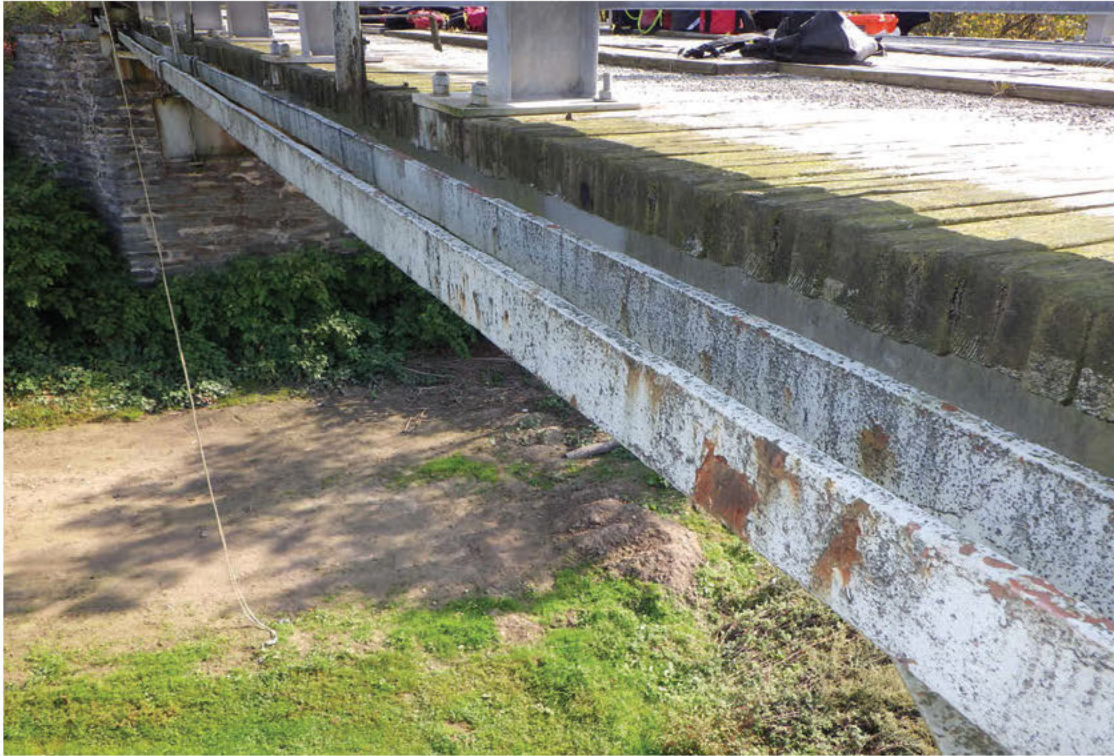
21. Typical bottom chord condition, L8-L9, Left Truss in Span 2, looking ahead.

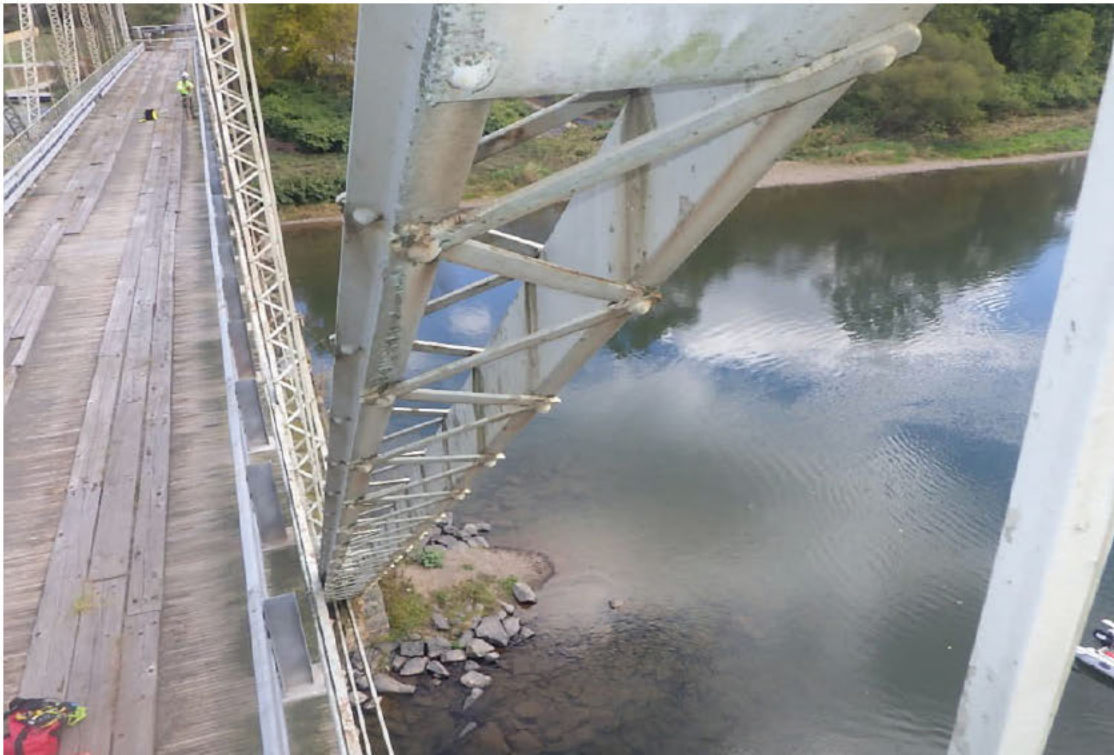
22. Typical diagonal condition, M9-L10, Right Truss in Span 1, looking ahead.

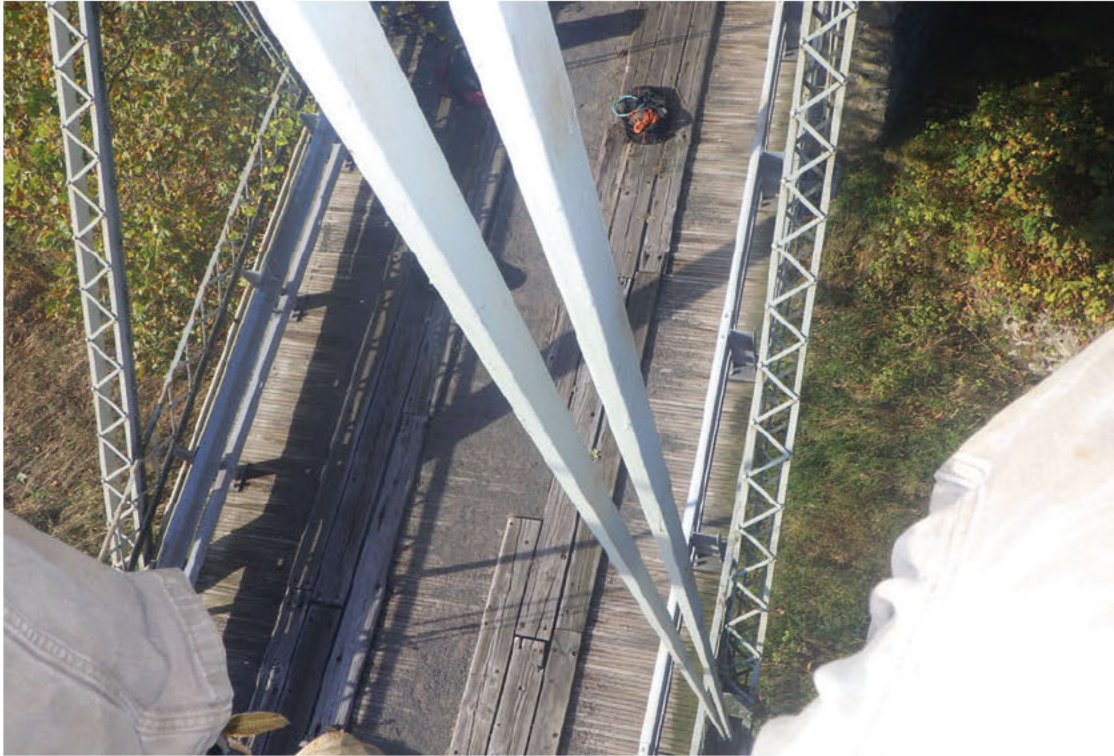
23. Typical vertical condition, L2-U2, Left Truss in Span 1.

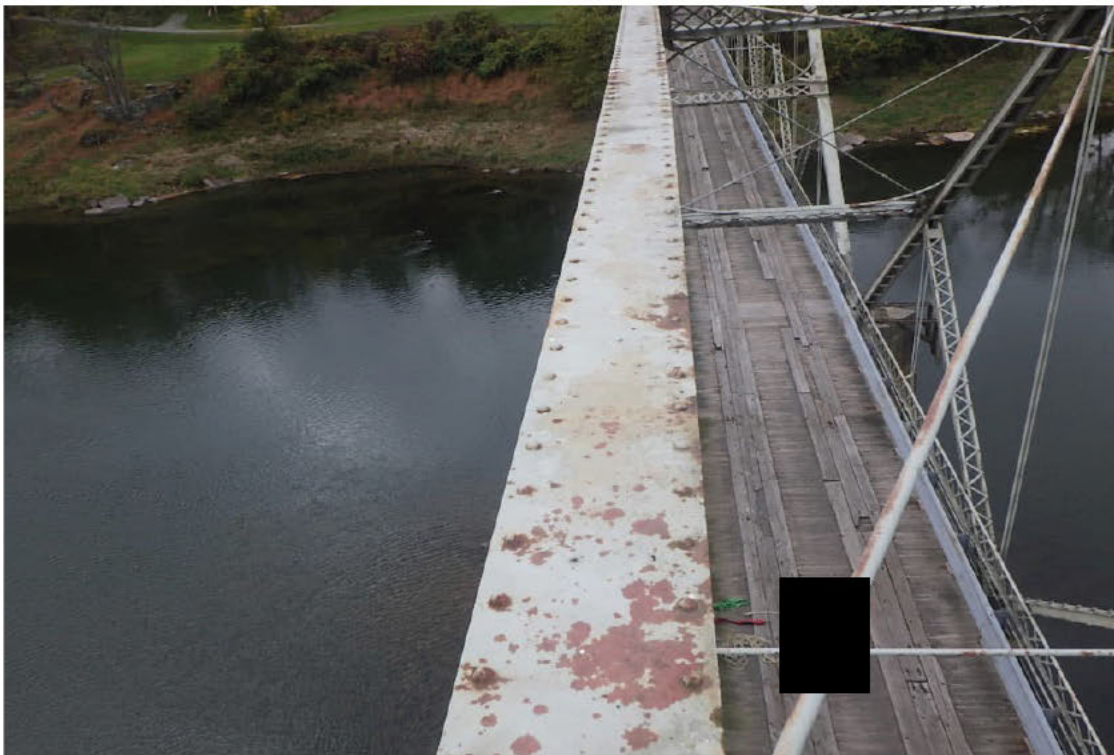
24. Typical top chord condition, U2-U4, Right Truss in Span 2.

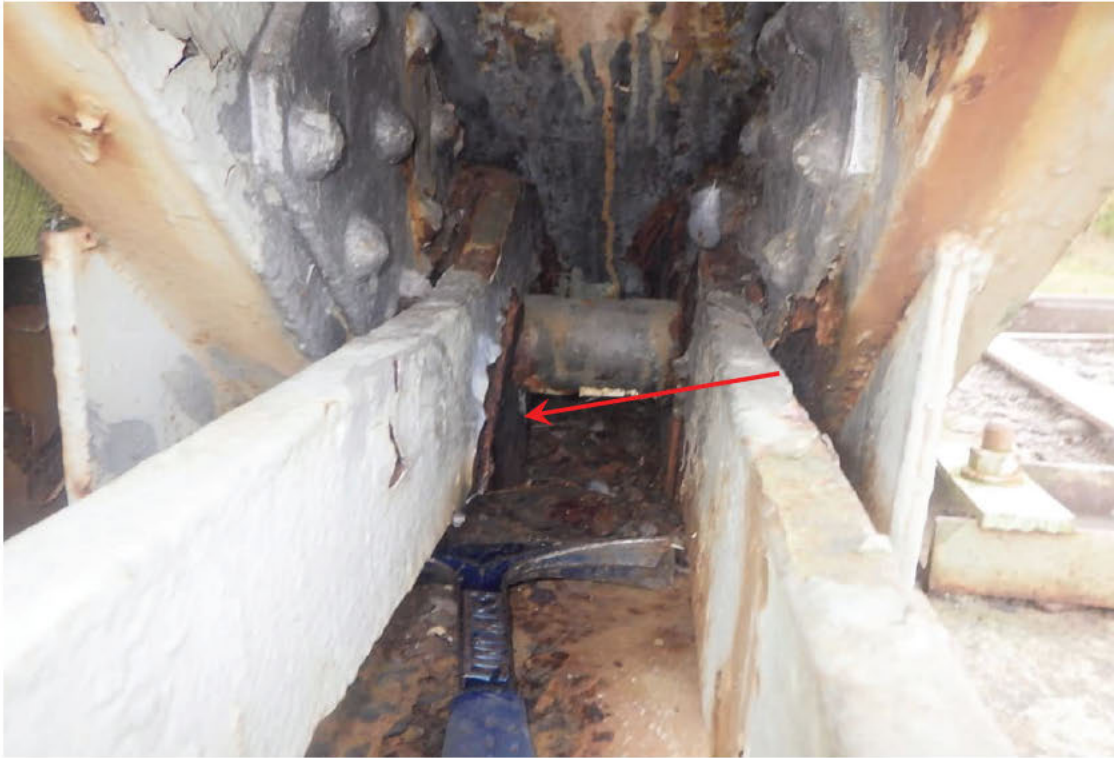
25. Severe corrosion to L0-L1 at L0, Left Truss in Span 2.

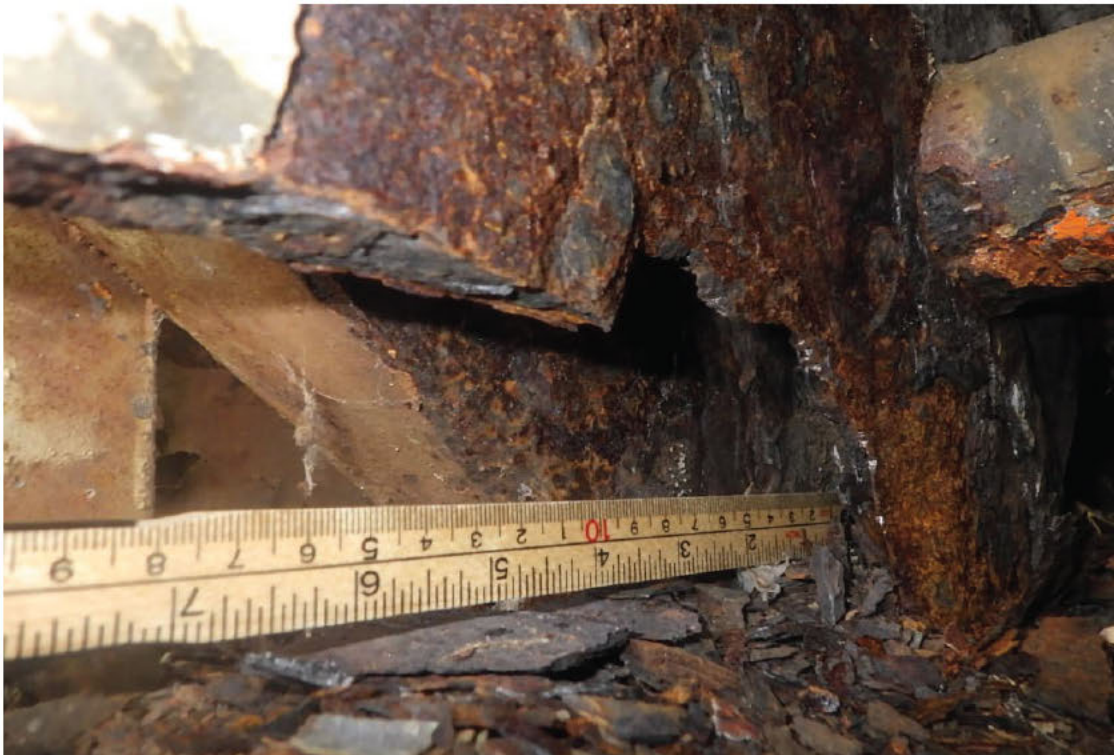
26. Close-up of previous photo showing section loss to eyebar head.

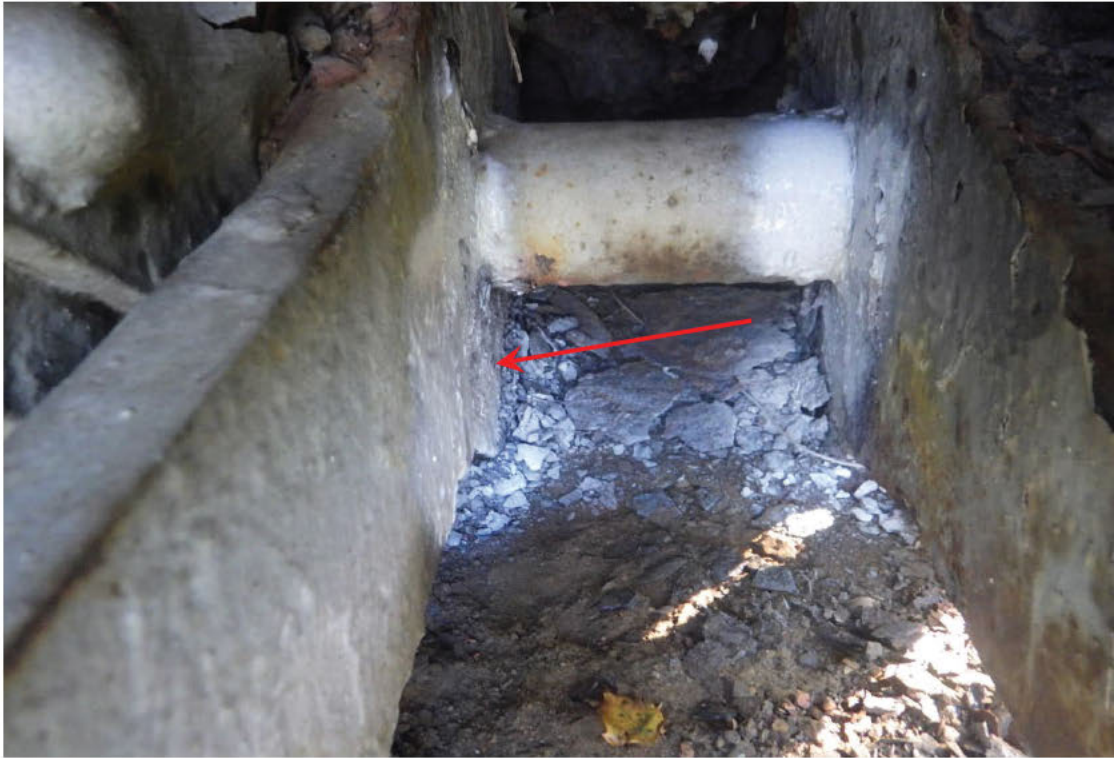
27. Severe corrosion to L11-L12 at L12, Right Truss in Span 2.

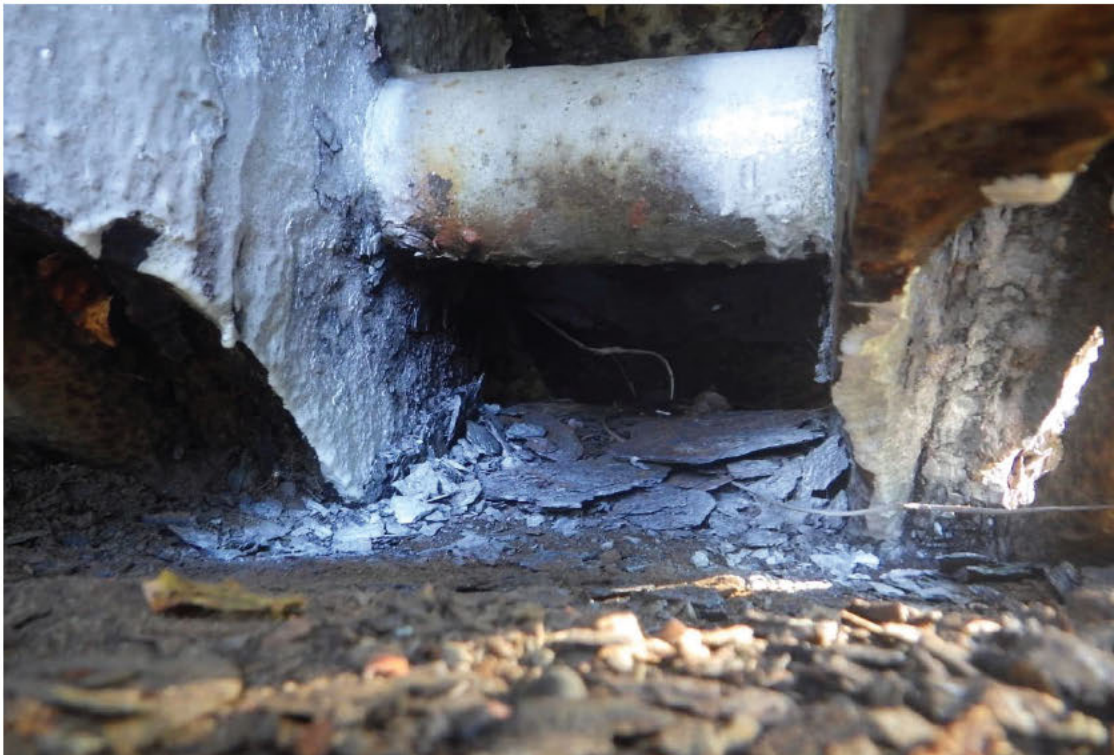
28. Close-up of previous photo showing section loss to eyebar head.

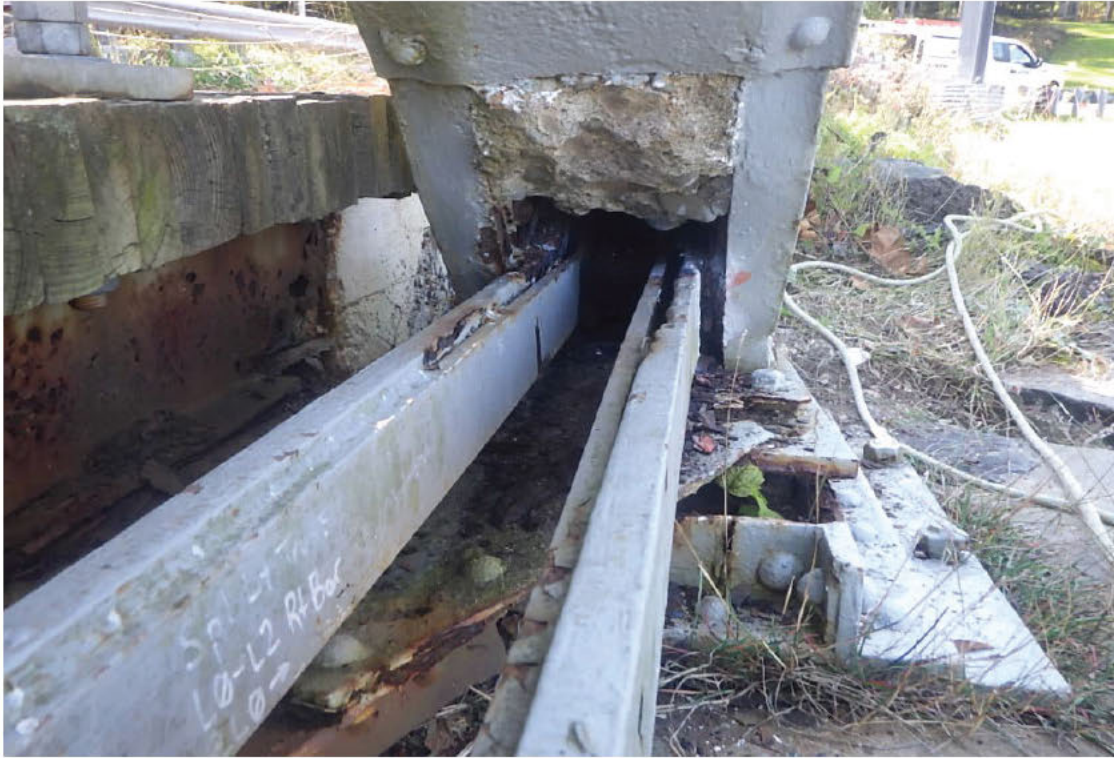
29. Bottom chord repair, L0-L1 at L0, Left Truss in Span 1.

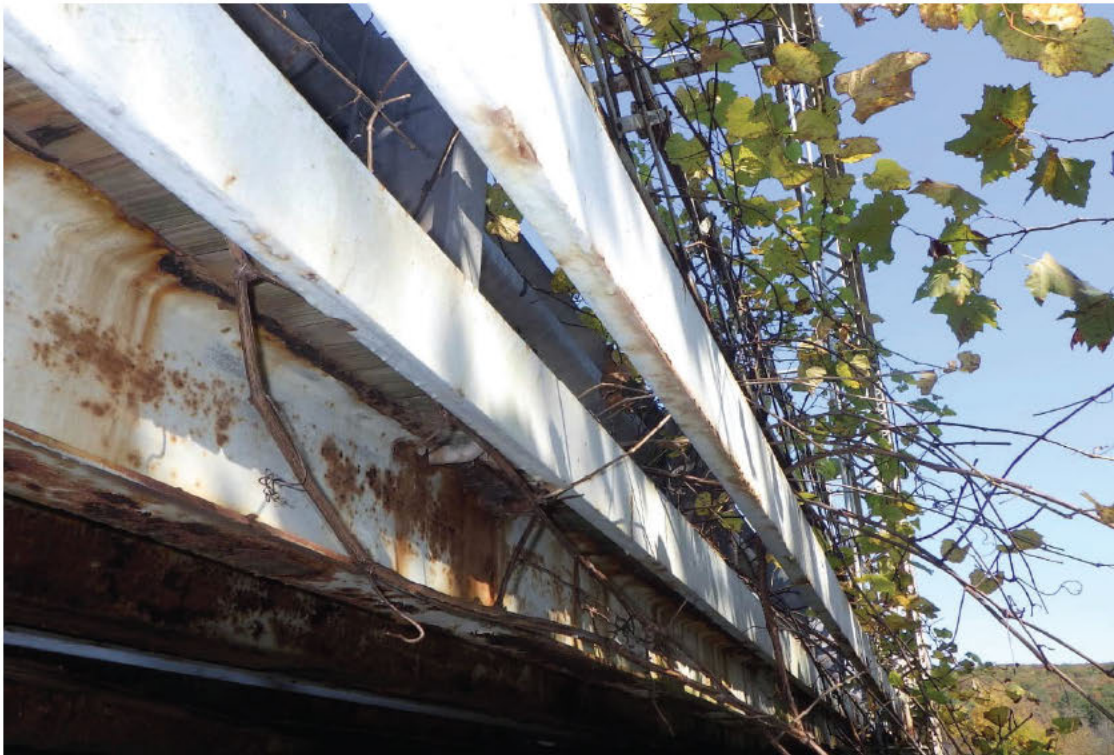
30. Bottom chord with vegetation growth, L0-L1, Right Truss in Span 1.

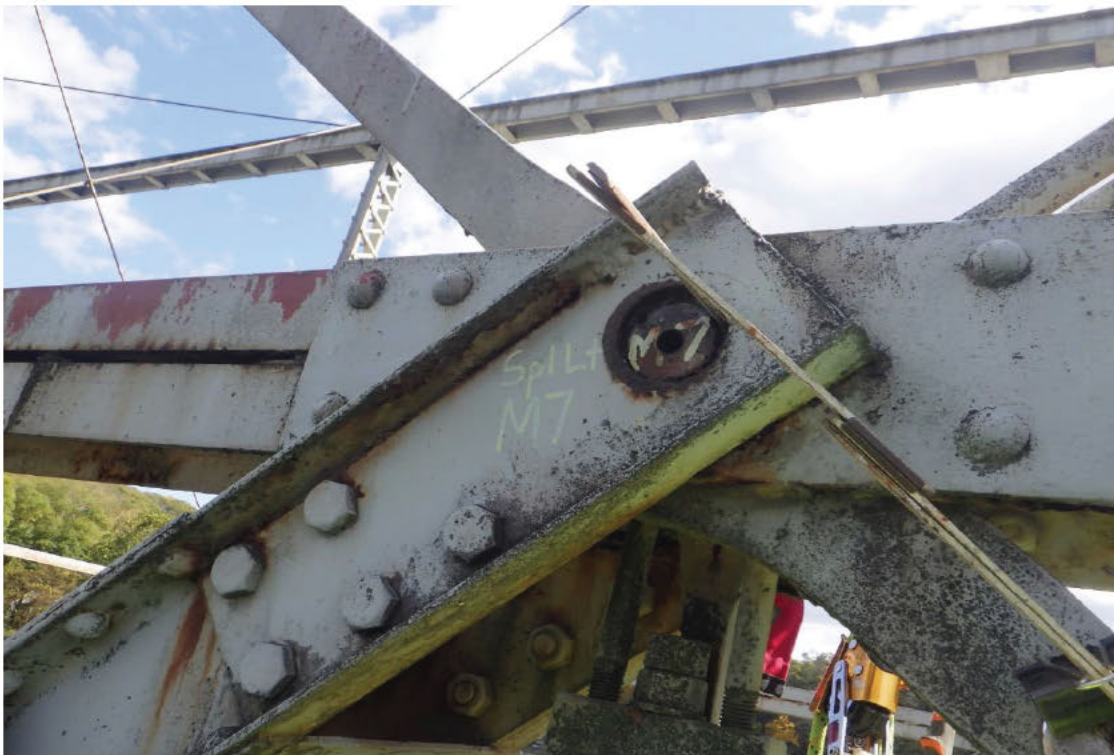
34. Missing pin cap for M7-L8 at M7, Left Truss, Span 1.

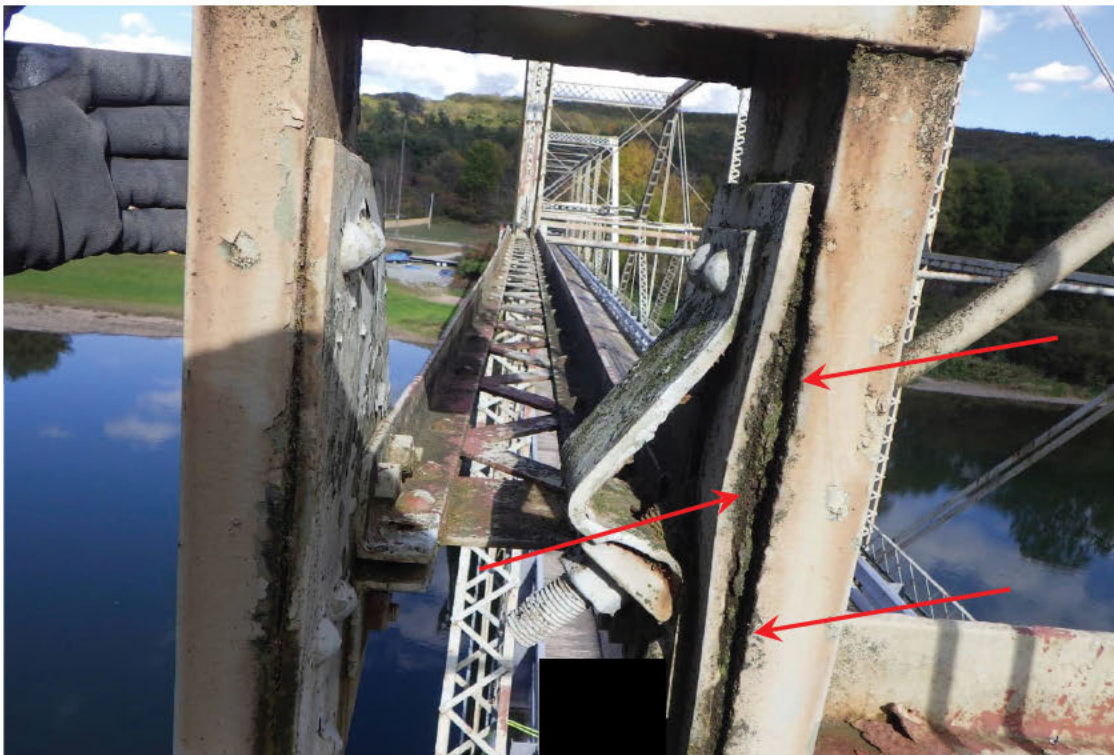
36. Pack rust between L4-U4 & M4-M5 at M4, Left Truss, Span 1.

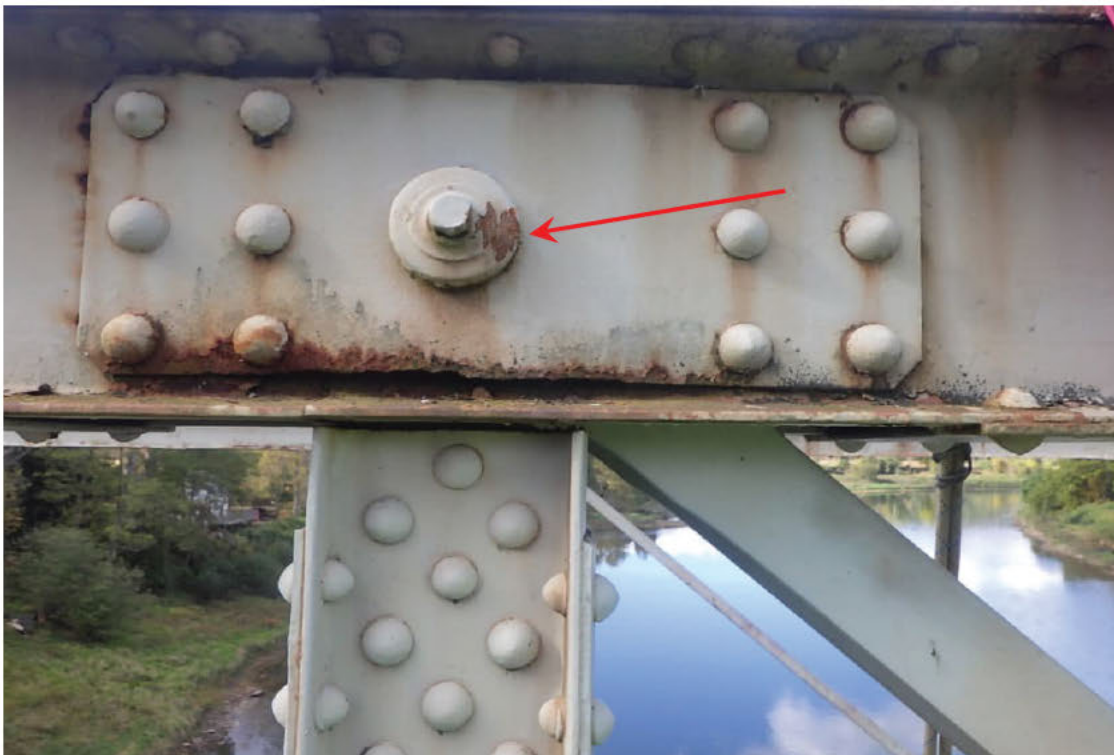
38. Cracked outboard pin cap at U4, Right Truss, Span 1.

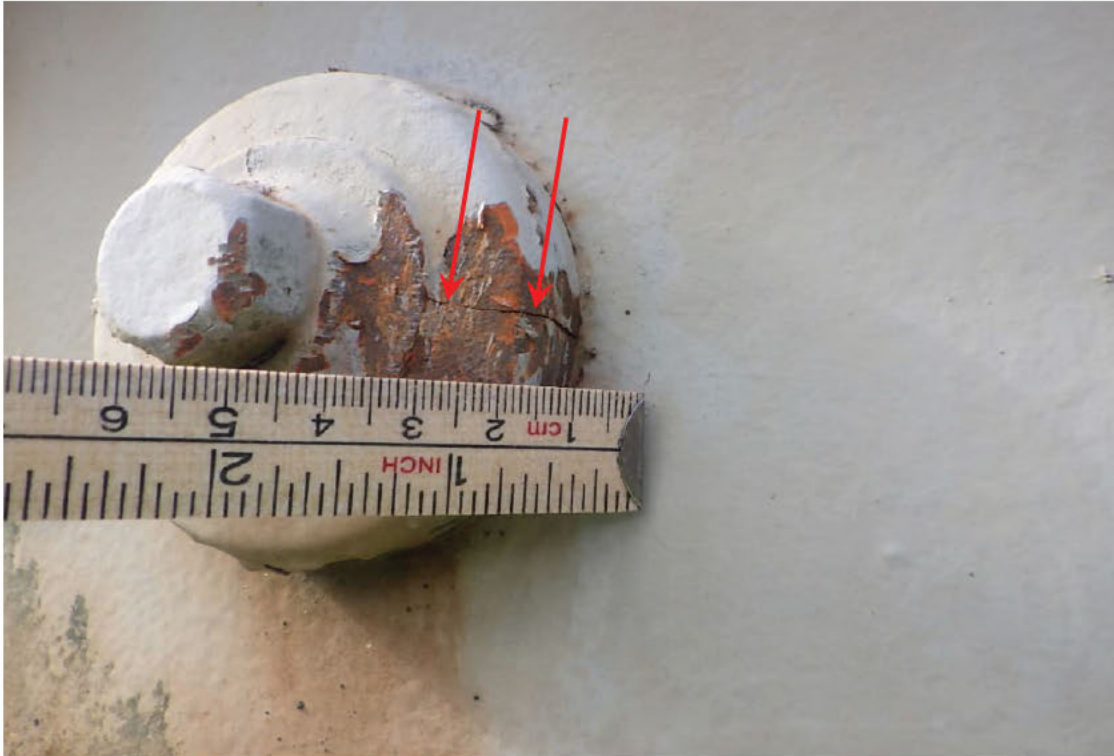
39. Cracked outboard pin cap at U4, Right Truss, Span 1.

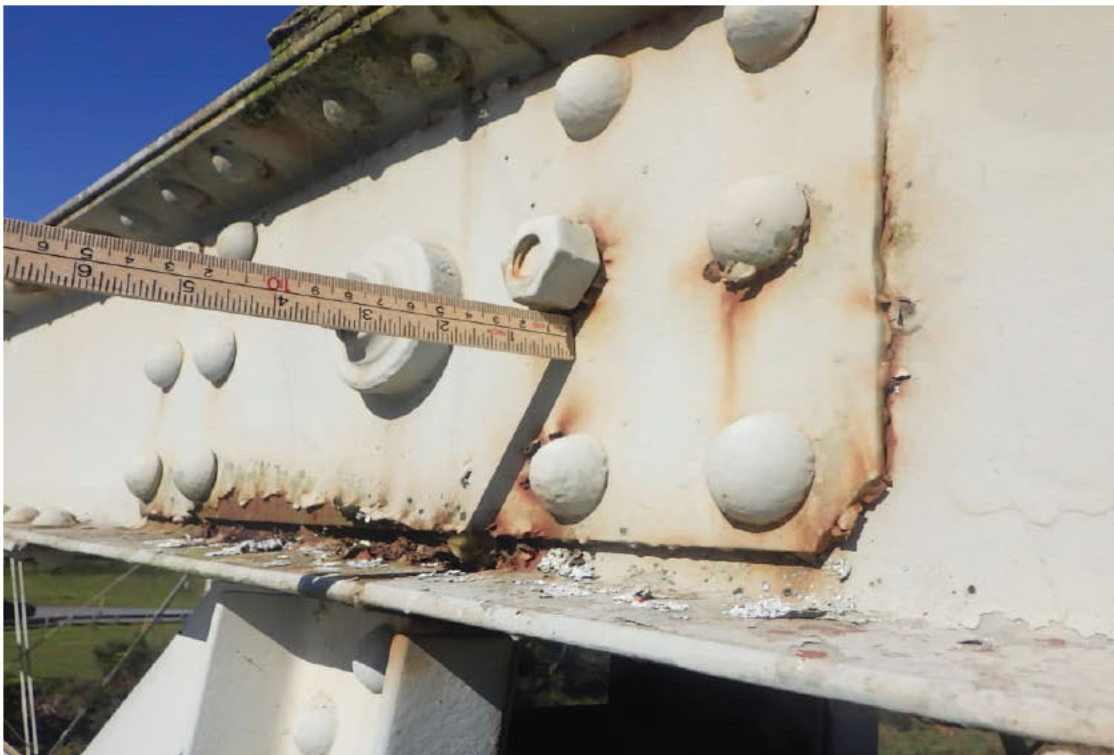
40. Un-seated bolt at U8, Right Truss, Span 1.

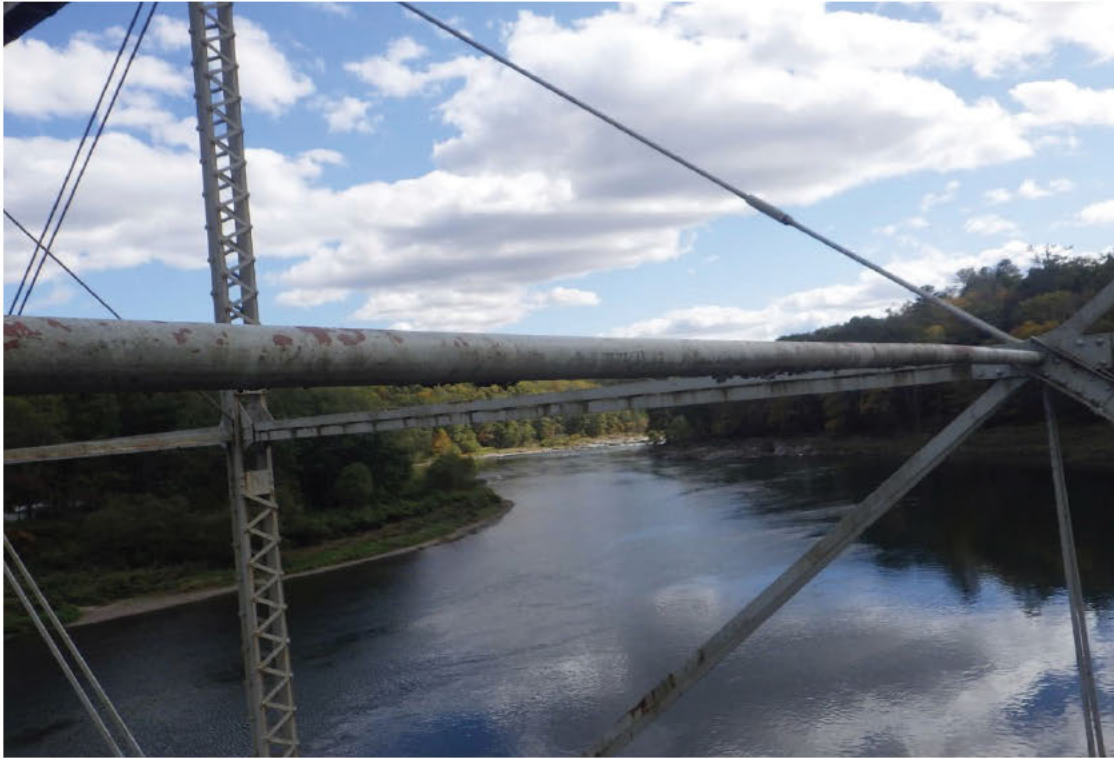
43. Collision damage to horizontal strut of sway bracing, M5 in Span 1, looking right.

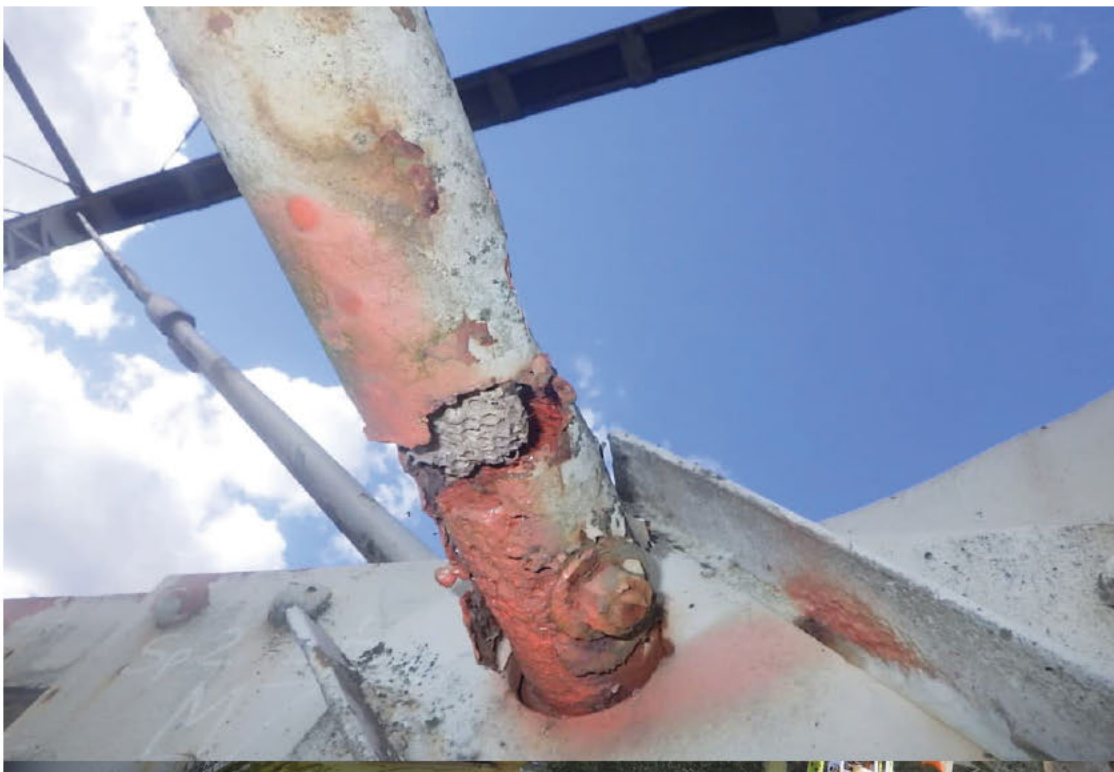
44. 100% section loss to horizontal strut of sway bracing at M7, Left Truss in Span 2.

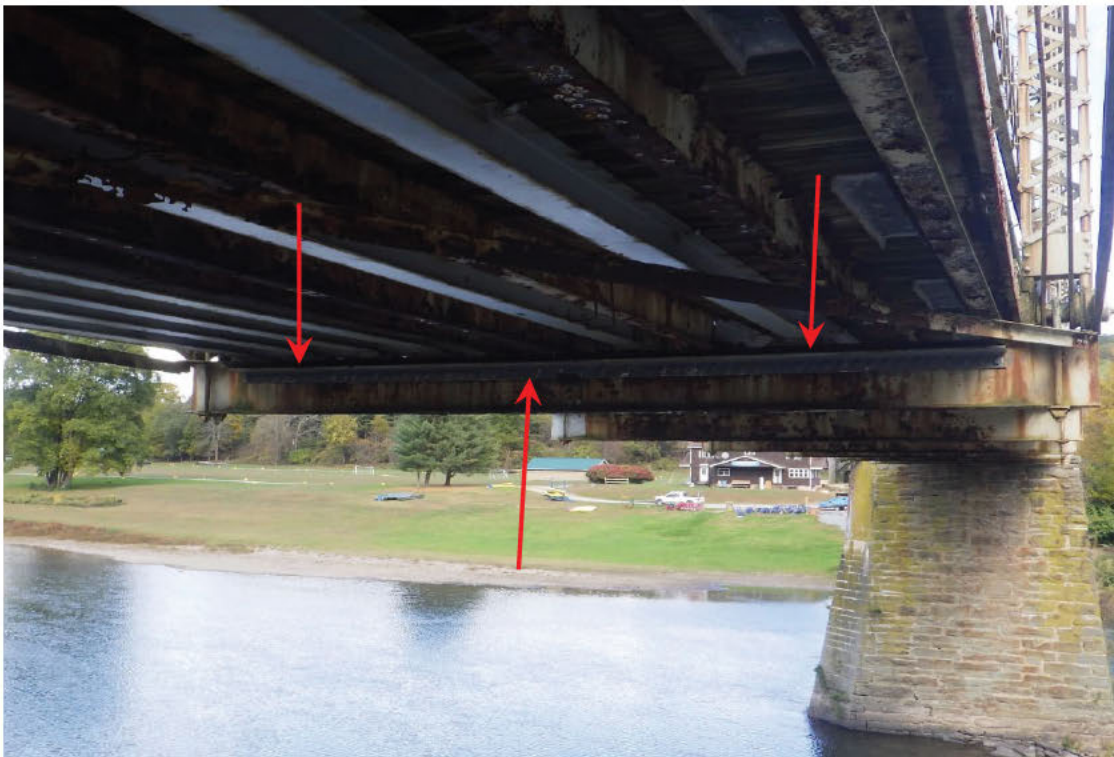
46. Angle repair to Floorbeam 8 in Span 1, looking ahead.

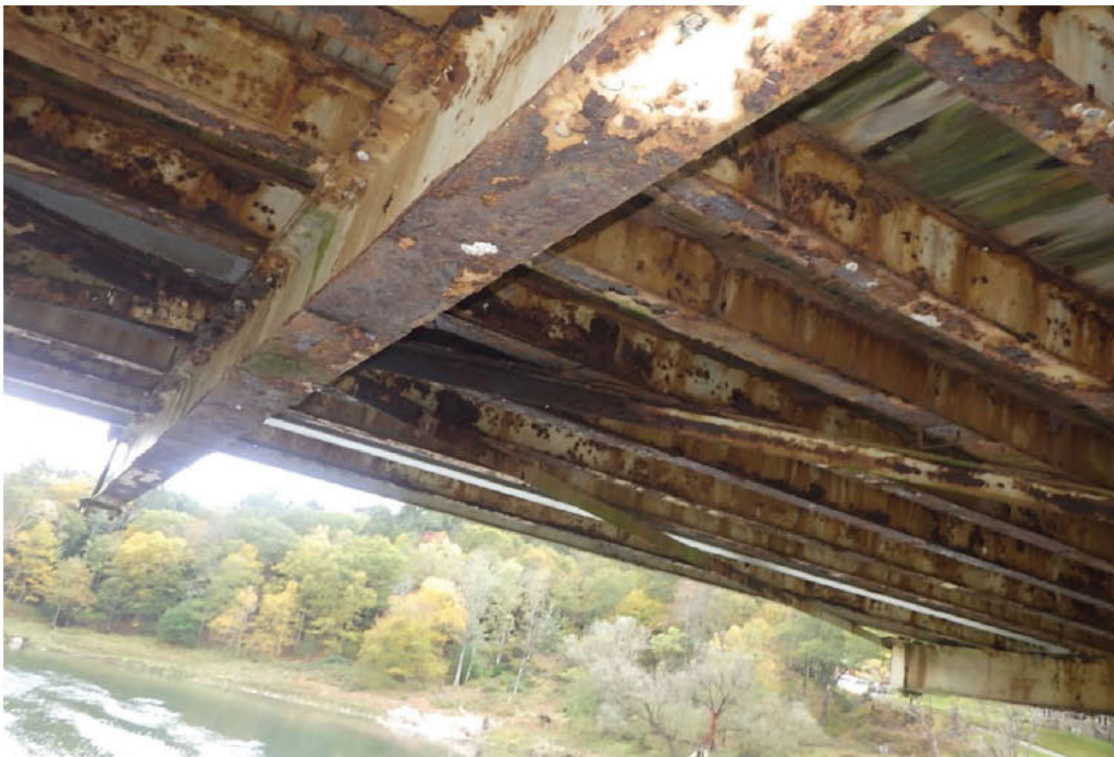
48. Typical condition of floorbeam bottom flange, FB 3 in Span 2, looking right.

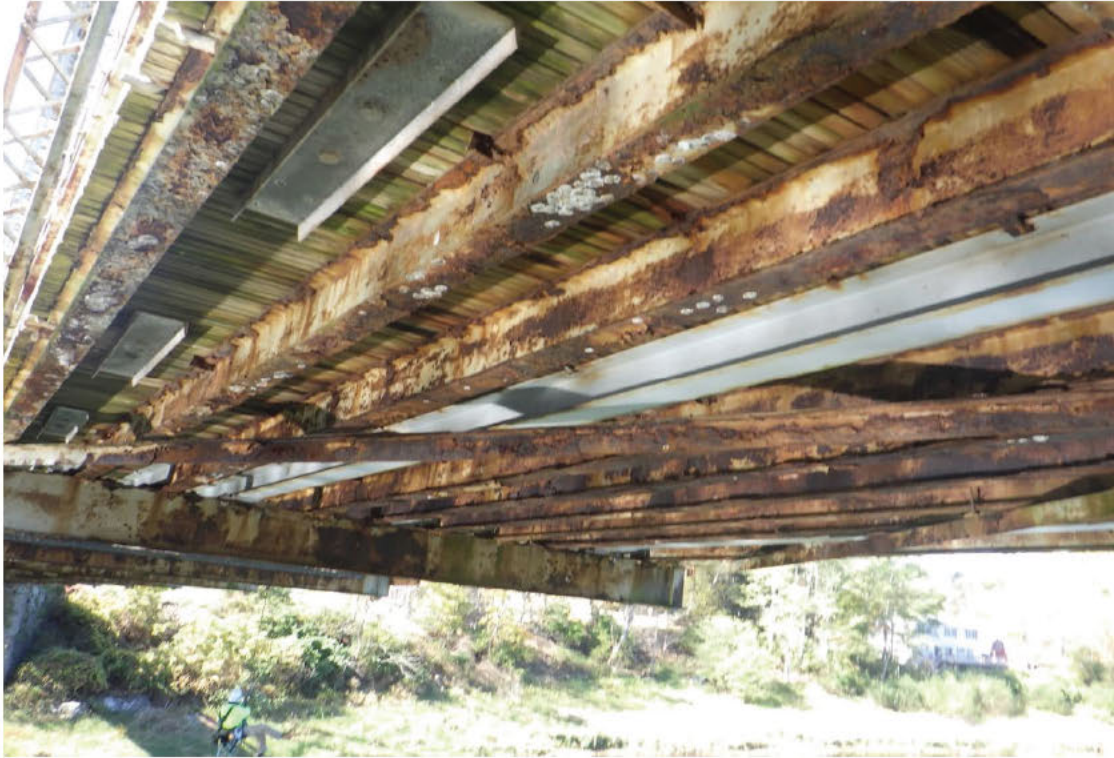
53. Typical stringer condition in Span 1 between Floorbeam 10 & 11, looking back.

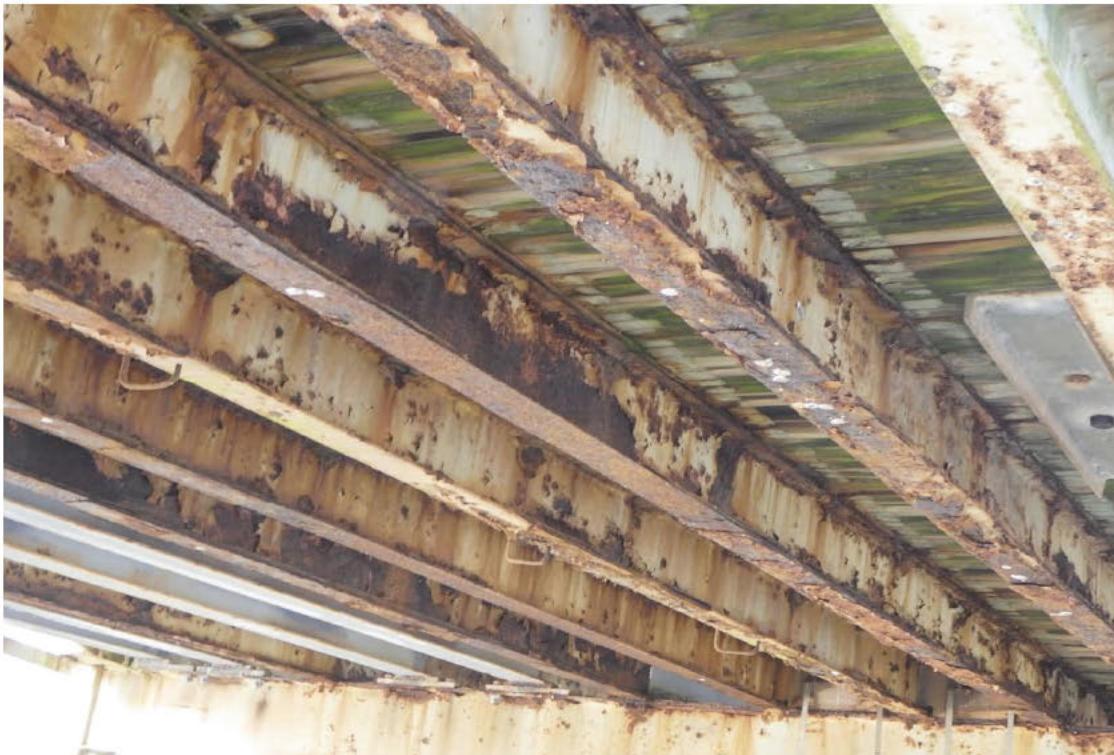
54. Typical stringer condition in Span 2 between Floorbeam 4 & 5, looking back.
