# 2024 Routine Bridge Inspection Report - District 4-0

BMS ID: 63 1002 0230 0739  
BRKEY: 35588  
Feature Carried: SR 1002  
Feature Under: Delaware River

**2024 ROUTINE BRIDGE INSPECTION REPORT  
SR 1002 over DELAWARE RIVER**

**BMS No. 63 1002 0230 0739**

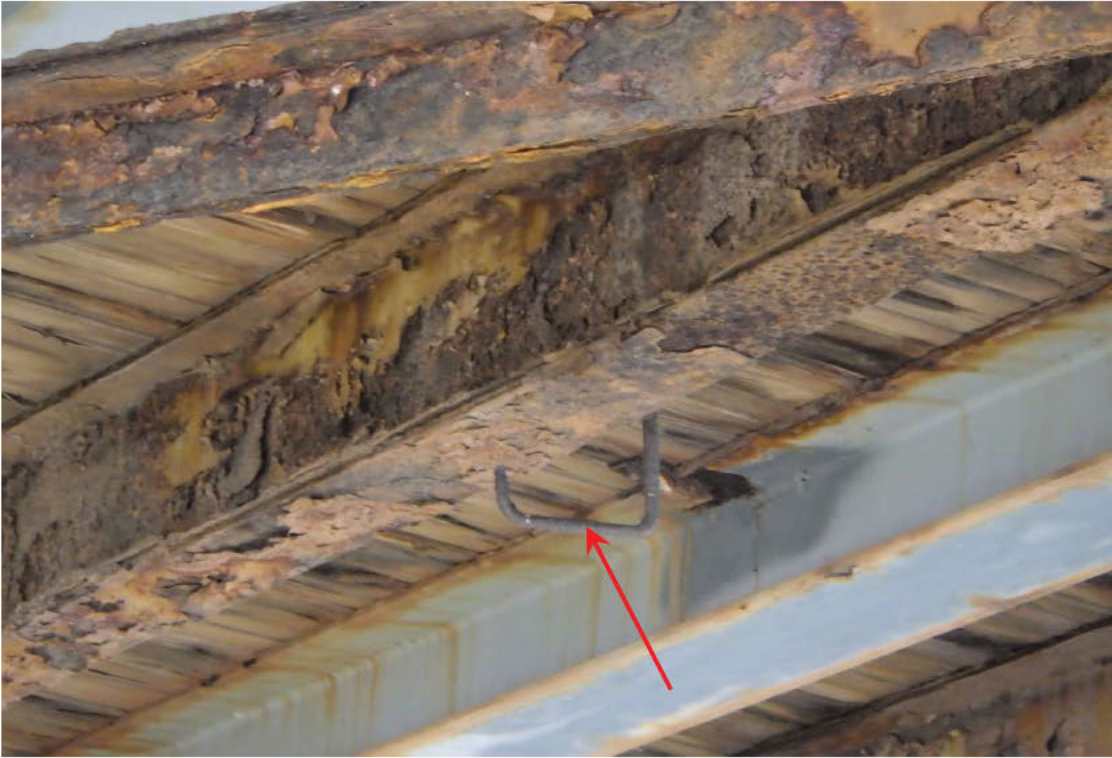
59. Loose "J" hook not engaging stringer bottom flange, Stringer Bay 1 in Span 1.

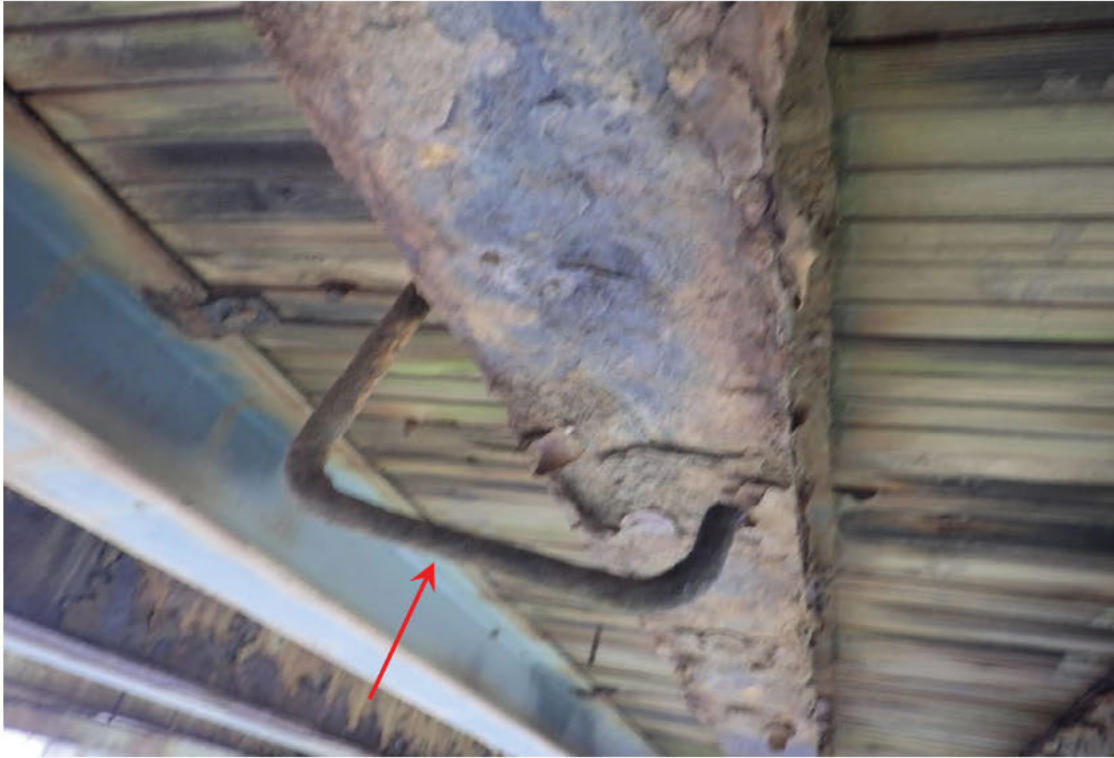
61. Loose "J" hook not engaging stringer bottom flange, Stringer Bay 10 in Span 1.

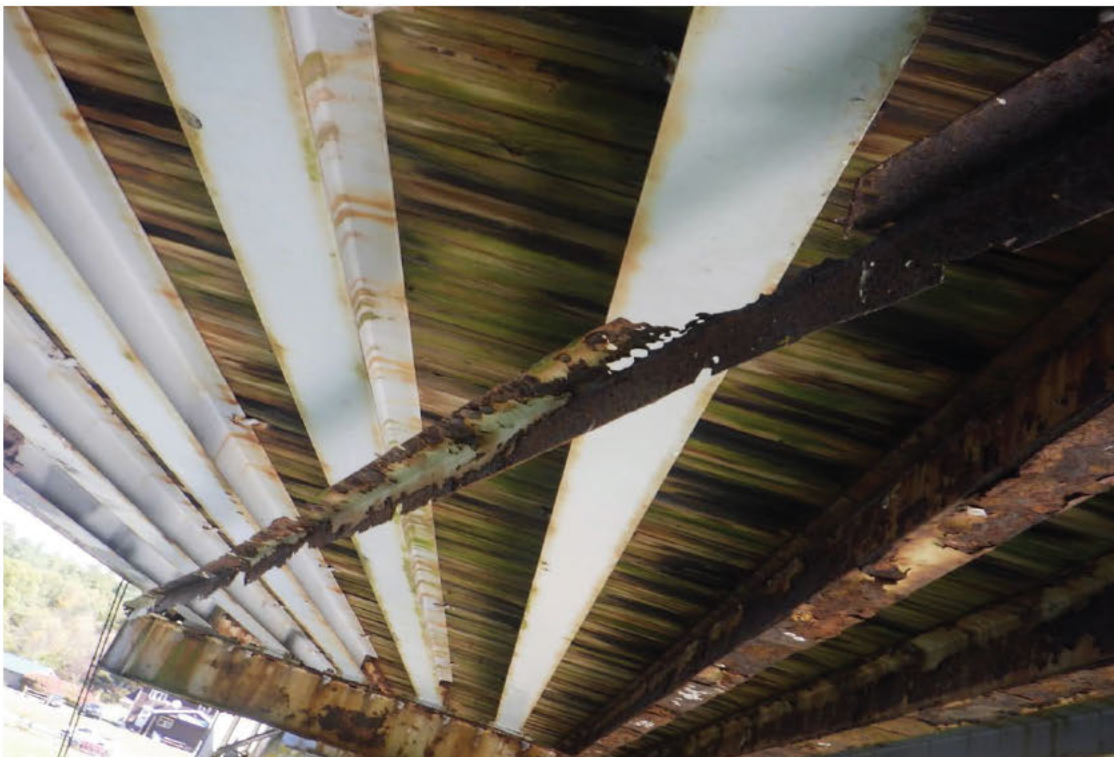
62. Severe section loss to left side lower lateral bracing, Bay 10 in Span 1.

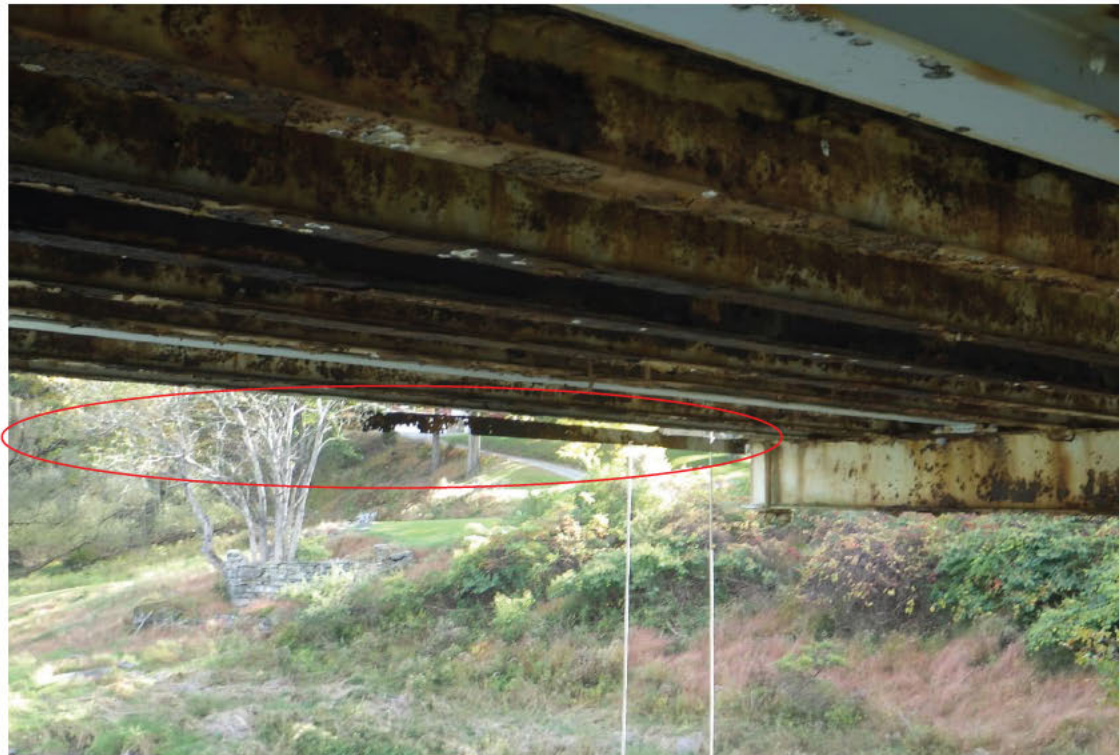
64. Partial length missing and cantilevered lower lateral bracing, Bay 6 in Span 1, looking right.

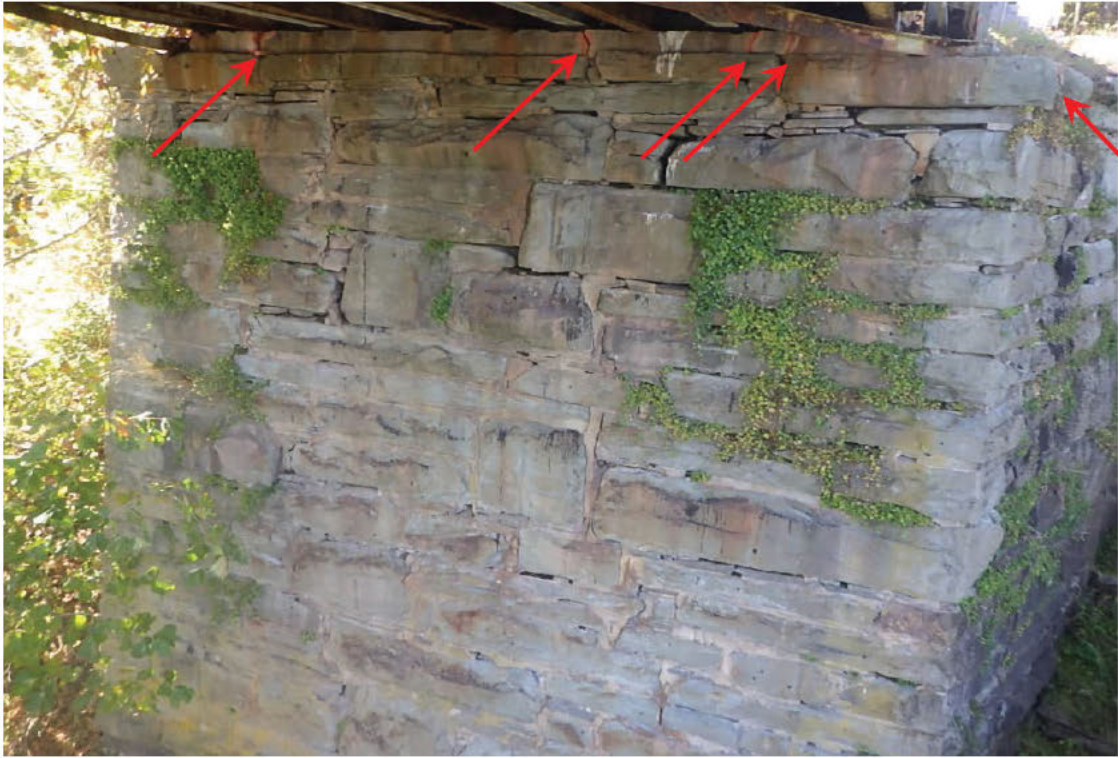
87. Several fractured cap stones along the top of the Near Abutment.

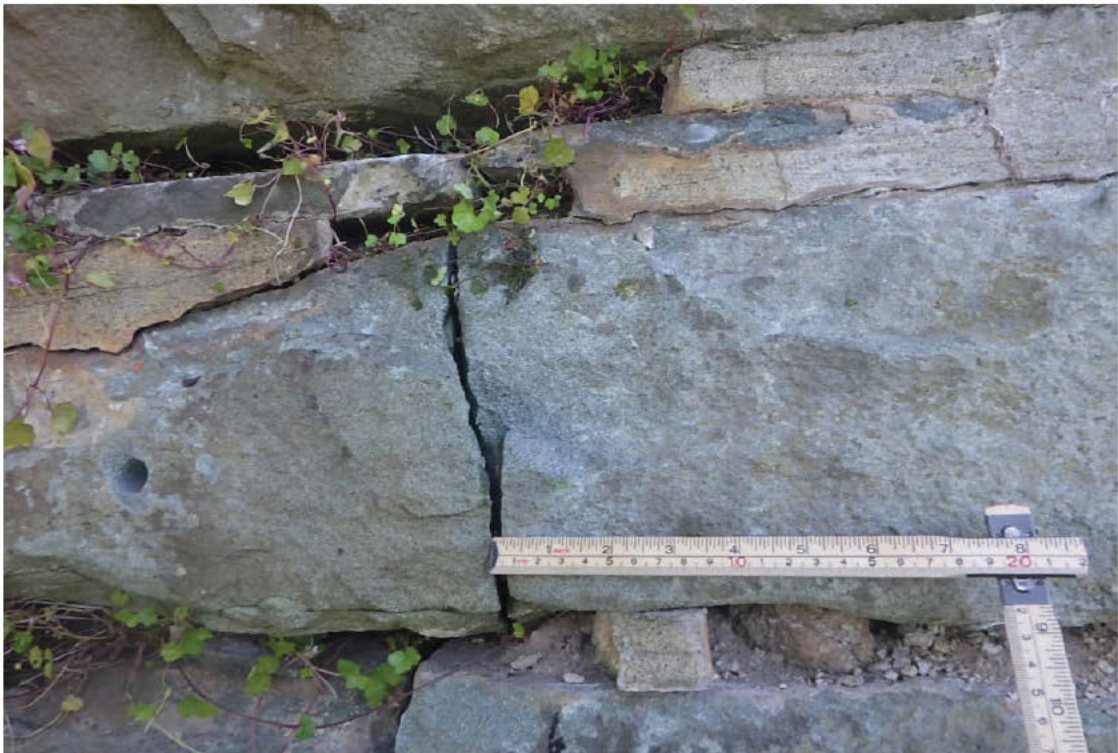
88. Fractured stone in 5th coarse below Left Truss a the Near Abutment.

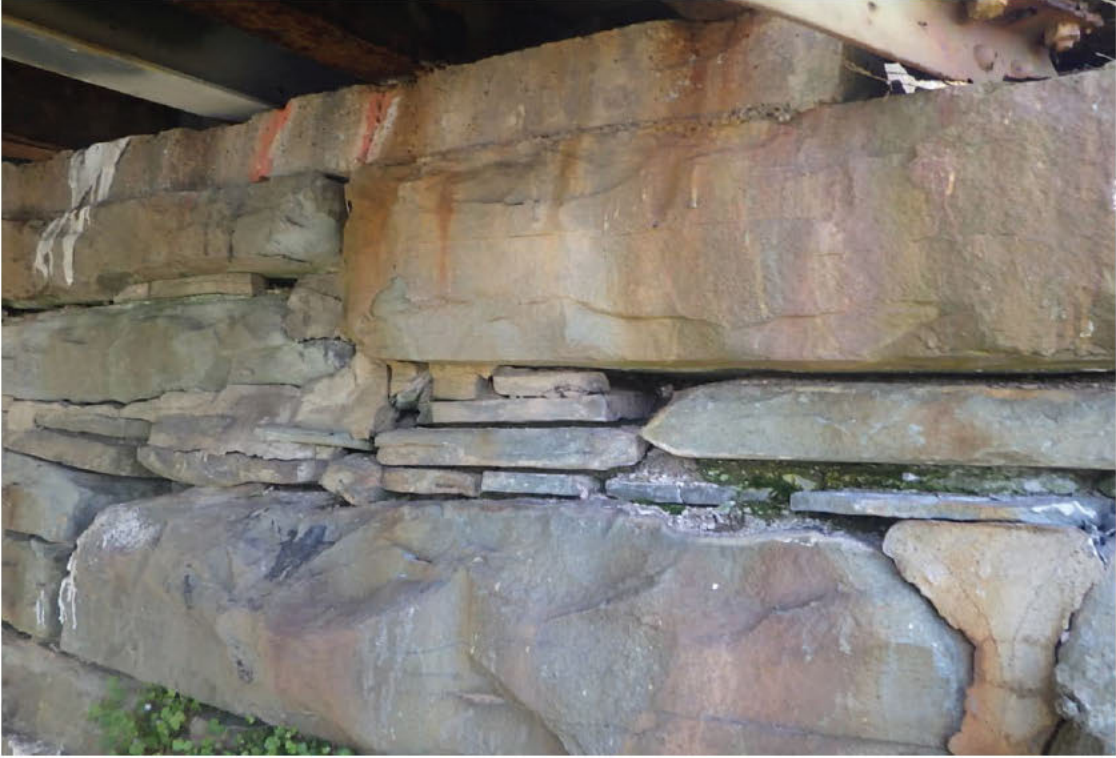
89. Area of deteriorated mortar and loose stones below Stringer 4 to Left Truss, Near Abutment.

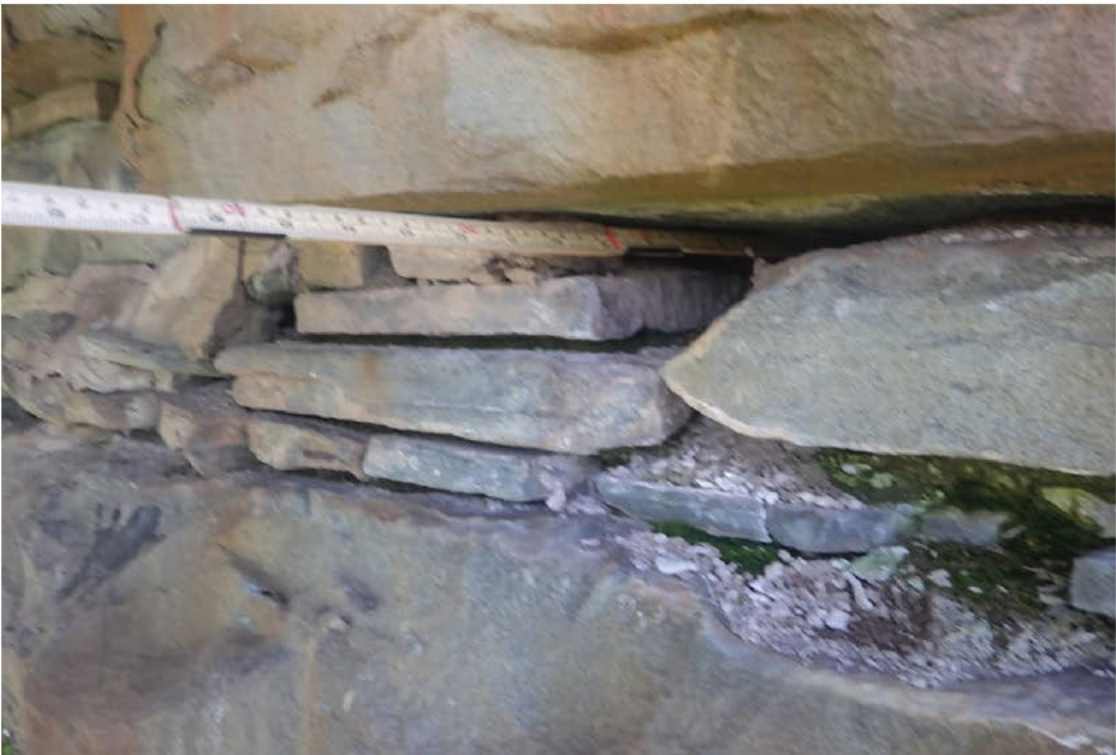
90. Close-up of previous photo showing deep voids in mortar joints.

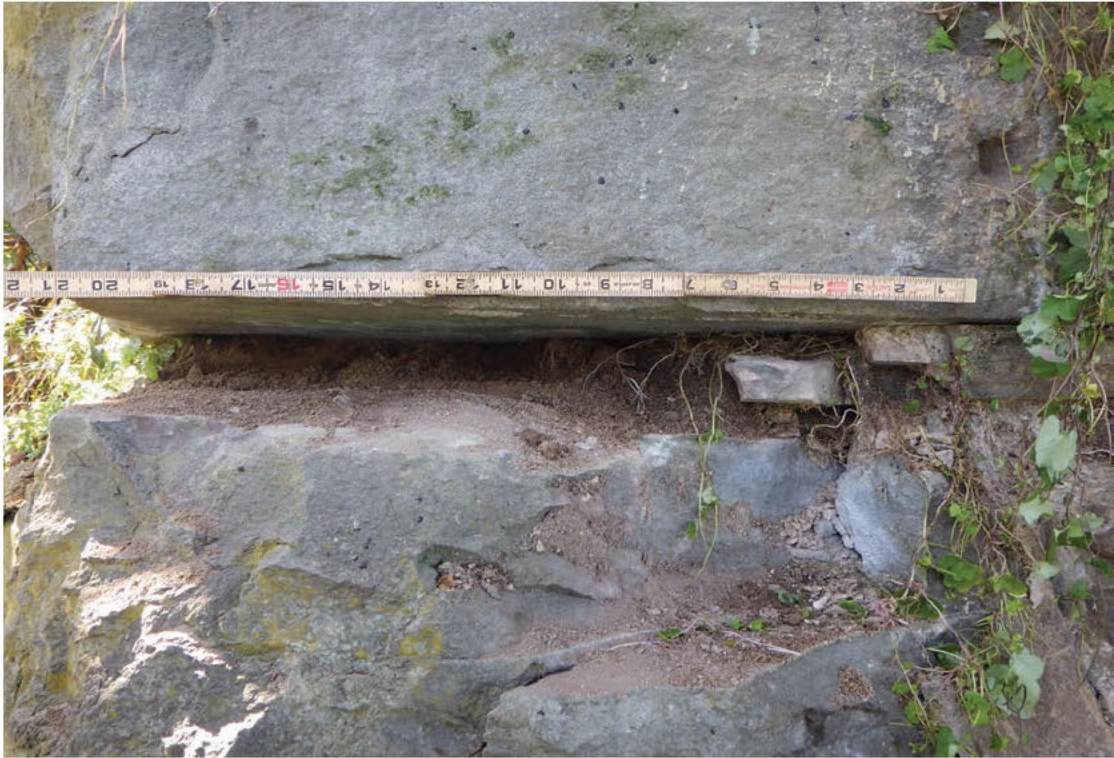
91. Missing stone/mortar under right capstone at the Near Abutment.

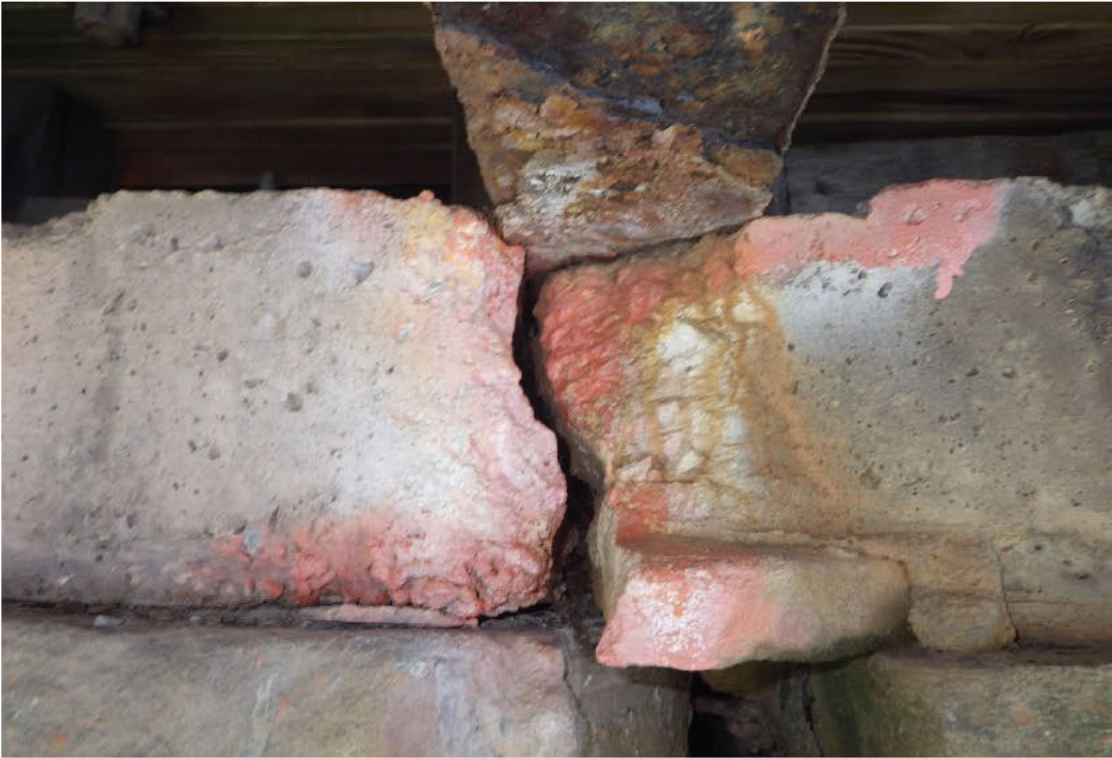
93. Fractured cap stone below Stringer 10 at the Near Abutment.

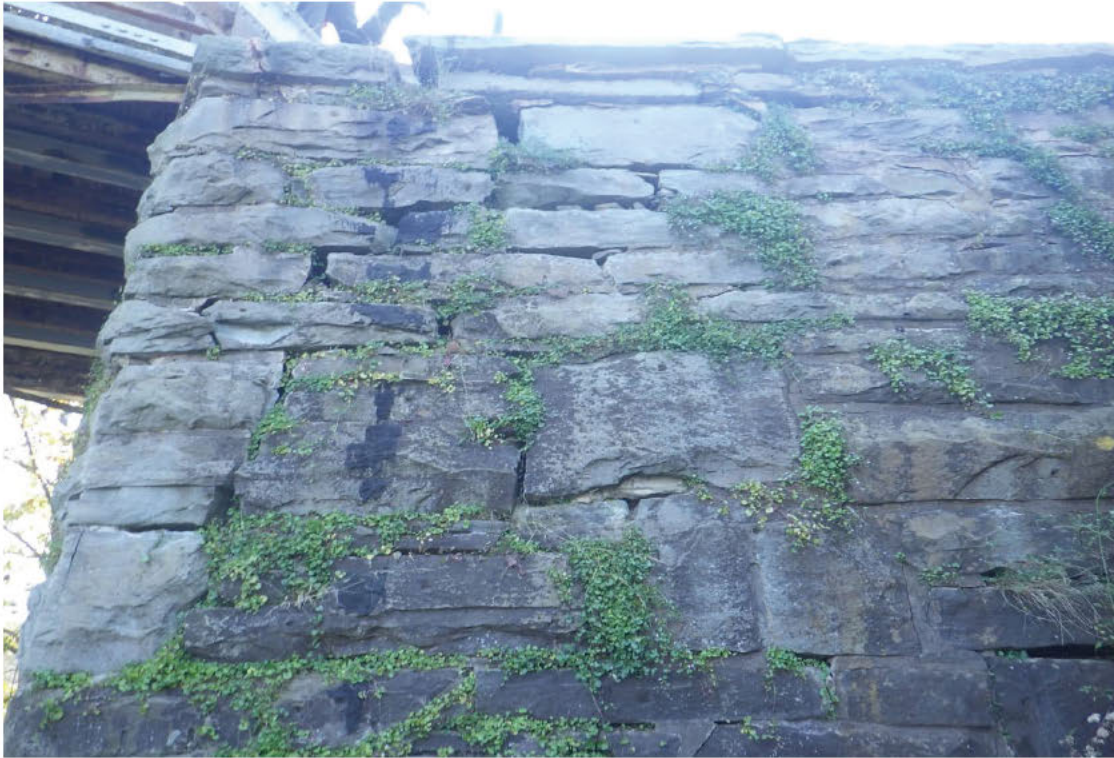
95. Fractured cap stone and deteriorated mortar at the Near Left wingwall.

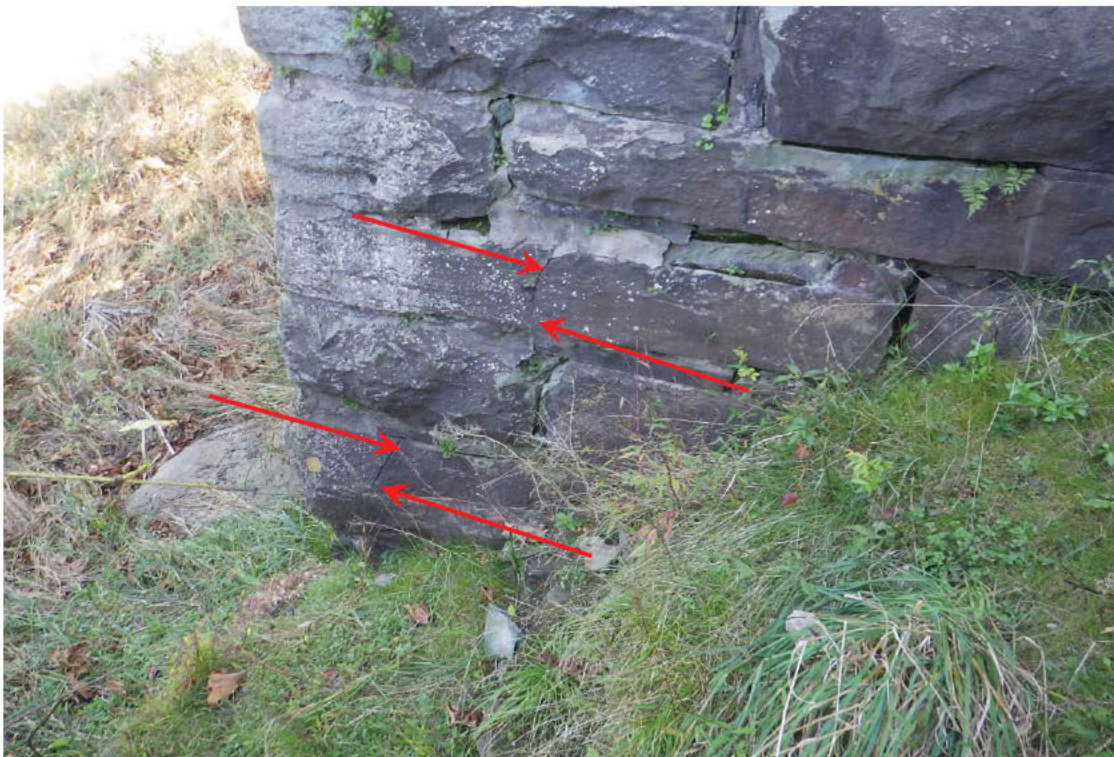
98. Fractured stones along the bottom of the Near Left wingwall.

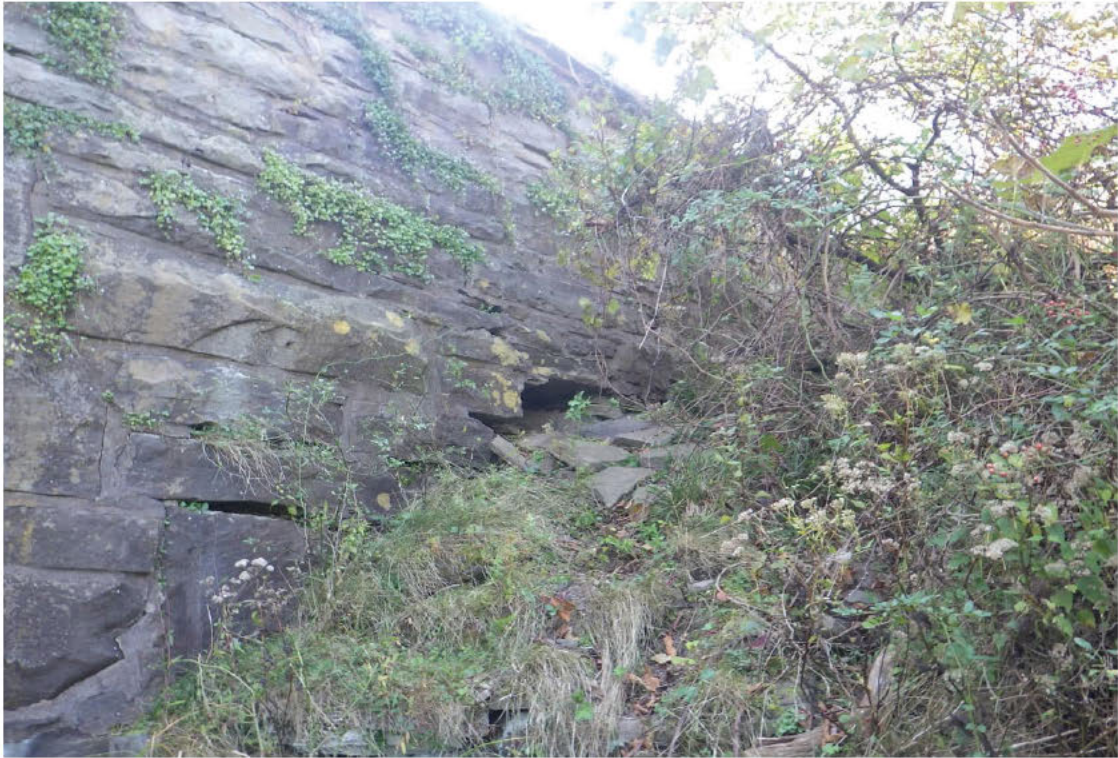
99. Missing stones with void along the base of the Near Left wingwall.

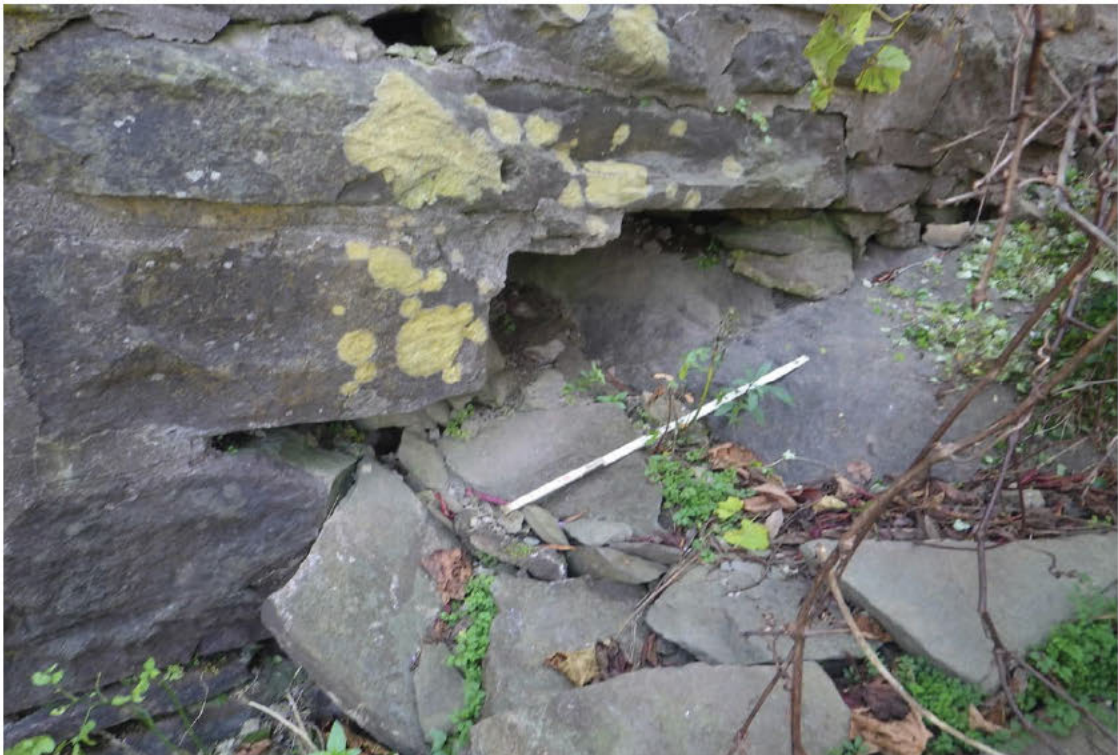
100. Close-up of previous photo.

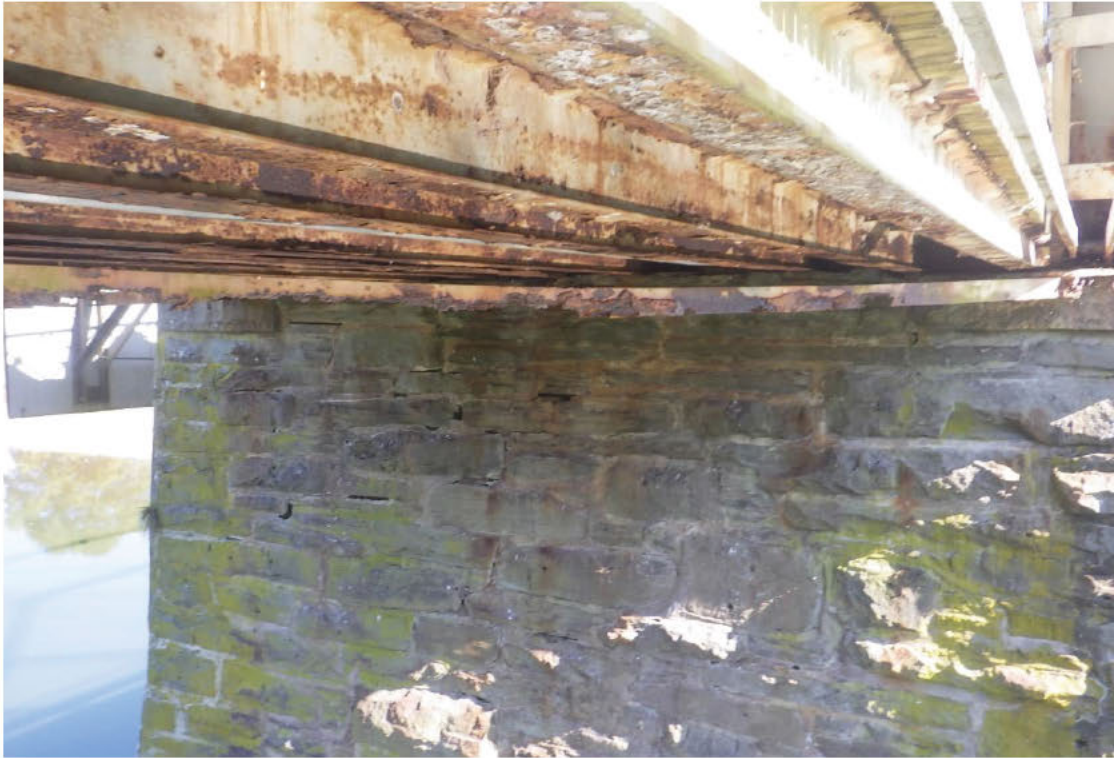
103. Areas of missing mortar along the top of the near face of Pier 1.

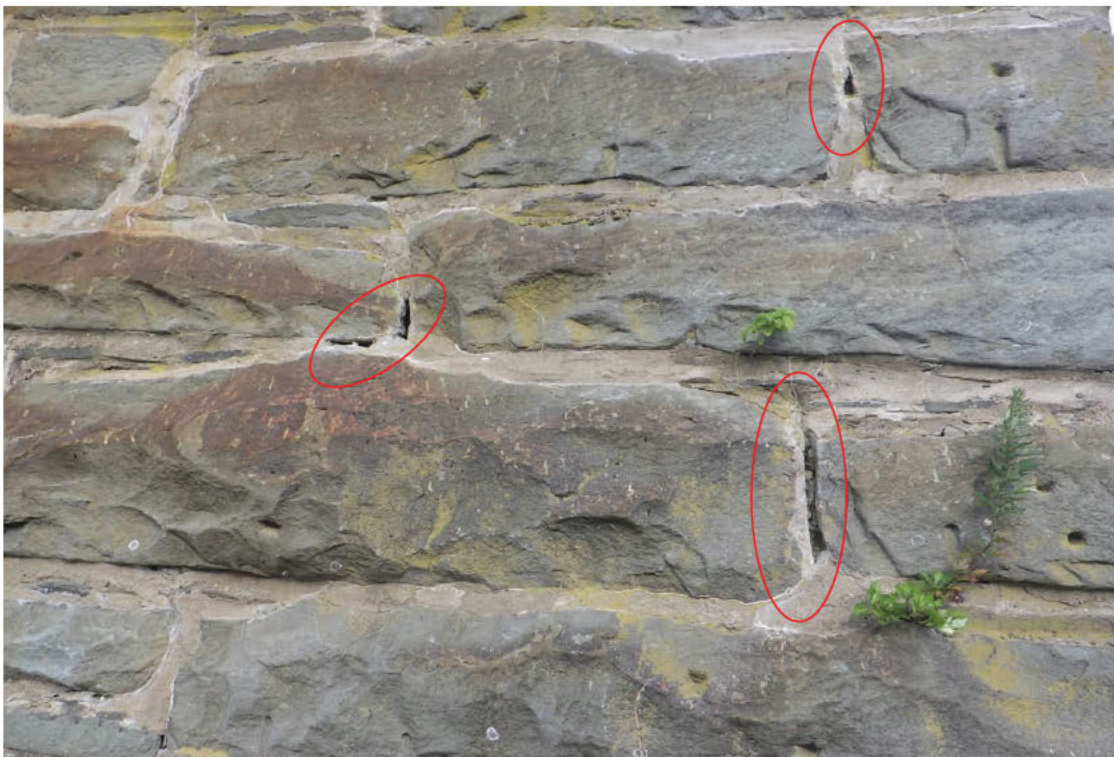
104. Close-up of deteriorated mortar on the near face of Pier 1.

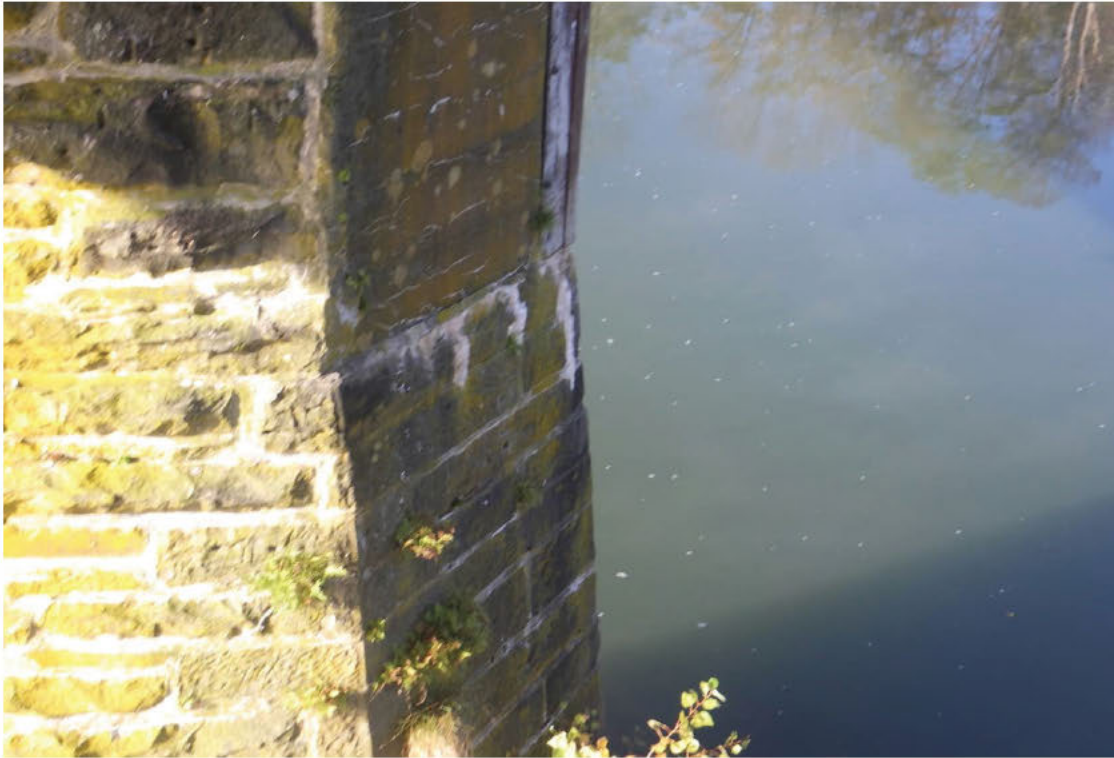
107. Cracks with efflorescence on the left nose of Pier 1.

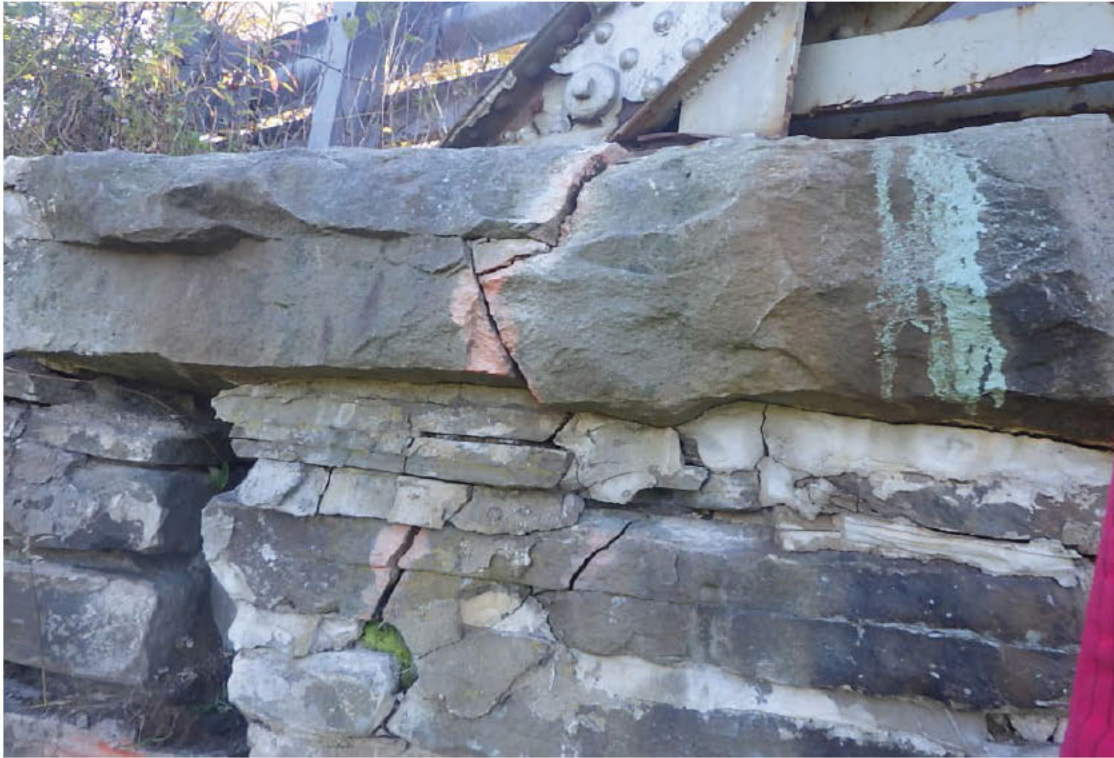
113. Fractured capstone on the Left side of the Far Abutment.

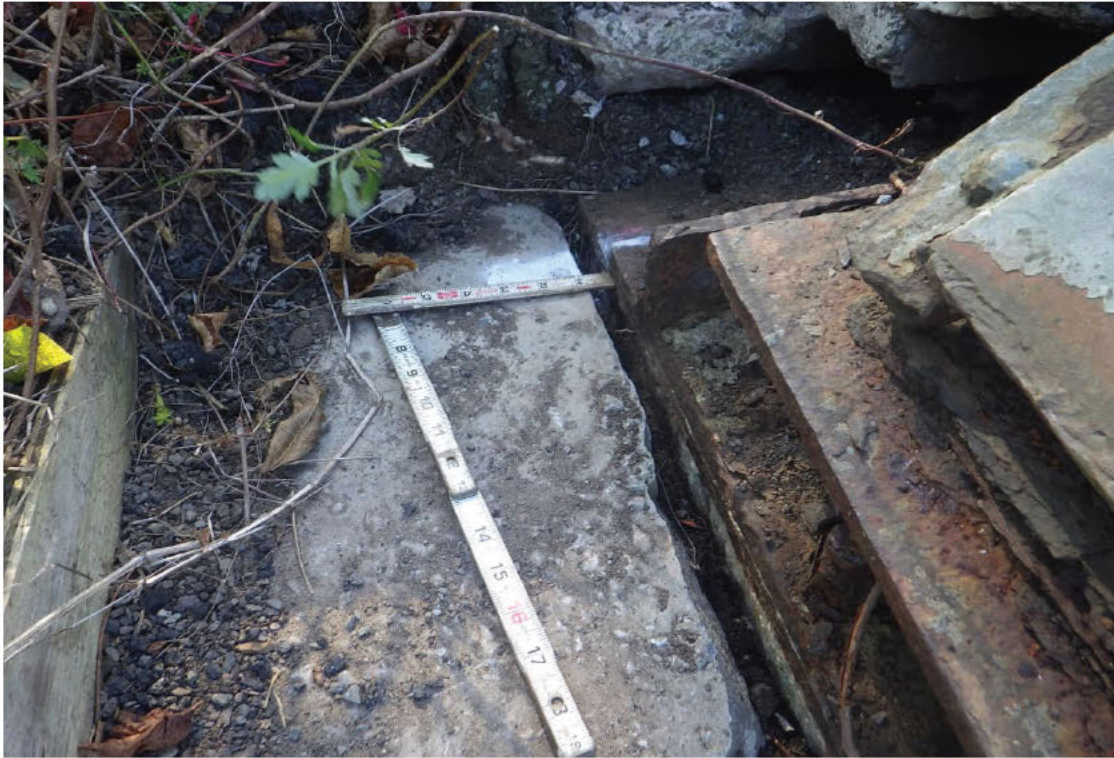
115. Separation of repair and left truss bearing at the Far Abutment.

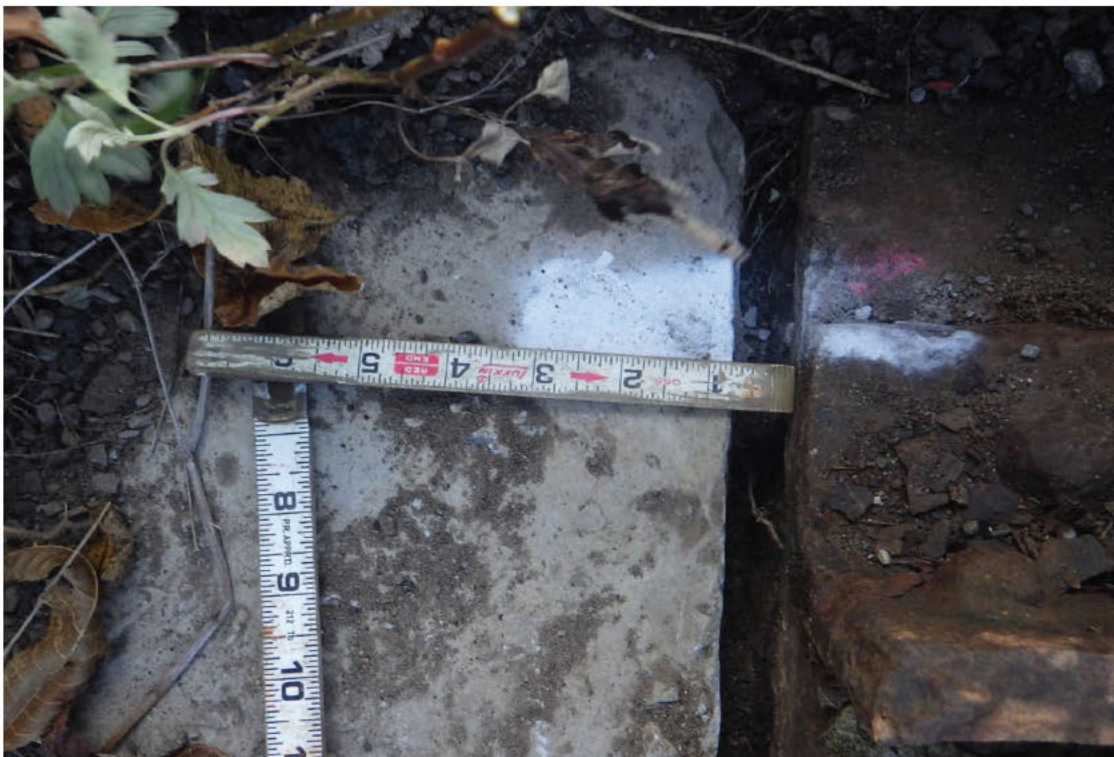
116. Close up of previous photo.

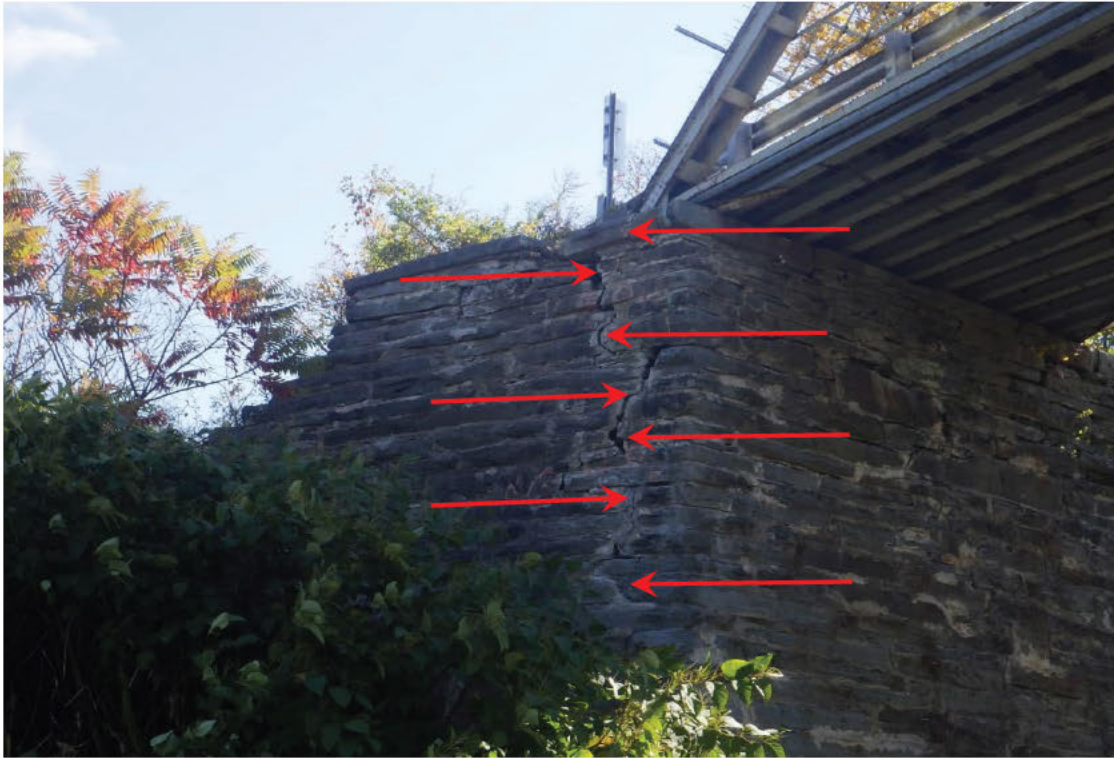
117. Crack with voids and loose stones at the Far Left wingwall.

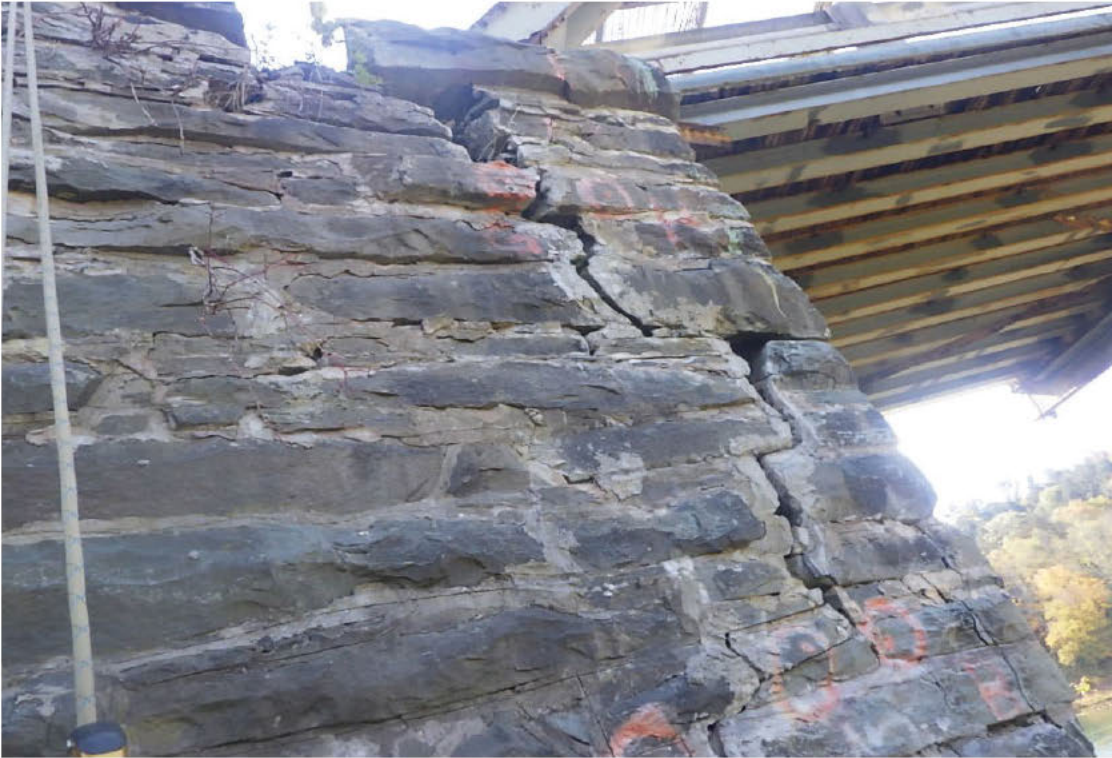
119. Deep void in crack with loose stones and fill at the Far Left wingwall.

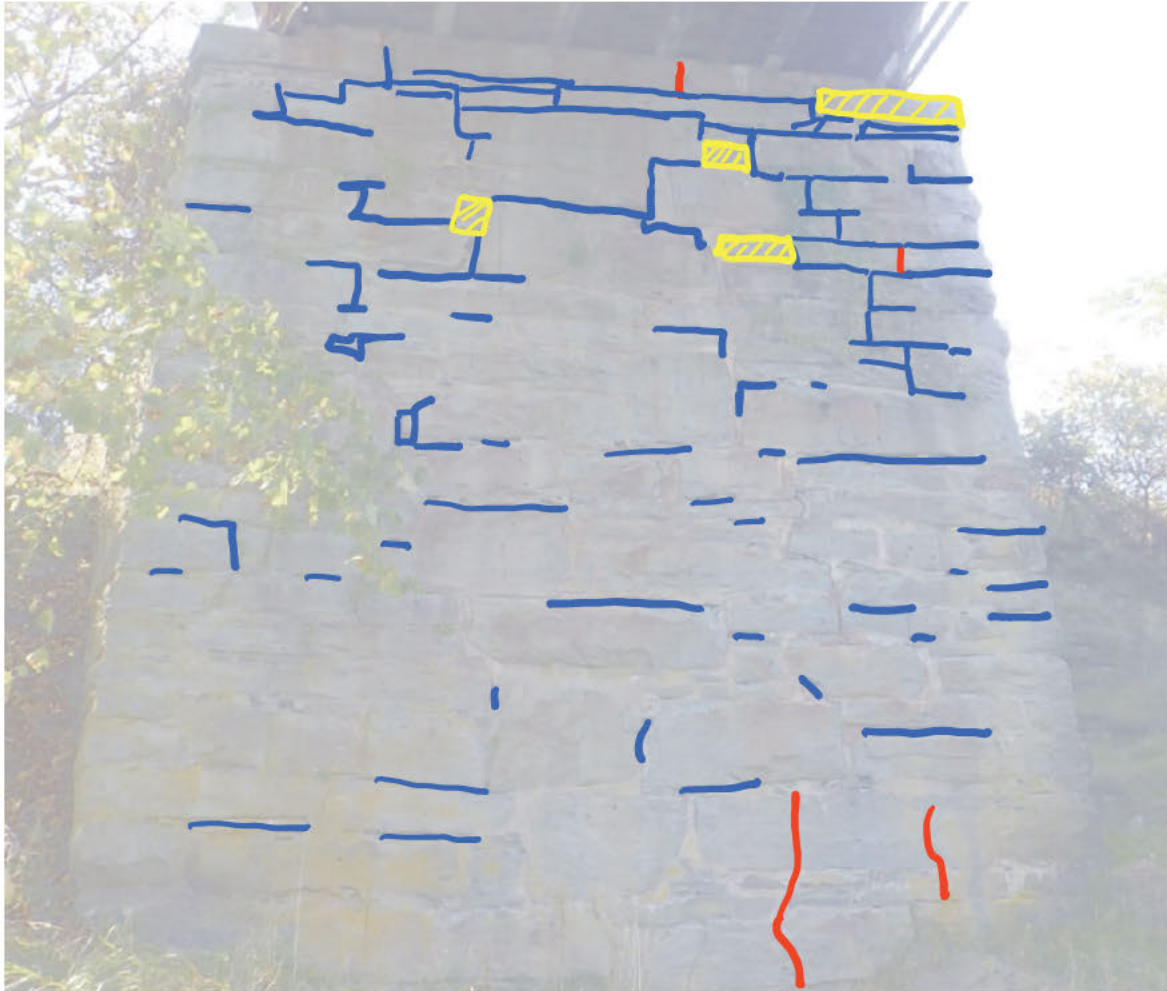
### NEAR ABUTMENT:

— MISSING MORTAR & VOIDS

— CRACKED STONES

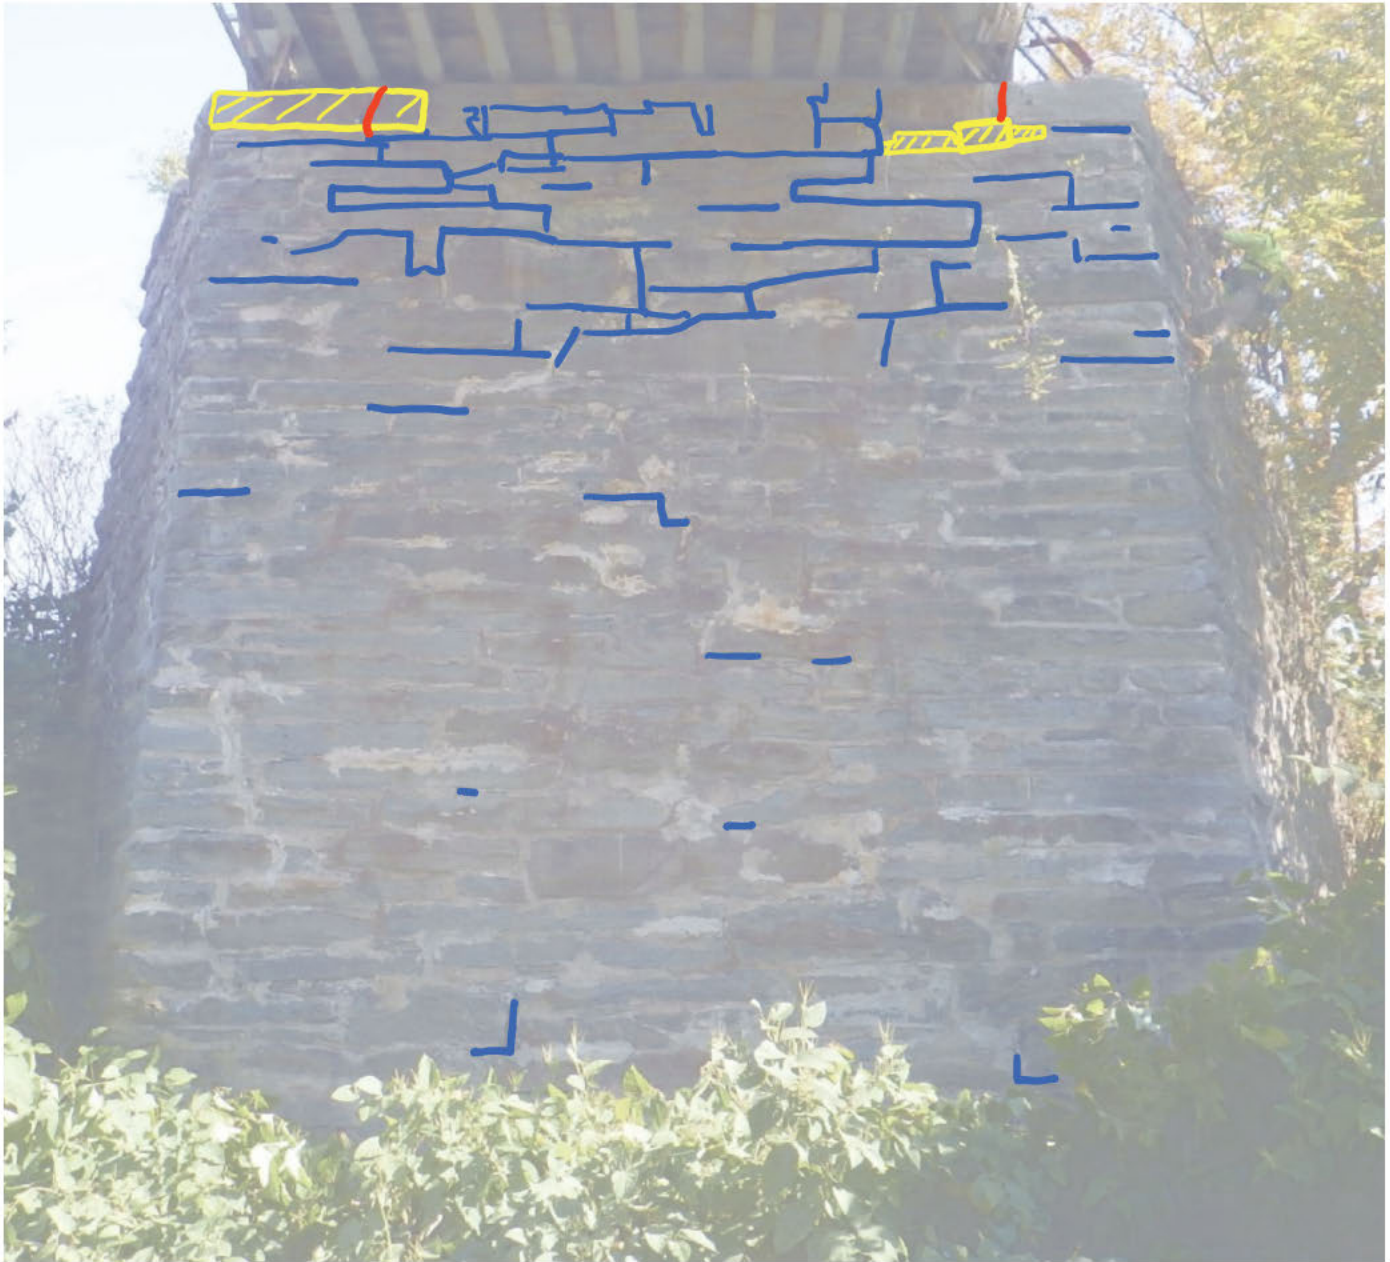
### FAL ABUTMENT:

— MISSING MORTAR & VOIDS

— CRACKED STONES

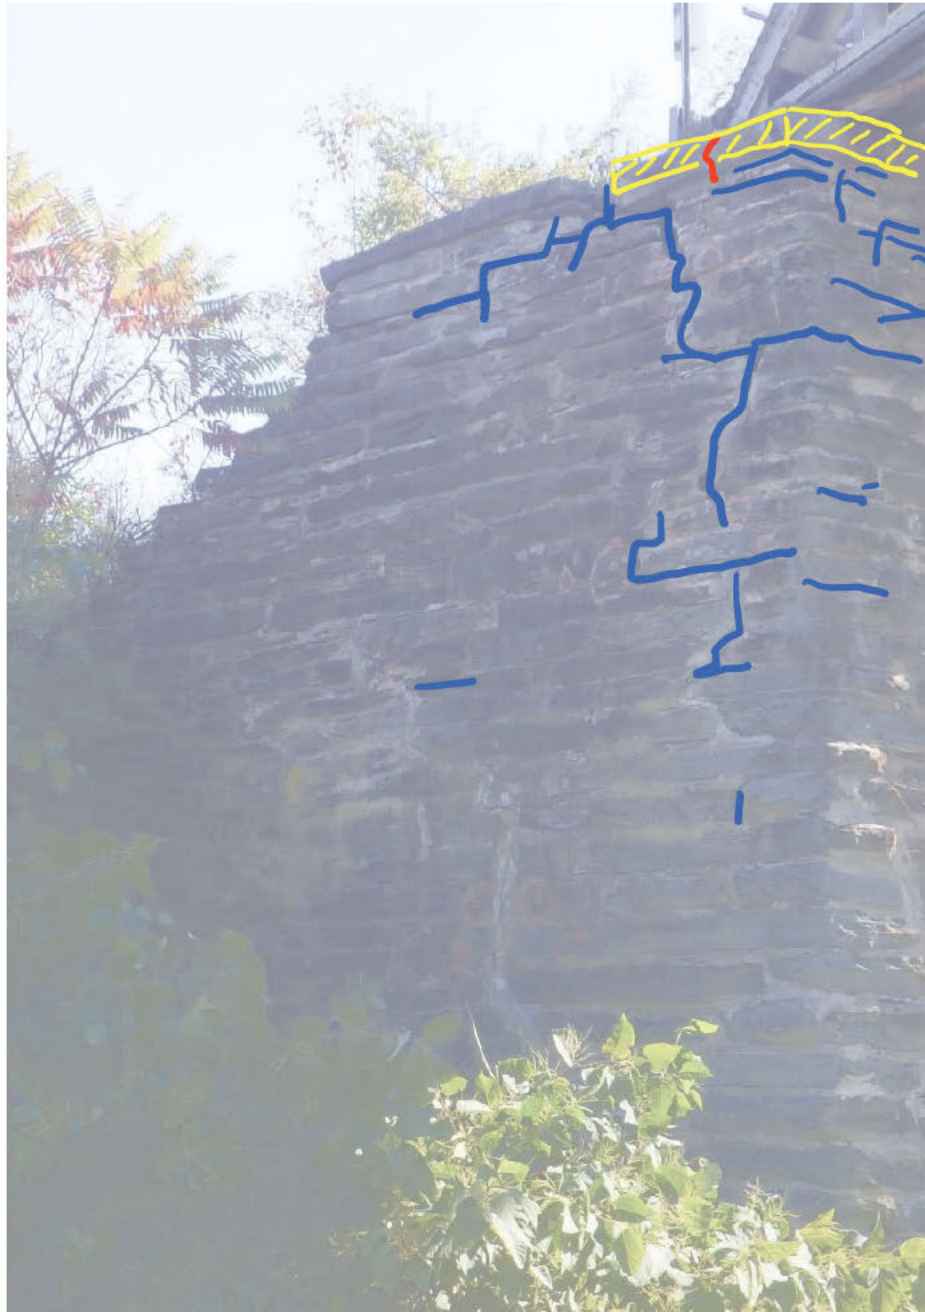
**FAL LEFT WING WALL:**

- MISSING MORTAR & VOIDS
- CRACKED STONES
- MISSING/DISPLACED STONES
