# 2024 Routine Bridge Inspection Report - District 4-0

BMS ID: 63 1002 0230 0739  
BRKEY: 35588  
Feature Carried: SR 1002  
Feature Under: Delaware River

**2024 ROUTINE BRIDGE INSPECTION REPORT  
SR 1002 over DELAWARE RIVER**

**BMS No. 63 1002 0230 0739**

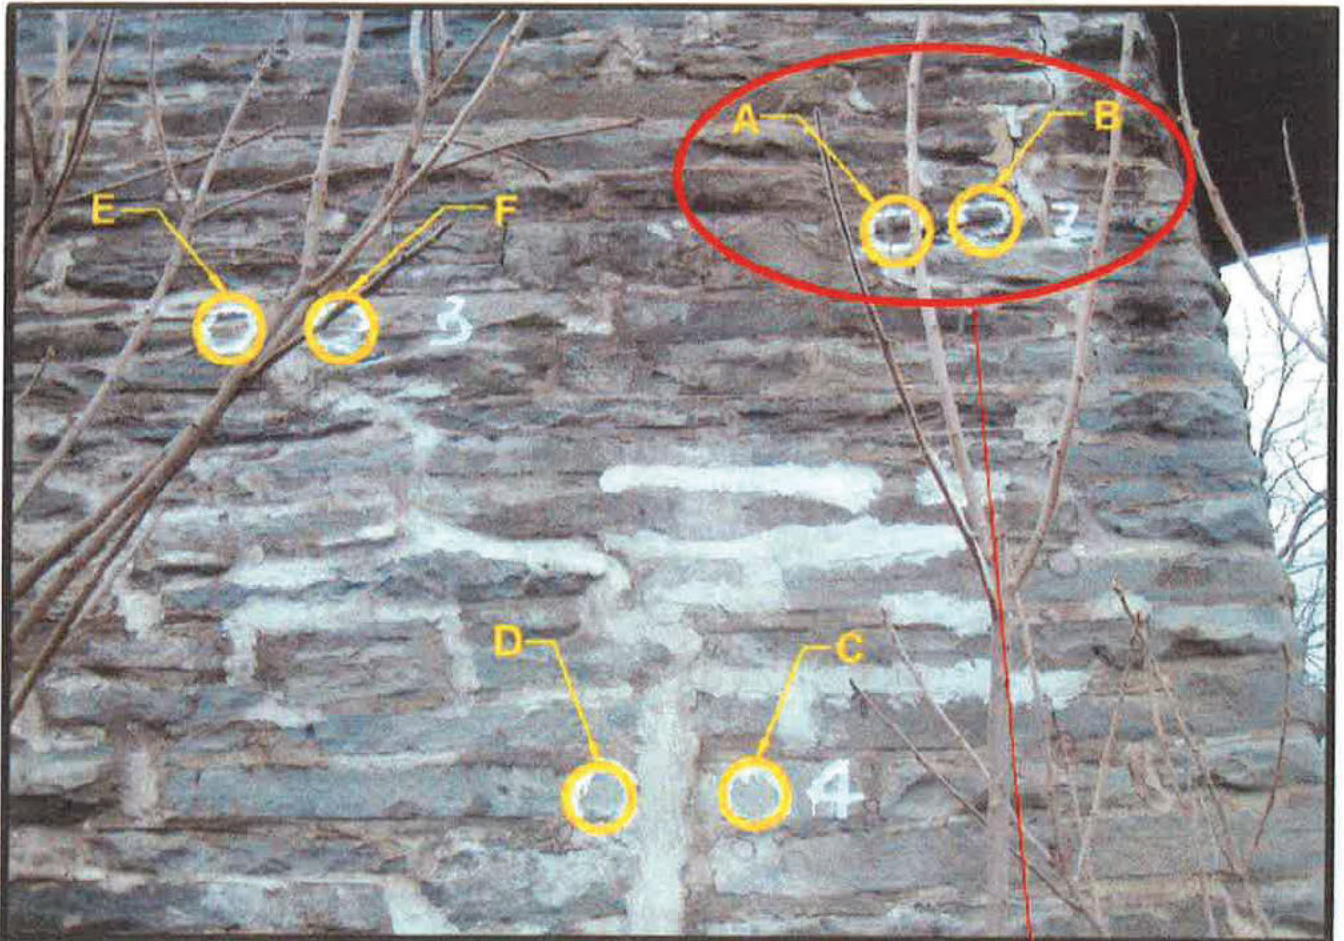
**MONITORING POINTS**  
**@ FAR LEFT WING WALL**

11/6/2014 : Previous Location 2 monitoring points no longer visible due to mortar repairs. See new monitoring points on Sheet 2 of 4.

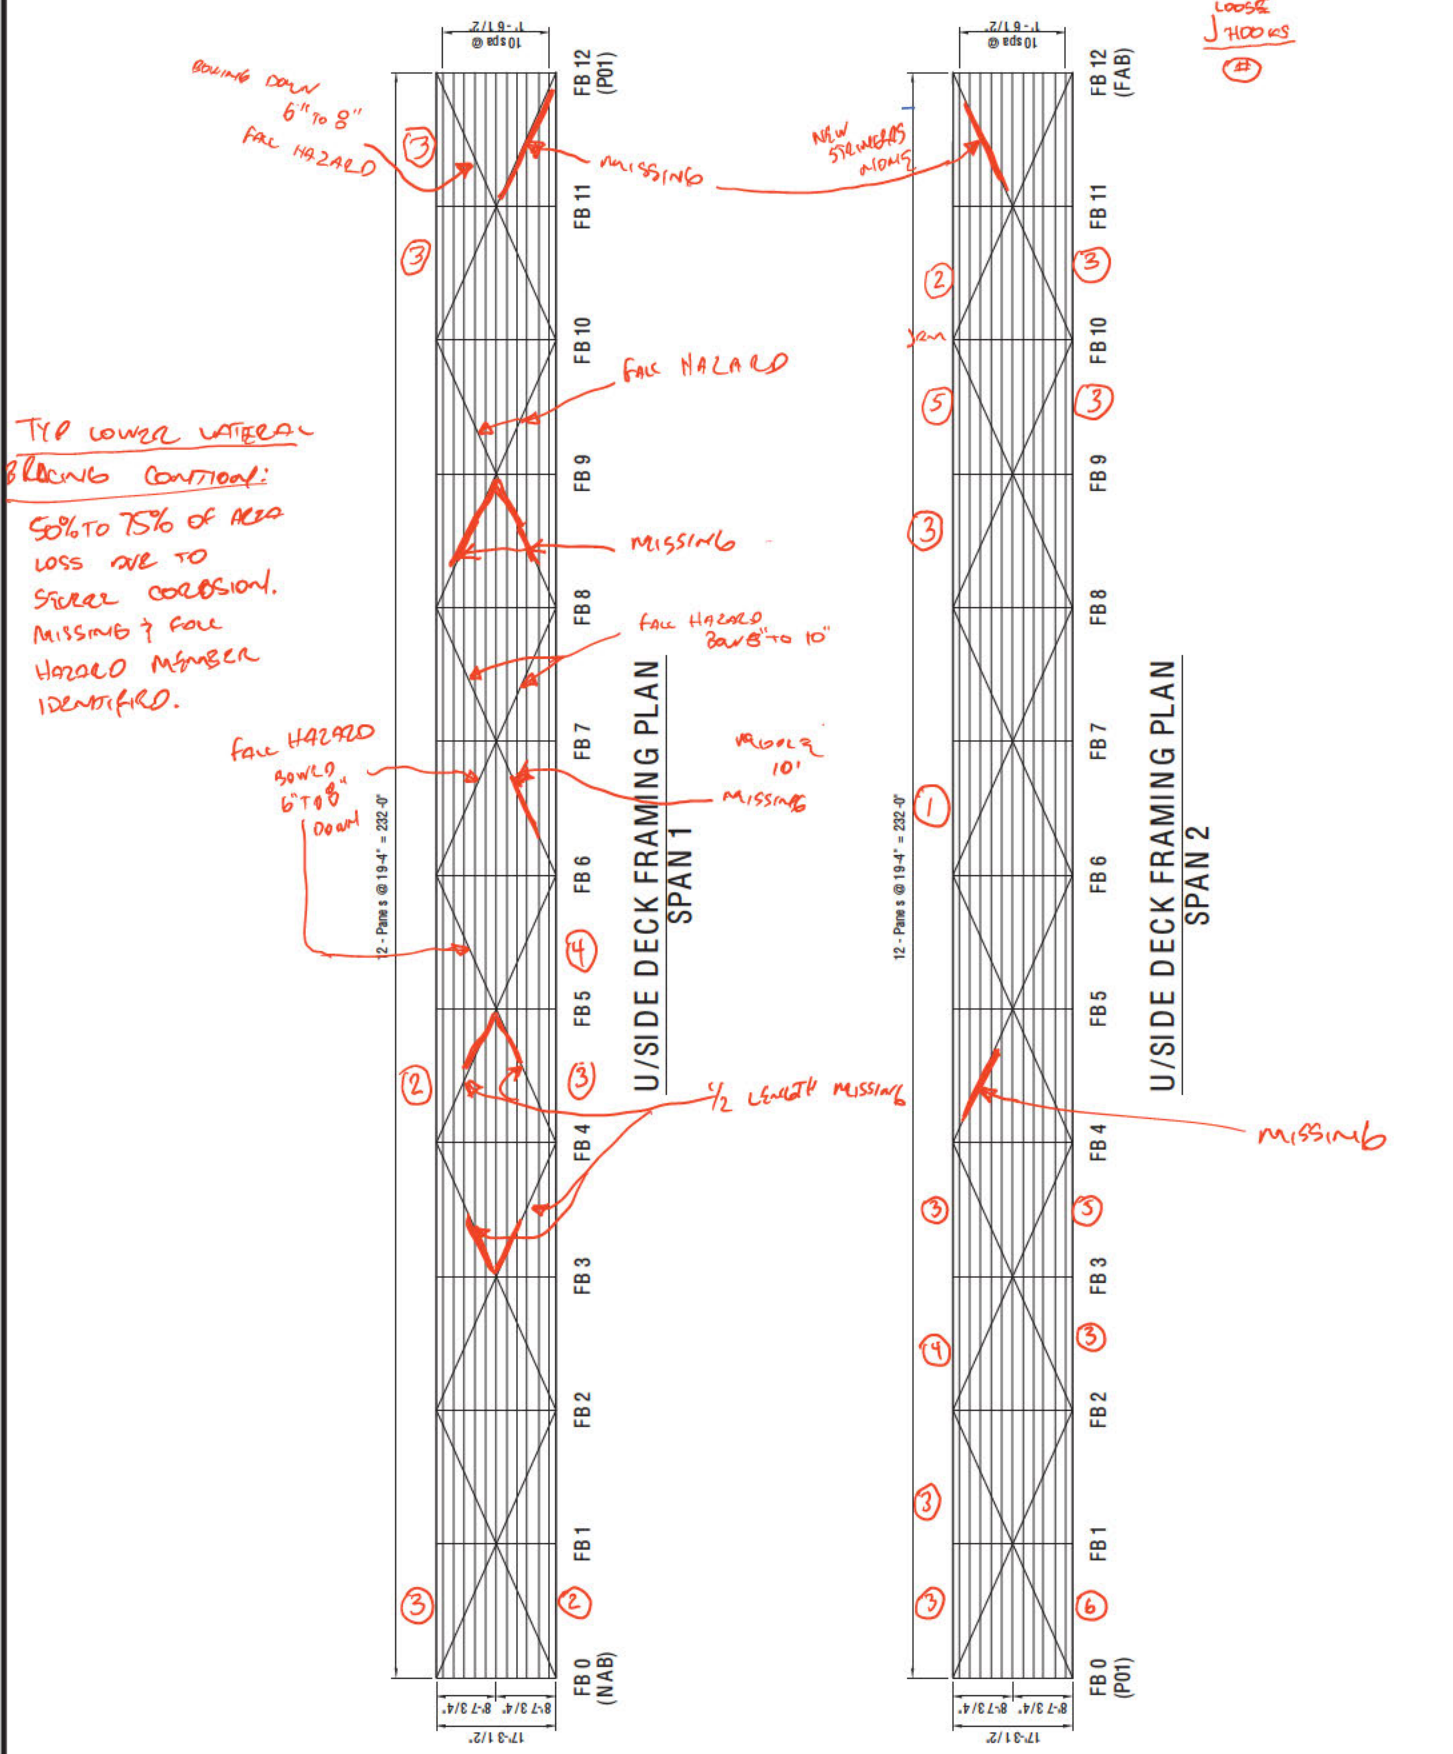
TYP LOWER LATERAL BRACING CONDITION:  
 50% TO 75% OF AREA LOSS DUE TO STEEL CORROSION.  
 MISSING & FACE HAZARD MEMBER IDENTIFIED.

Loose J Hooks #

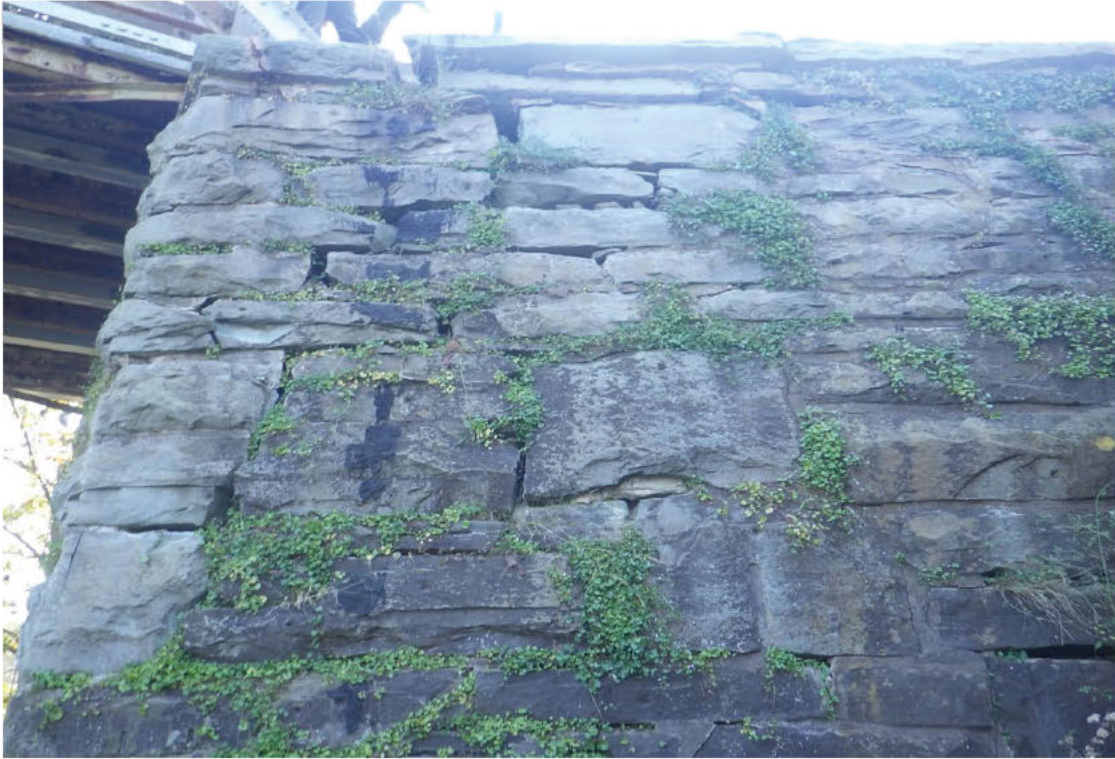
7. Near Left wingwall with loose and fractured stones with adjacent mortar joint voids

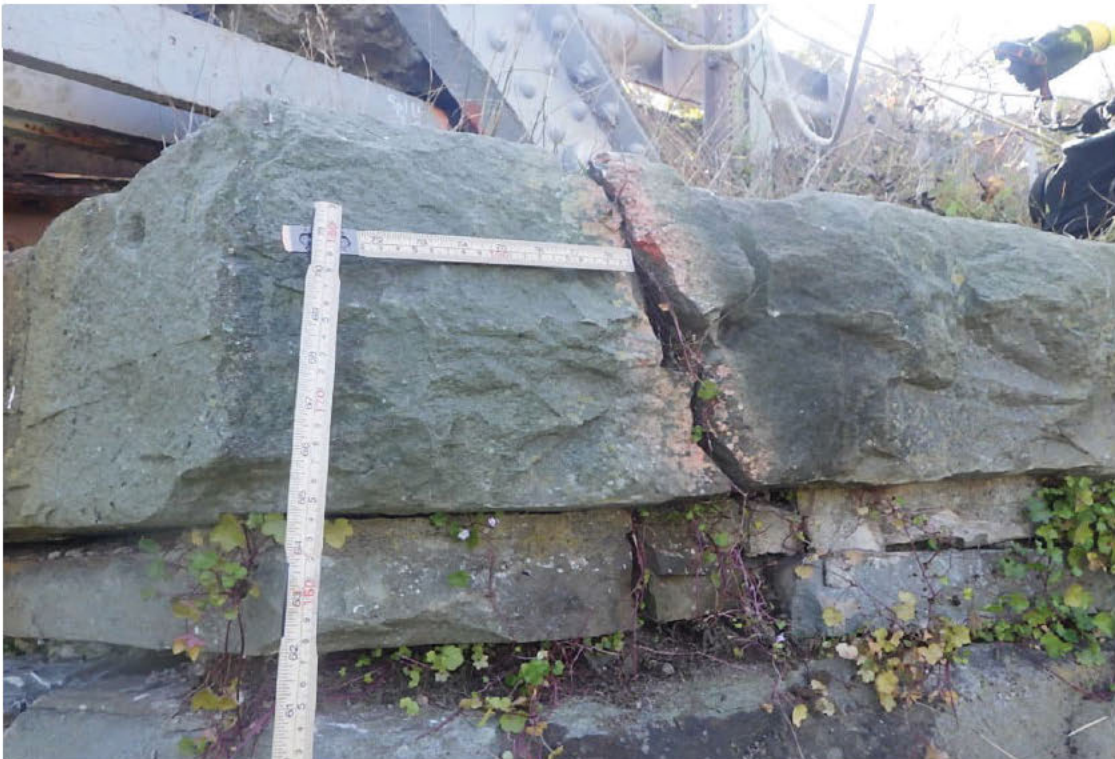
8. Fractured cap stone at NAB/NL Wingwall interface.

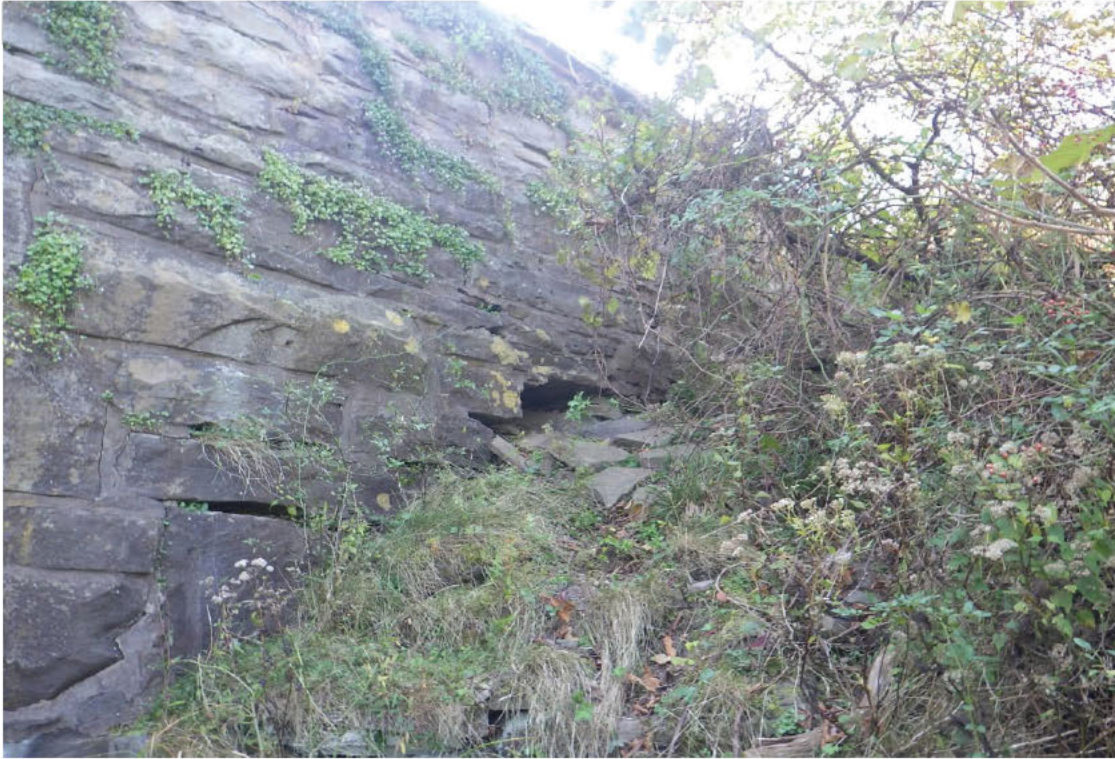
9. Near Left wingwall with large void due to missing stones.

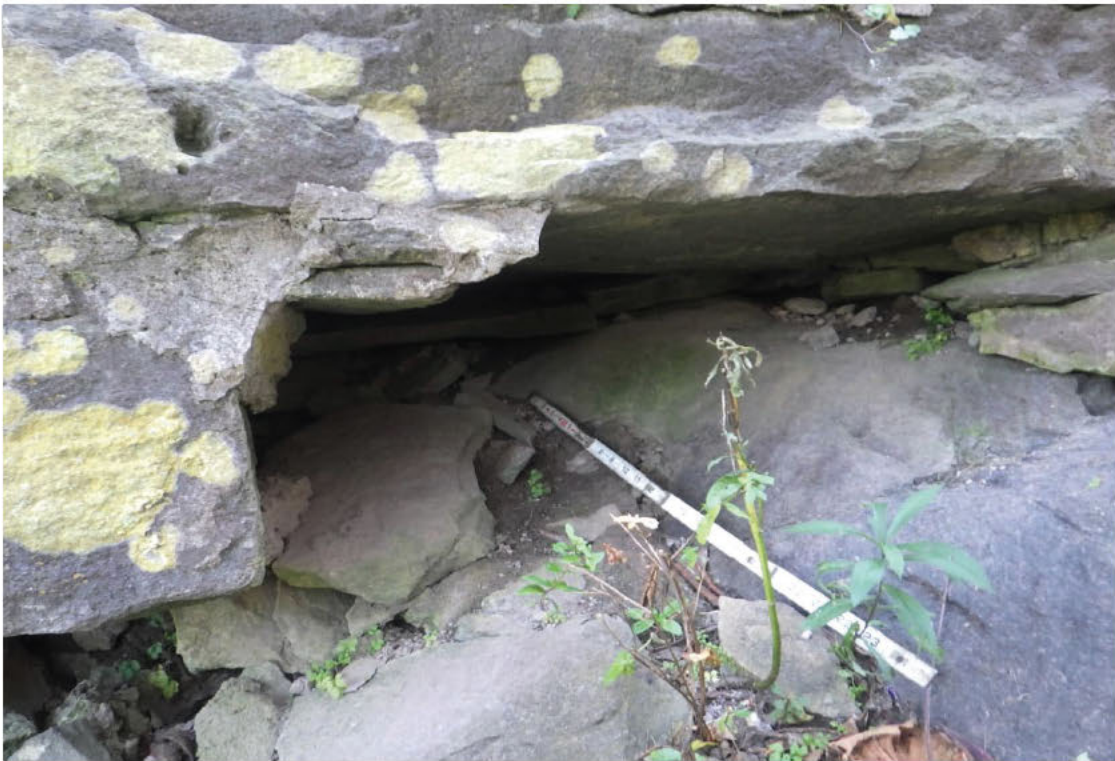
10. Close-up of previous Photo.

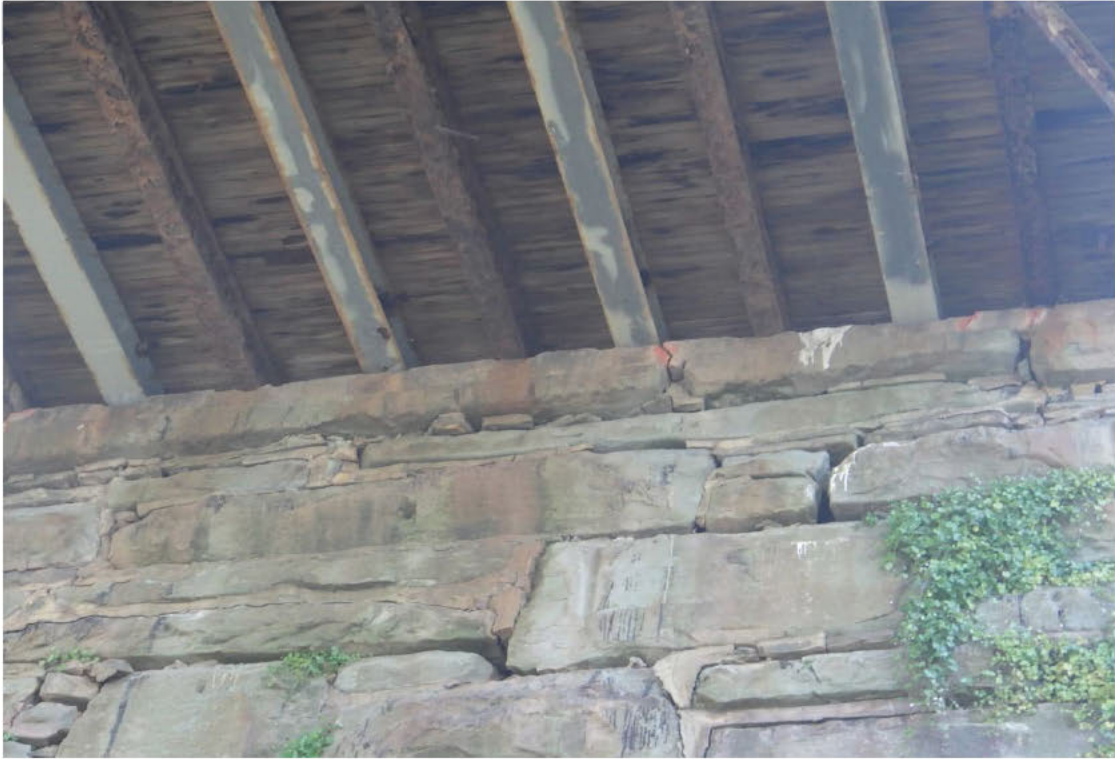
11. Area of loose stones and missing mortar at left end of the Near Abutment.

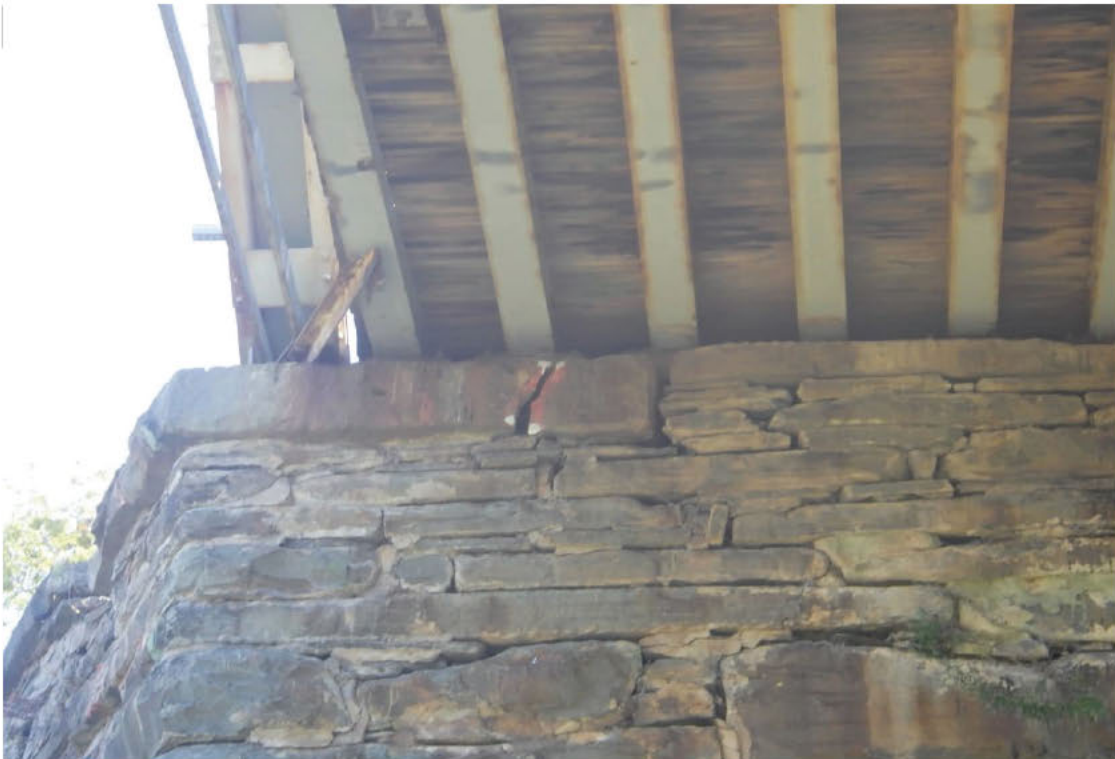
12. Area of loose stones and missing mortar at left end of the Far Abutment.

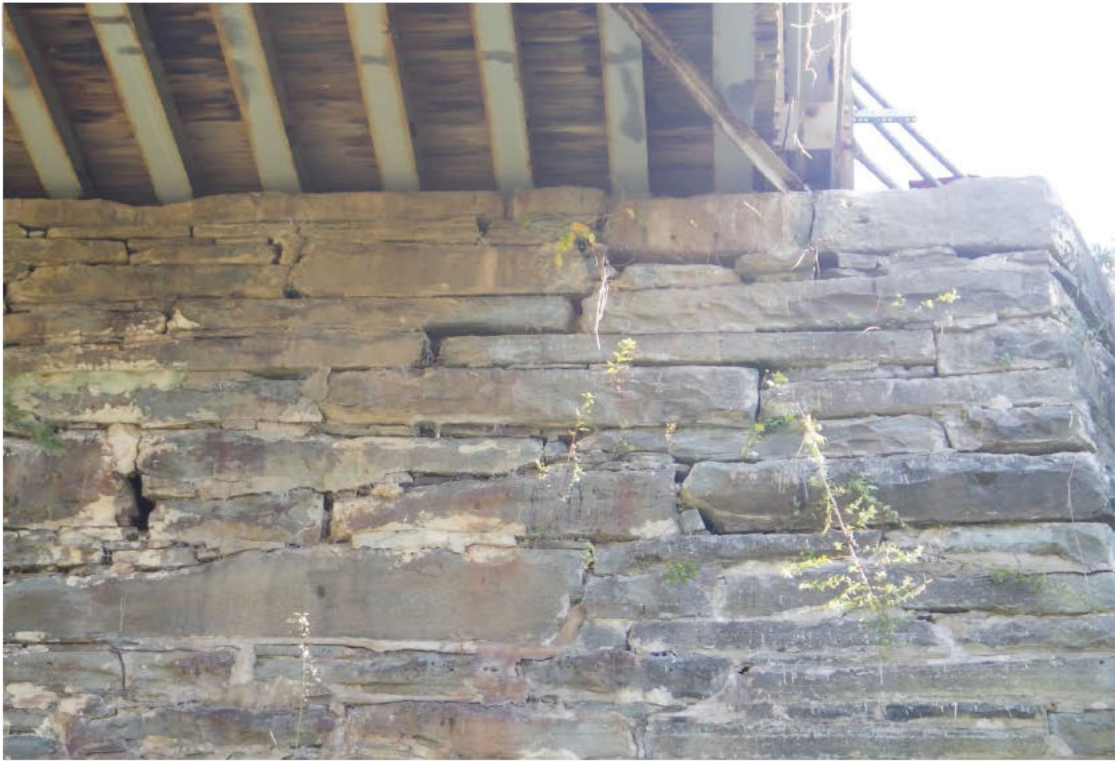
13. Area of loose/displaced stones and missing mortar at right end of the Far Abutment.

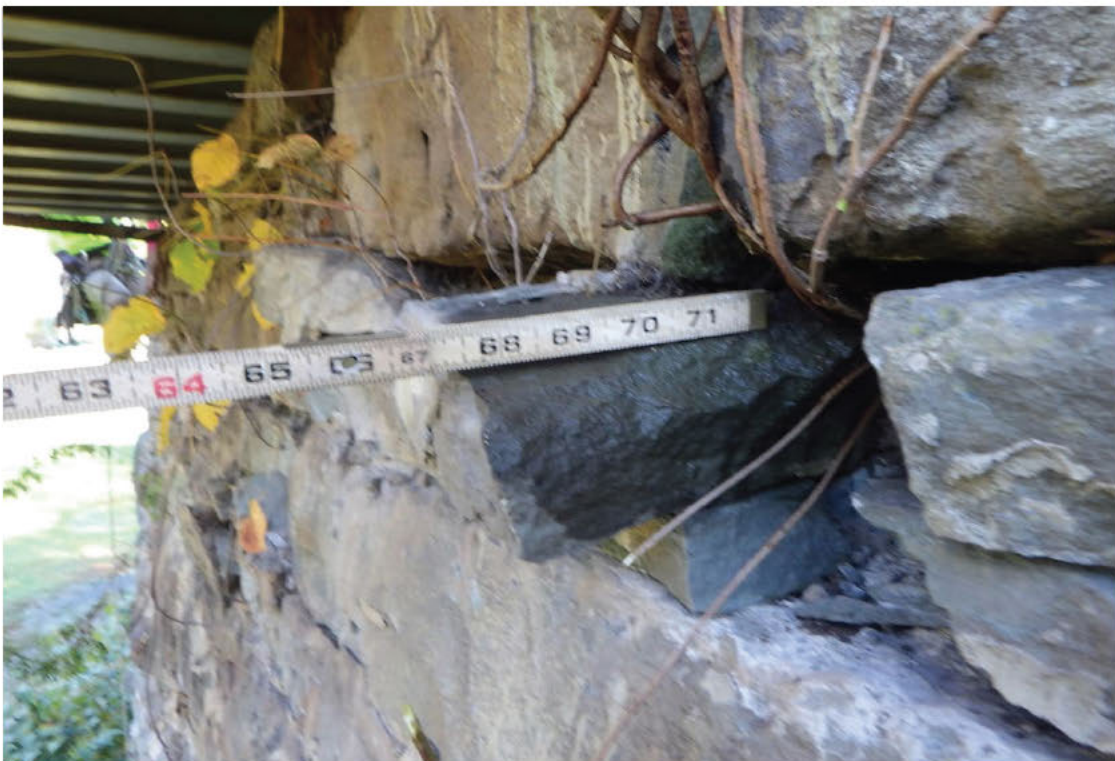
14. Close-up of previous photo showing displaced stone.

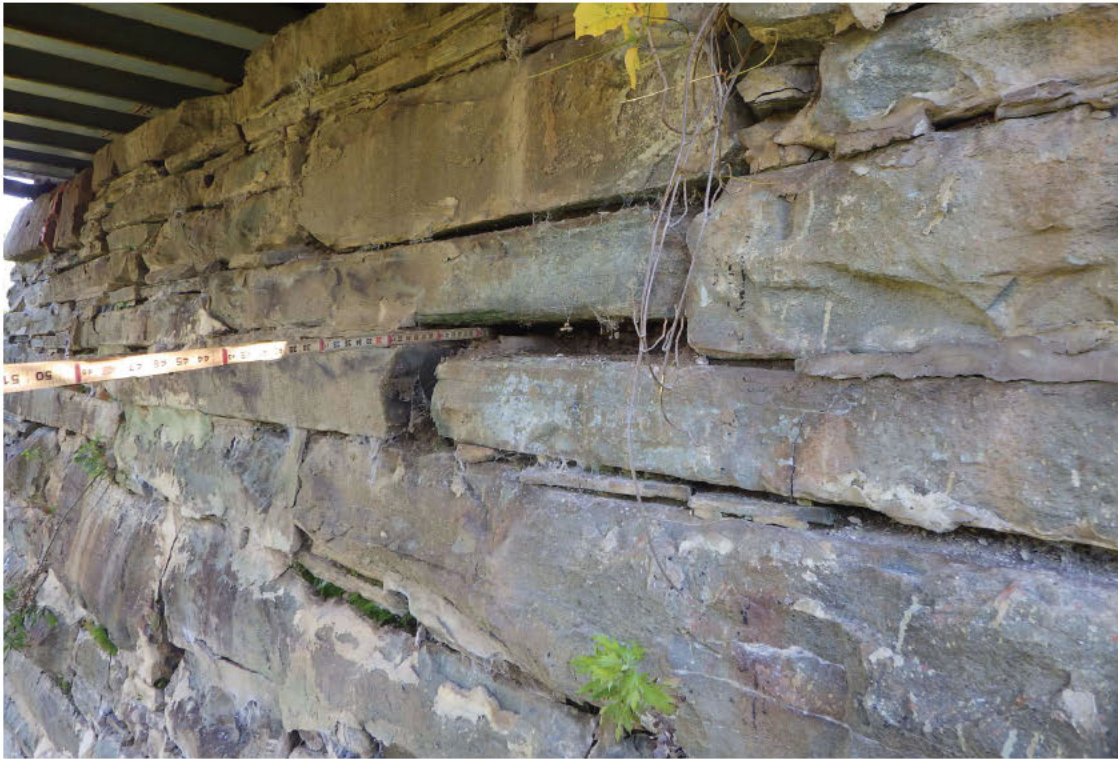
15. Deep void and loose stones on the right side of the Far Abutment.

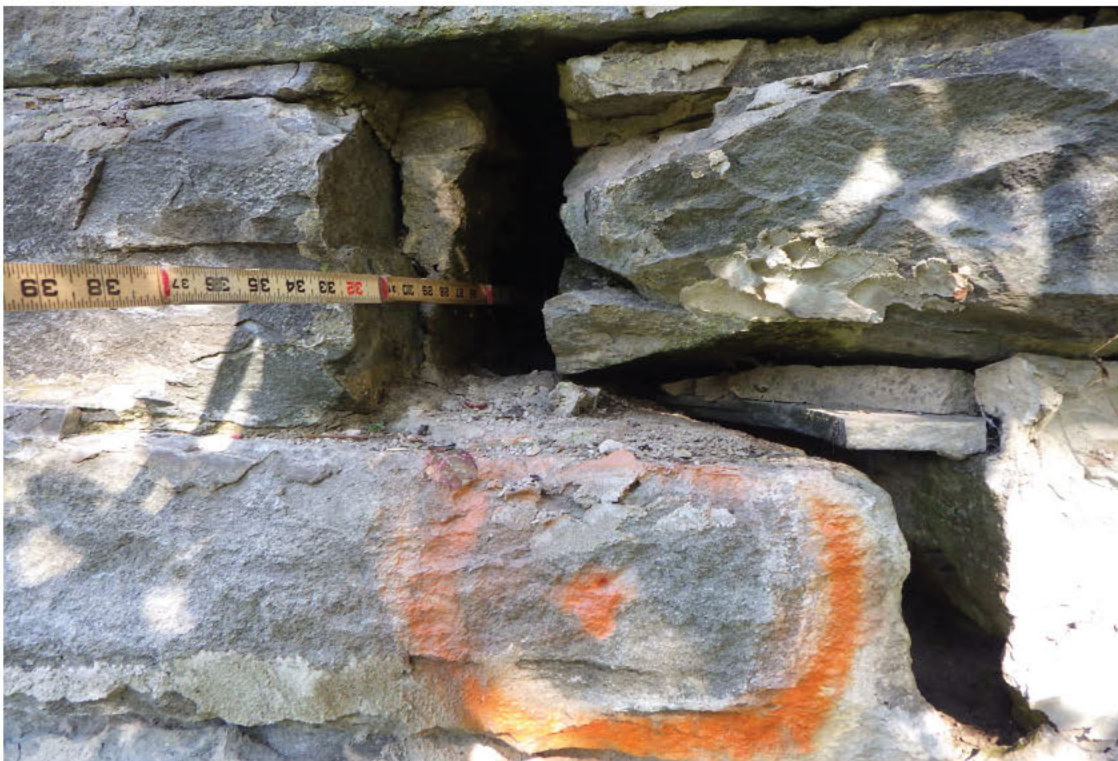
16. Deep void and loose stones at the Far Right Wingwall.

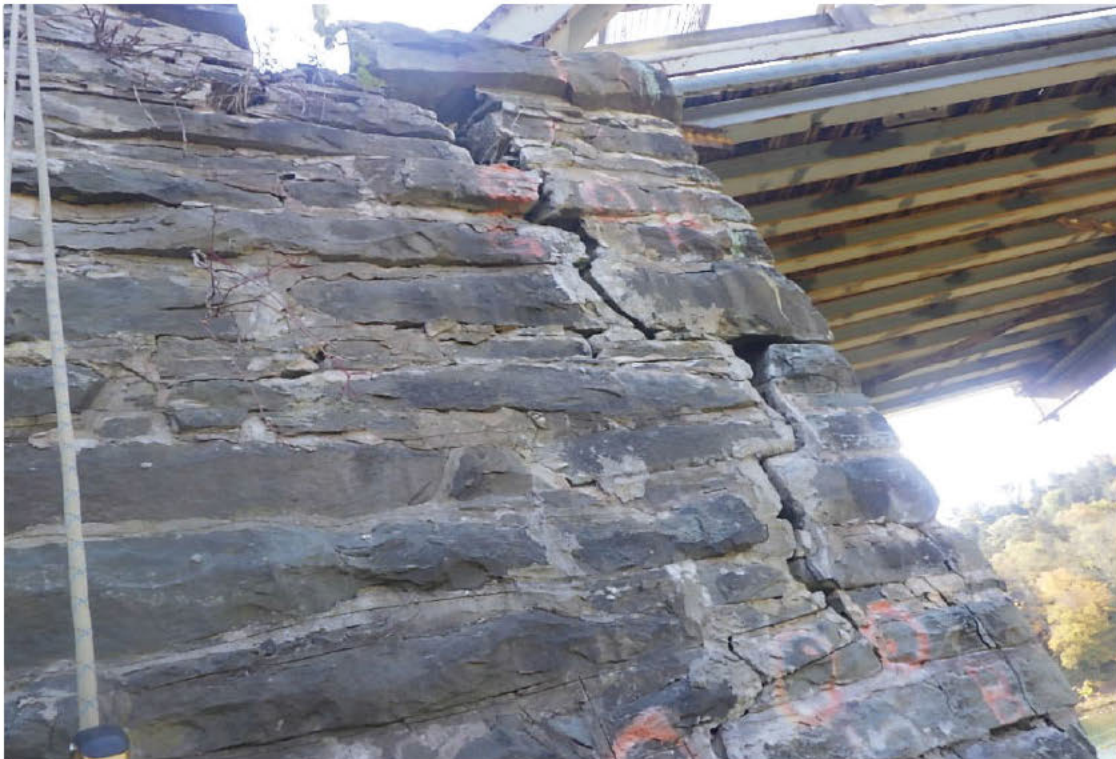
18. Wide crack with loose stones and missing mortar in the Far Left Wingwall.

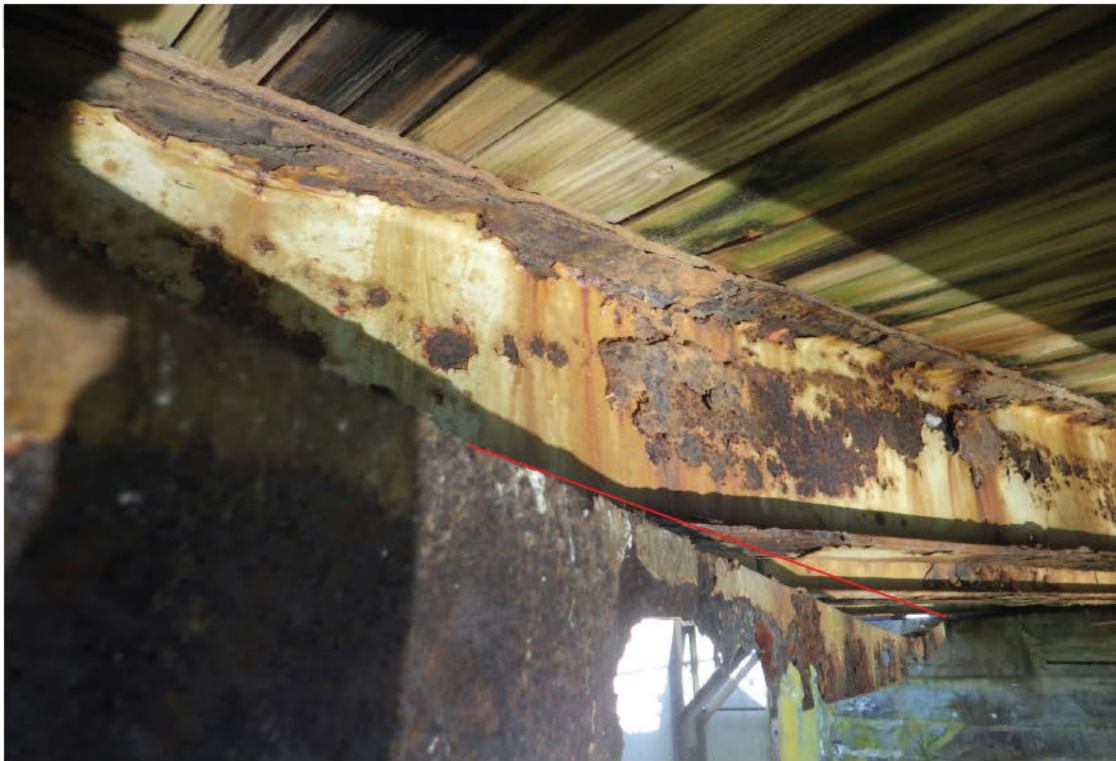
20. Deflected left lower lateral brace with severe corrosion, Span 1 between FB 11 & 12, looking ahead.

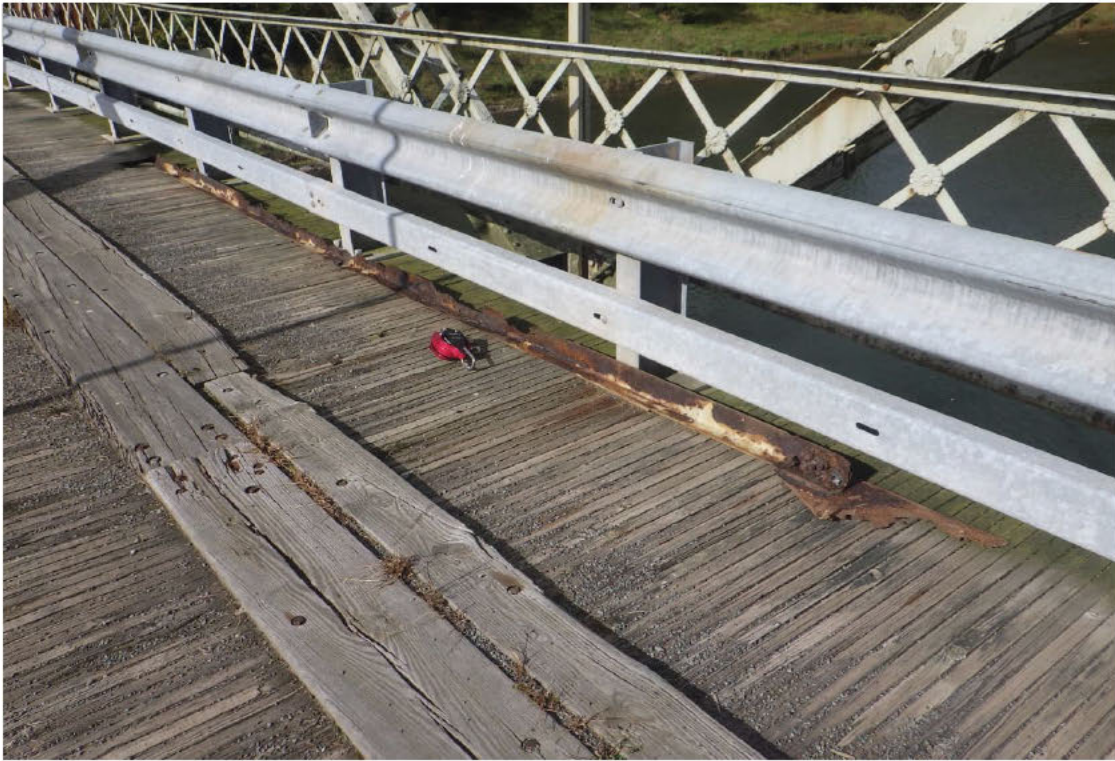
21. Loose right lower lateral brace member removed and left on the top of deck, Span 1 between FB 11 & 12.

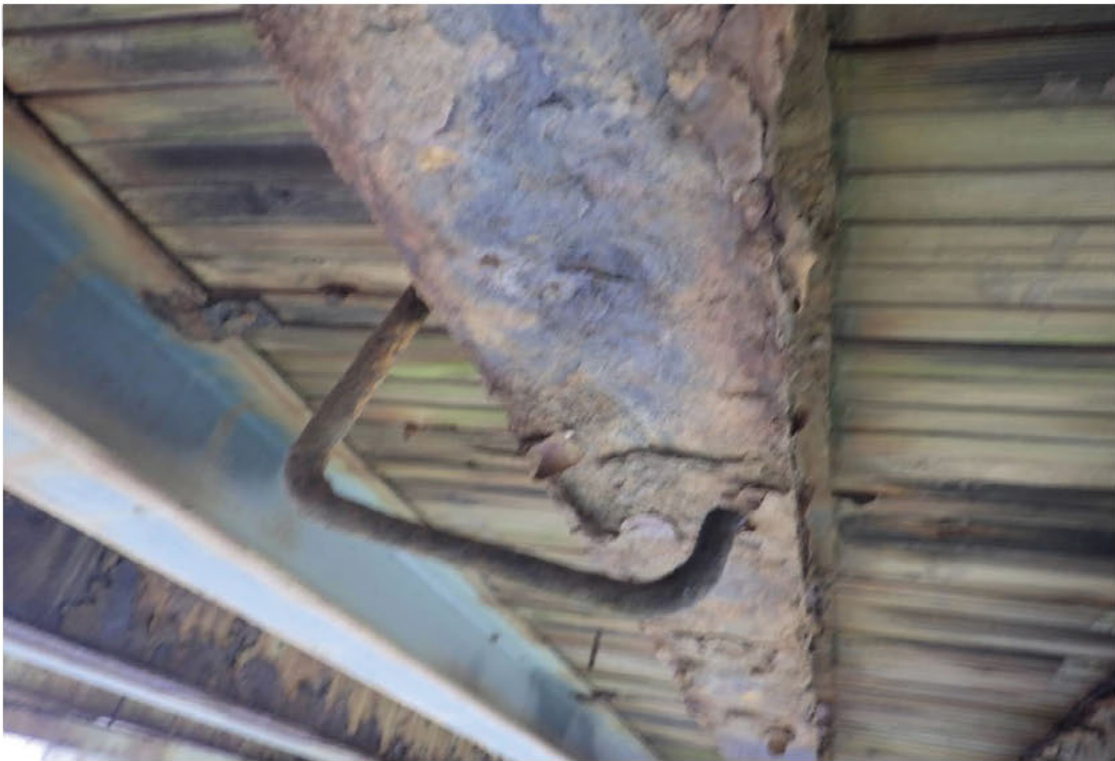
22. Loose deck "J" hook in Span 2, between FB 9 & 10.
