# 2024 Routine Bridge Inspection Report - District 4-0

BMS ID: 63 1002 0230 0739  
BRKEY: 35588  
Feature Carried: SR 1002  
Feature Under: Delaware River

**2024 ROUTINE BRIDGE INSPECTION REPORT  
SR 1002 over DELAWARE RIVER**

**BMS No. 63 1002 0230 0739**

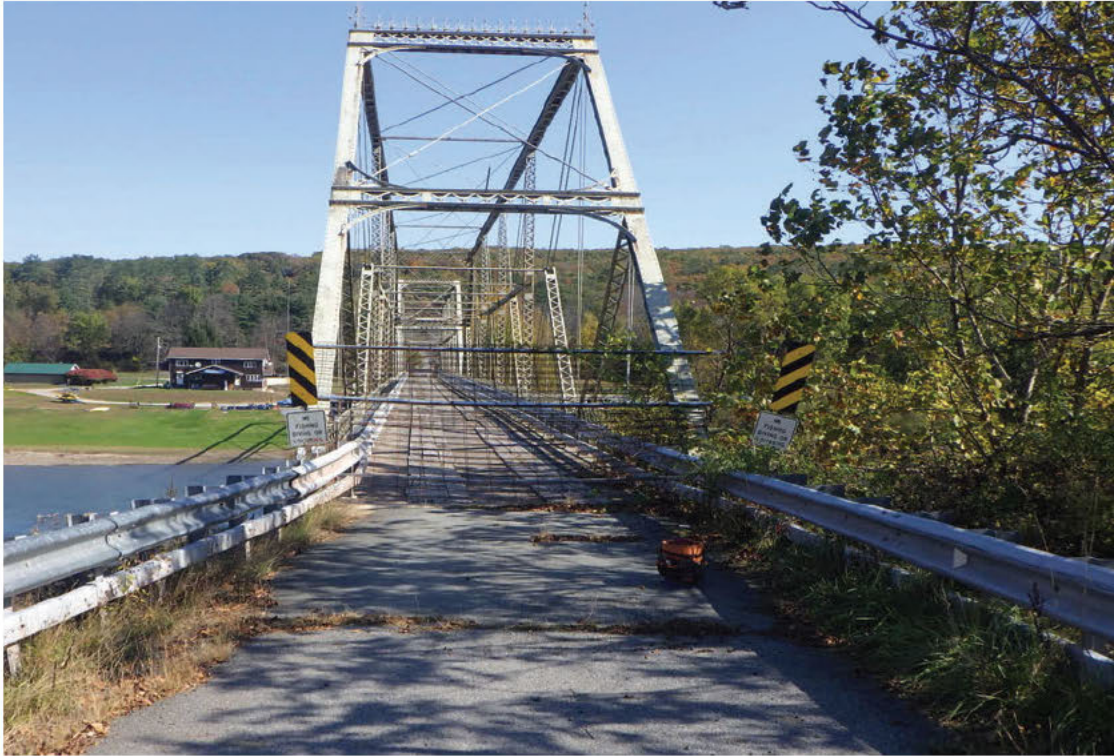
5. Near portal with reinforcement mesh used to restrict access to bridge.

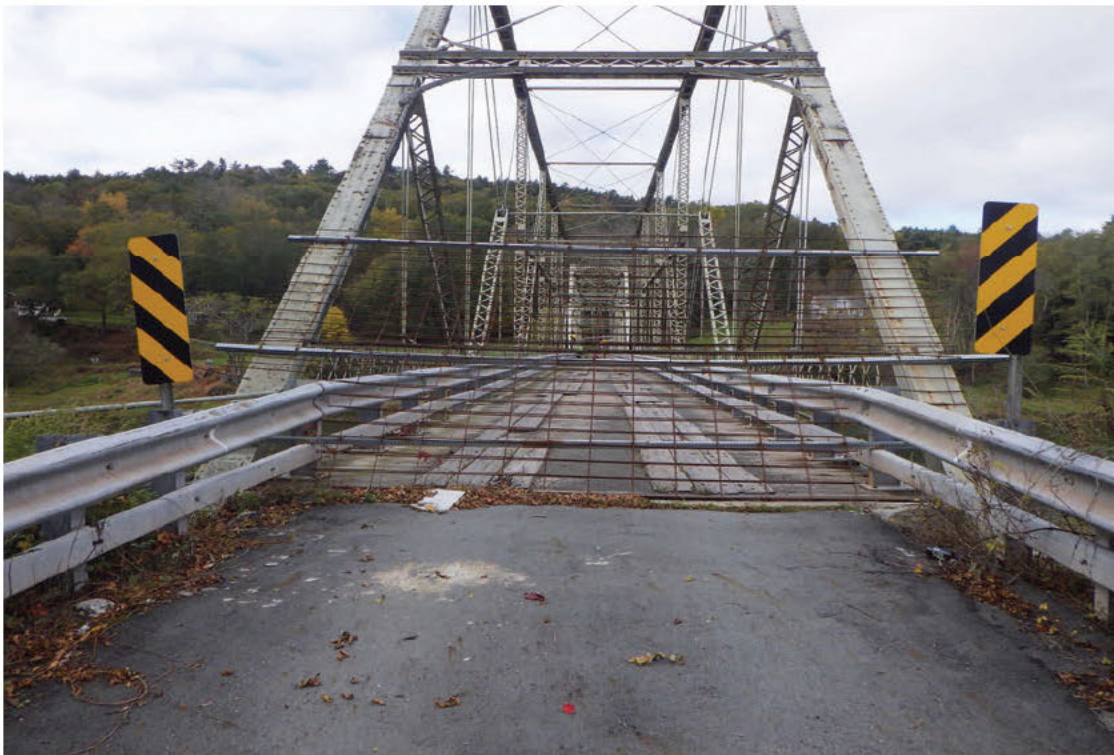
6. Far portal with reinforcement mesh used to restrict access to bridge.

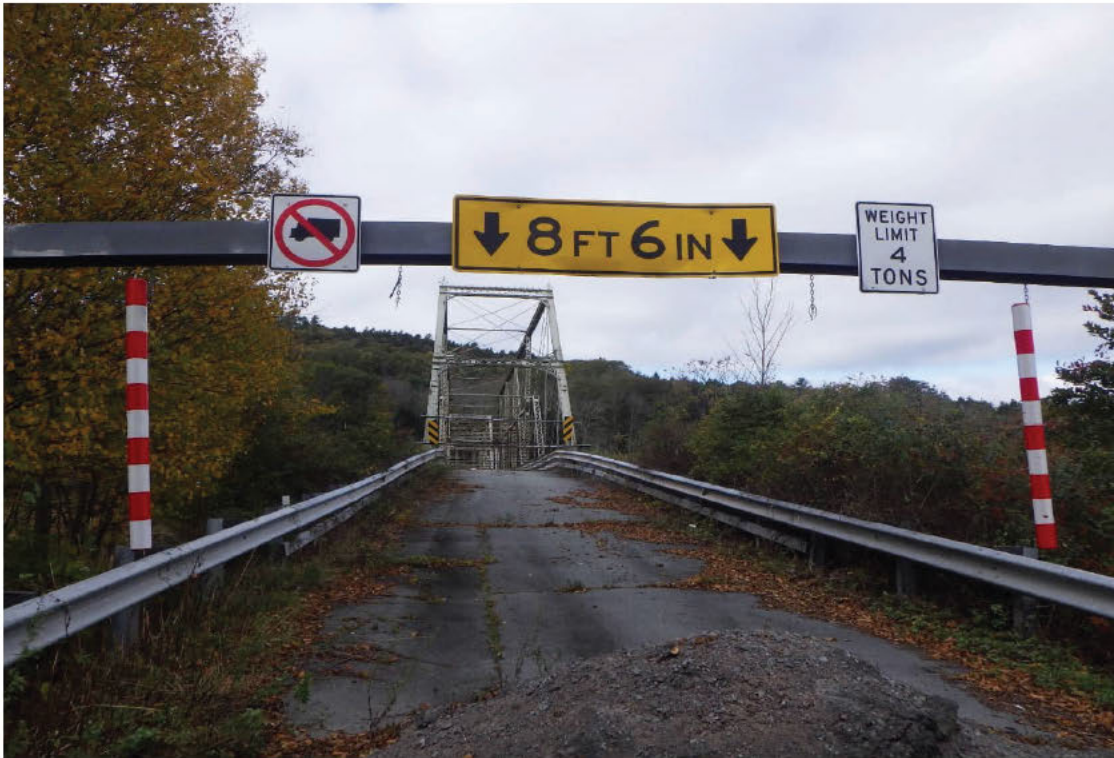
7. PVC tubes detached and hanging from far clearance bar.

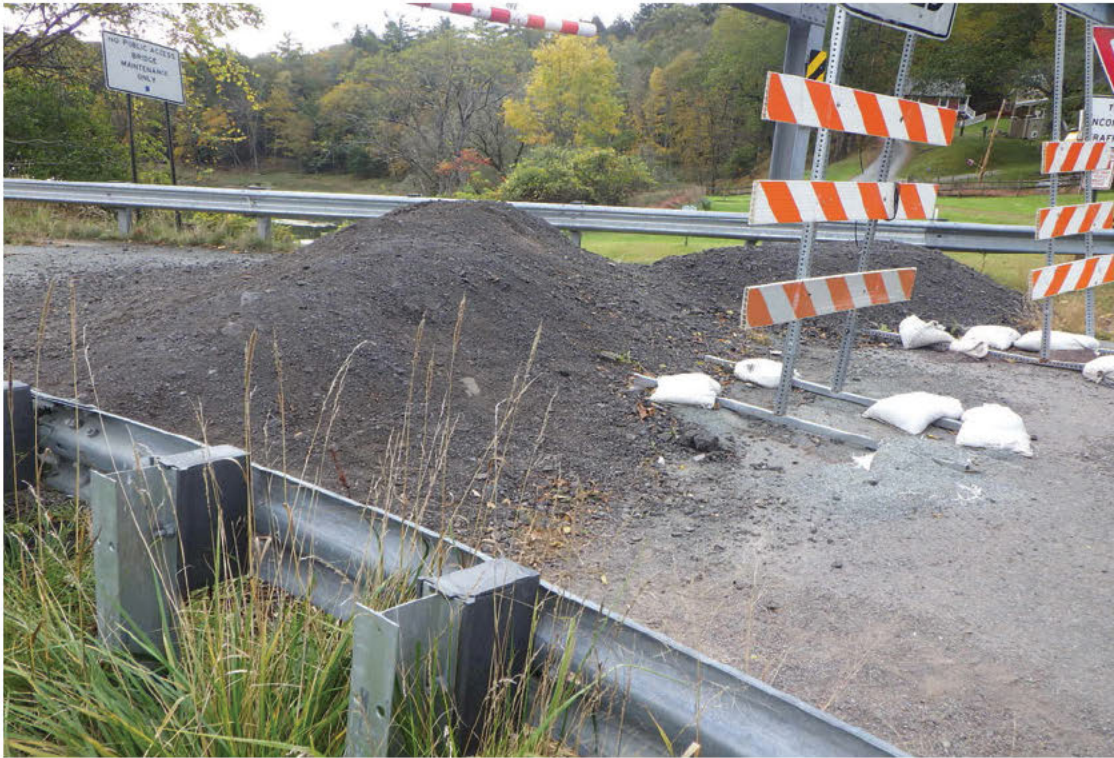
9. Typical gravel dumped at the ends of the bridge.

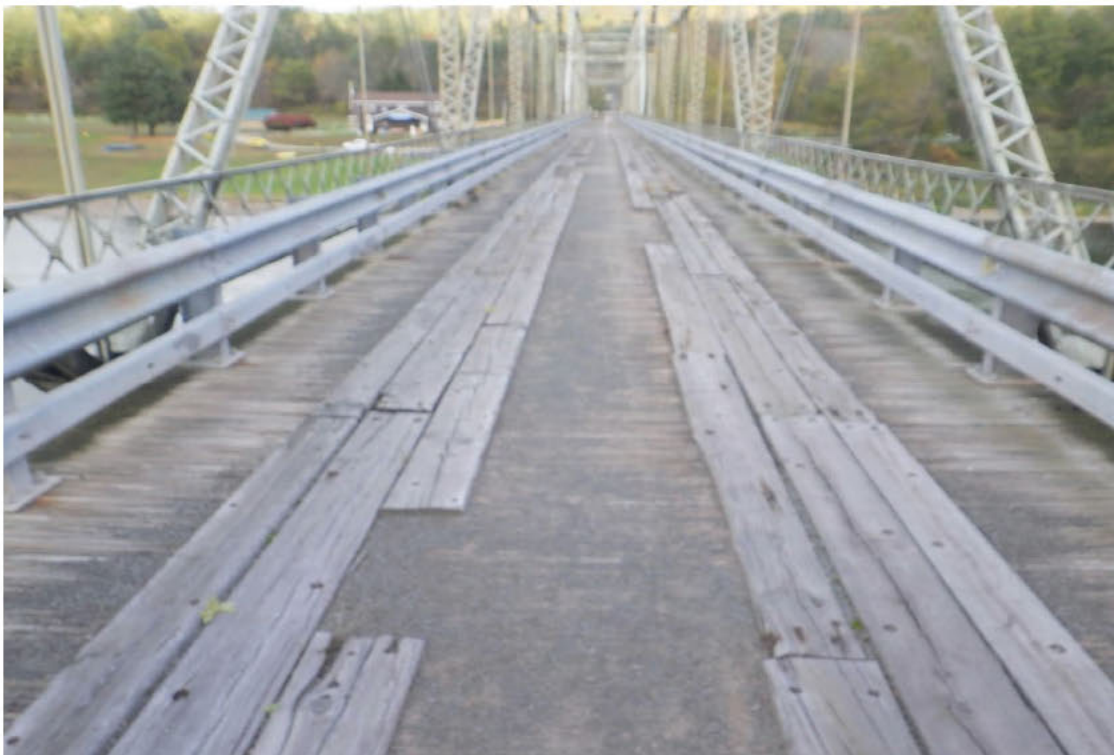
The timber wearing surface consists of timber planks along the wheel paths with splits and checks throughout. Several of the planks are bent up, dry rotted, missing bolts, and missing throughout. Several of the bolts are protruding, causing puncture hazards.

10. Top of deck in Span 1, looking ahead.

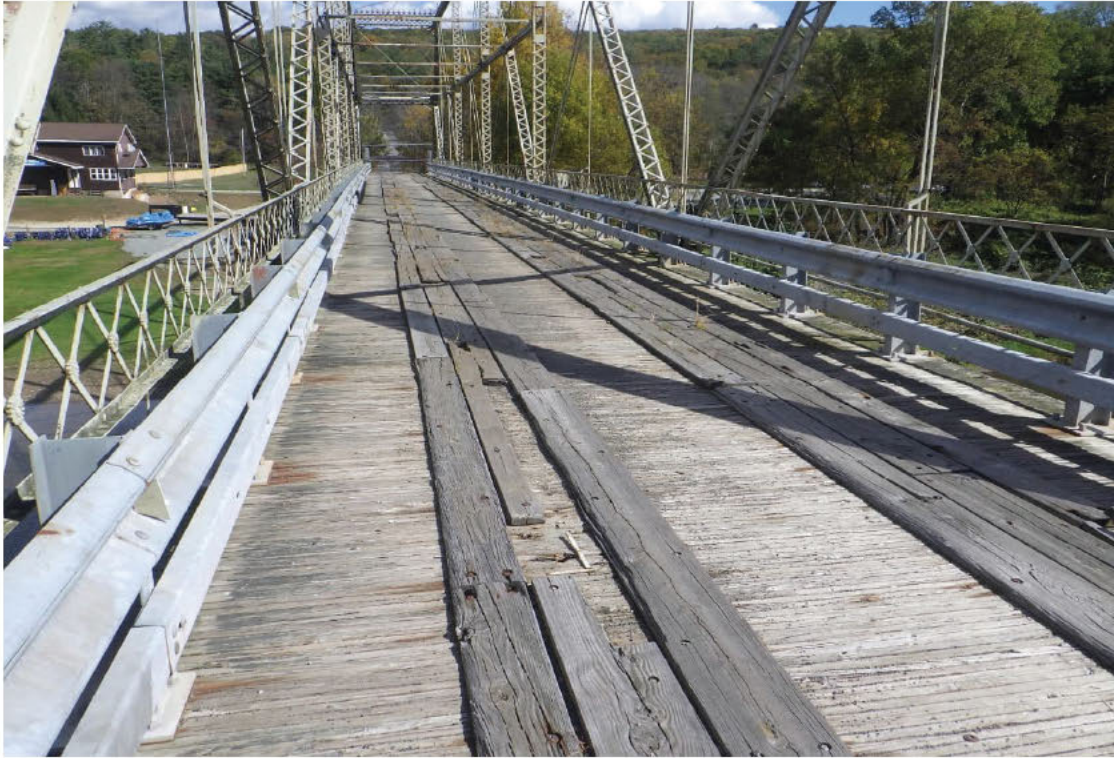
11. Top of deck in Span 2, looking ahead.

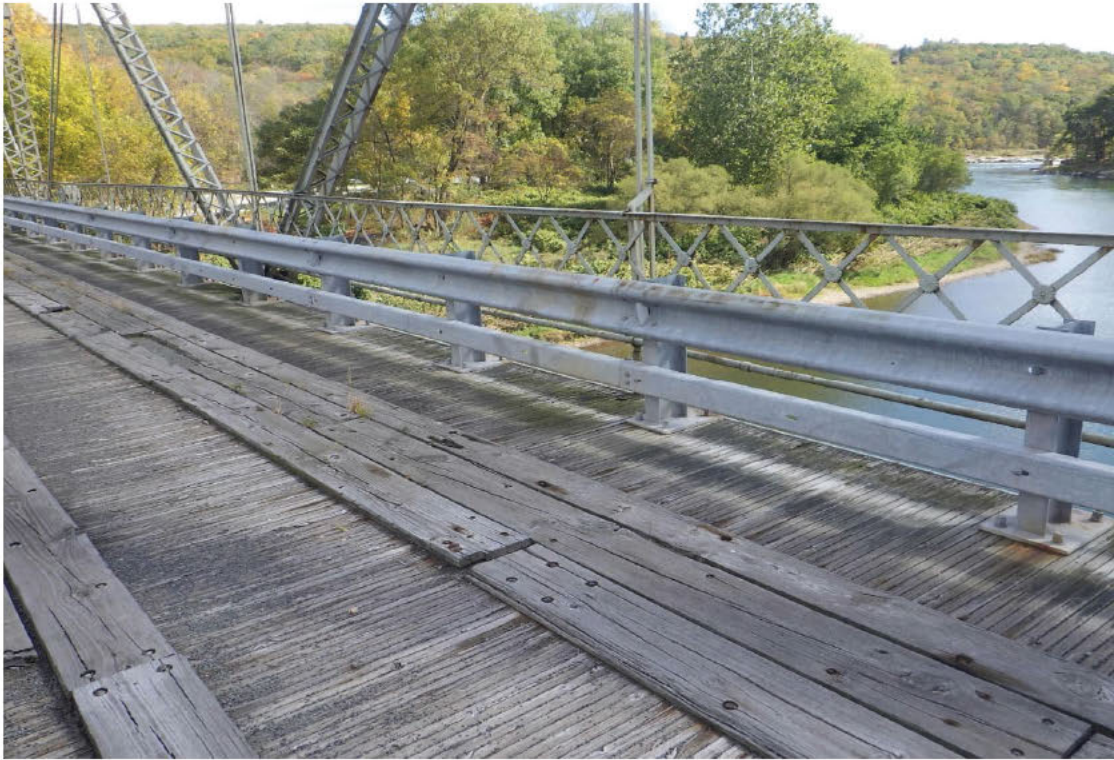
The bridge railings are 2'-9" high Type 2S W-beam guiderail with reflectors, a rub rail, and no offset brackets. Several of the outboard anchor bolts for the guiderail posts are loose or dislodge, due to a poor connection to the deck. The transition has a minimum 2'-9" high Type 2SC W-beam guiderail with steel offset brackets, a rub rail, and reflectors. The near approach guiderail has a minimum 2'-6" high Type 2SC W-beam guiderail with plastic offset brackets and a rub rail. The far approach guiderail has a minimum 2'-7" high Type 2S W-beam guiderail with steel offset brackets and a rub rail. The end treatment is considered continuous at >87.5' from the bridge.

17. Typical bridge railing, looking right.

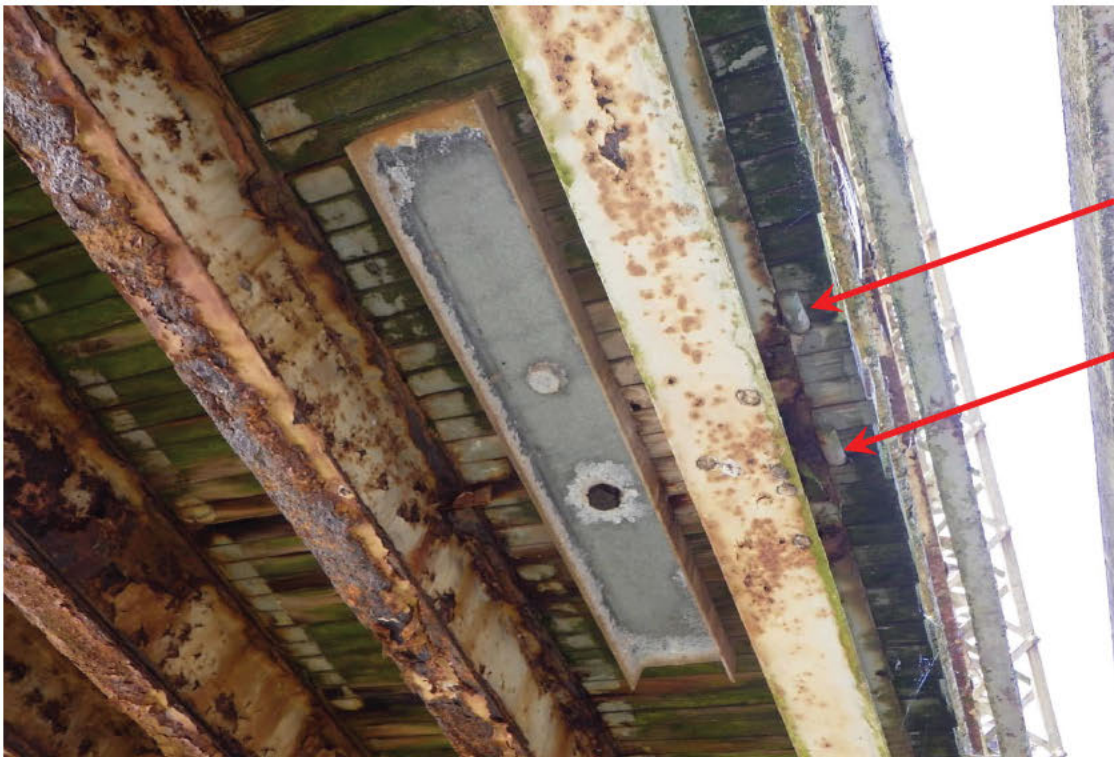
18. Typical bridge rail anchor not engaging stringer top flange.

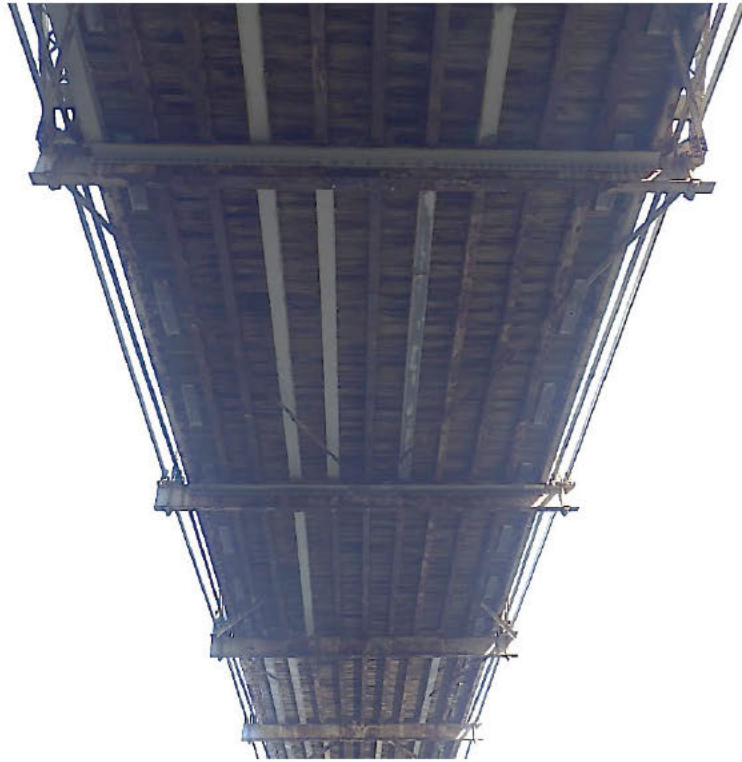
19. General underside of Span 1, looking ahead.

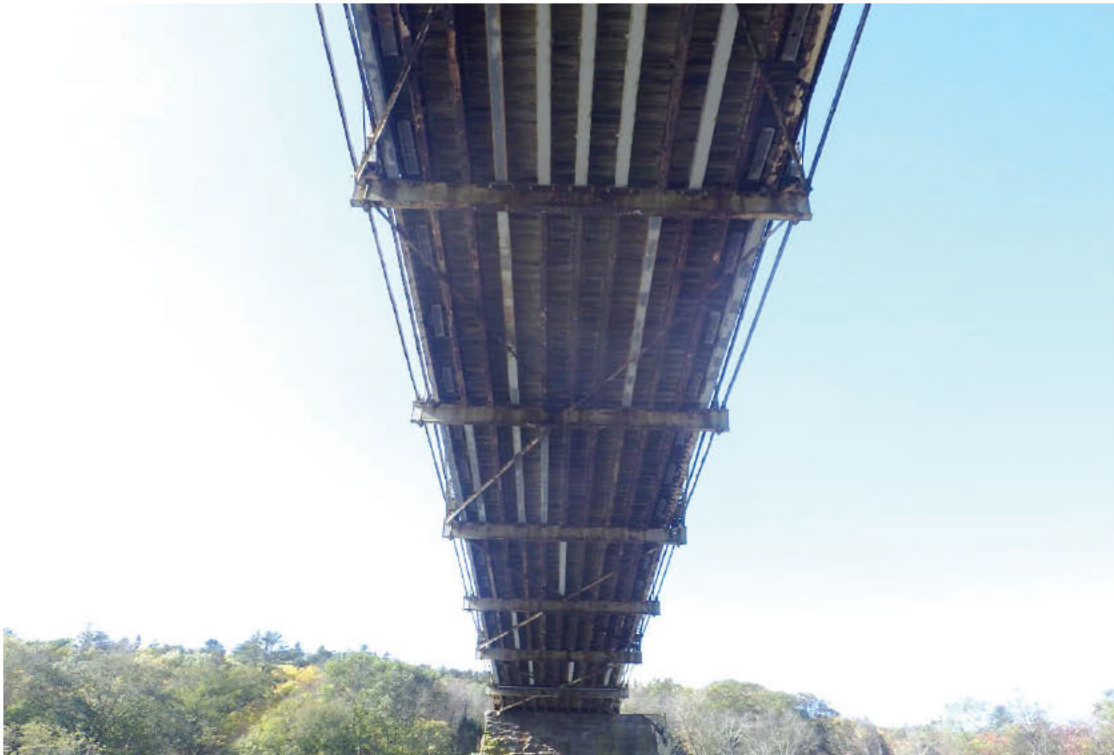
20. General underside of Span 2, looking back.

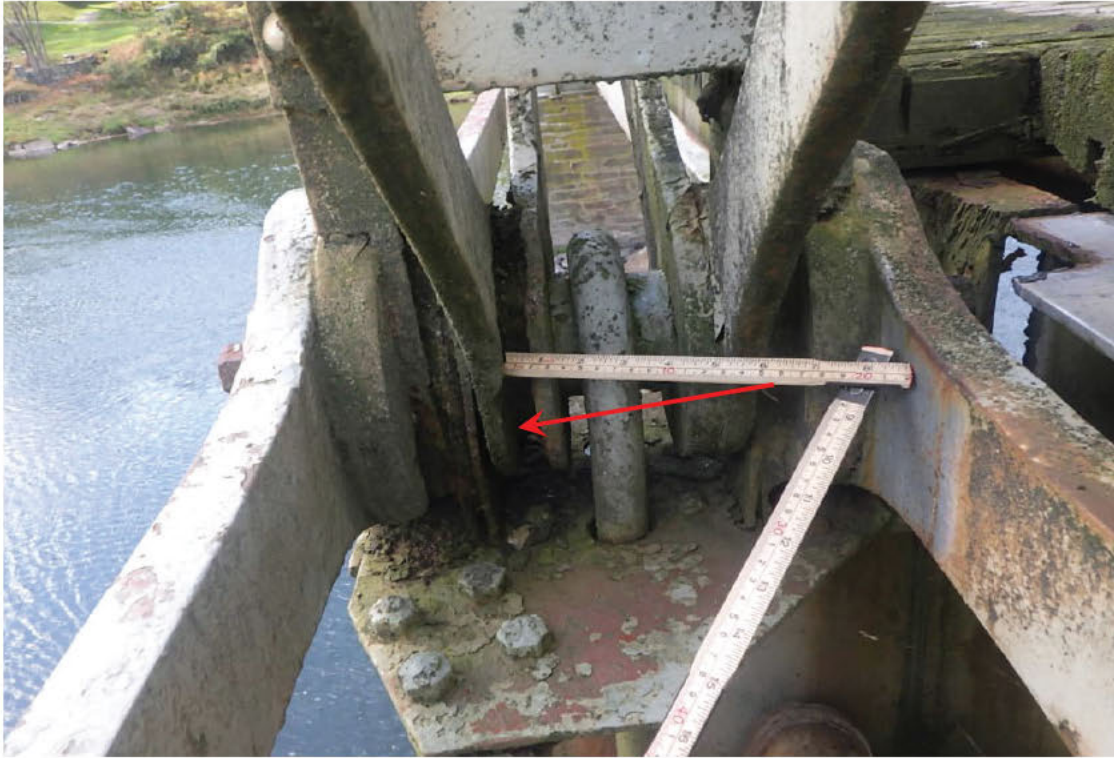
The steel truss consists of lattice channels, angles, and eyebars with paint failure, and minor section loss throughout, worst at the vertical and diagonal eyebar connections to the bottom chord. Various repairs and/or replacement of entire members have been completed since the 1980 rehabilitation, which display no significant defects. There is severe corrosion to the bottom chord eye bars at the bearing locations, missing/crack pin retaining nuts at several upper/middle panel points, and pack rust between members/gusset plates.

31. Diagonal eyebar with section loss, L6-M7, Right Truss.

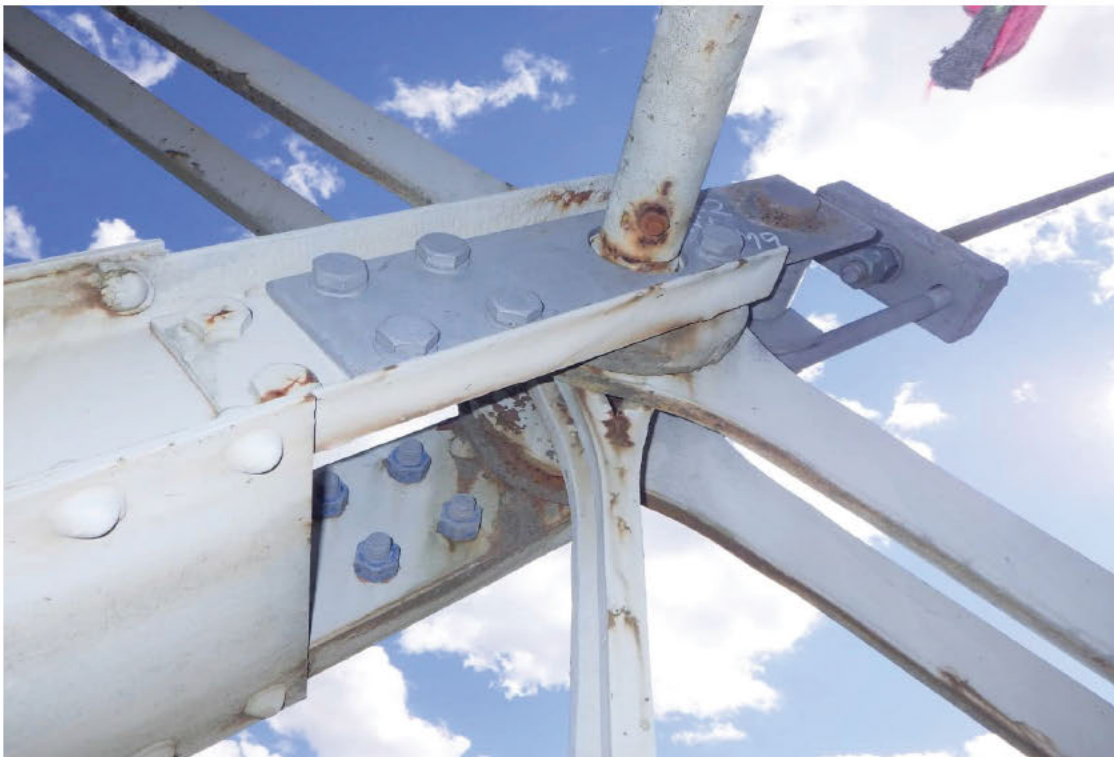
32. Retrofit U8-M9 at M9, Right Truss, Span 2.

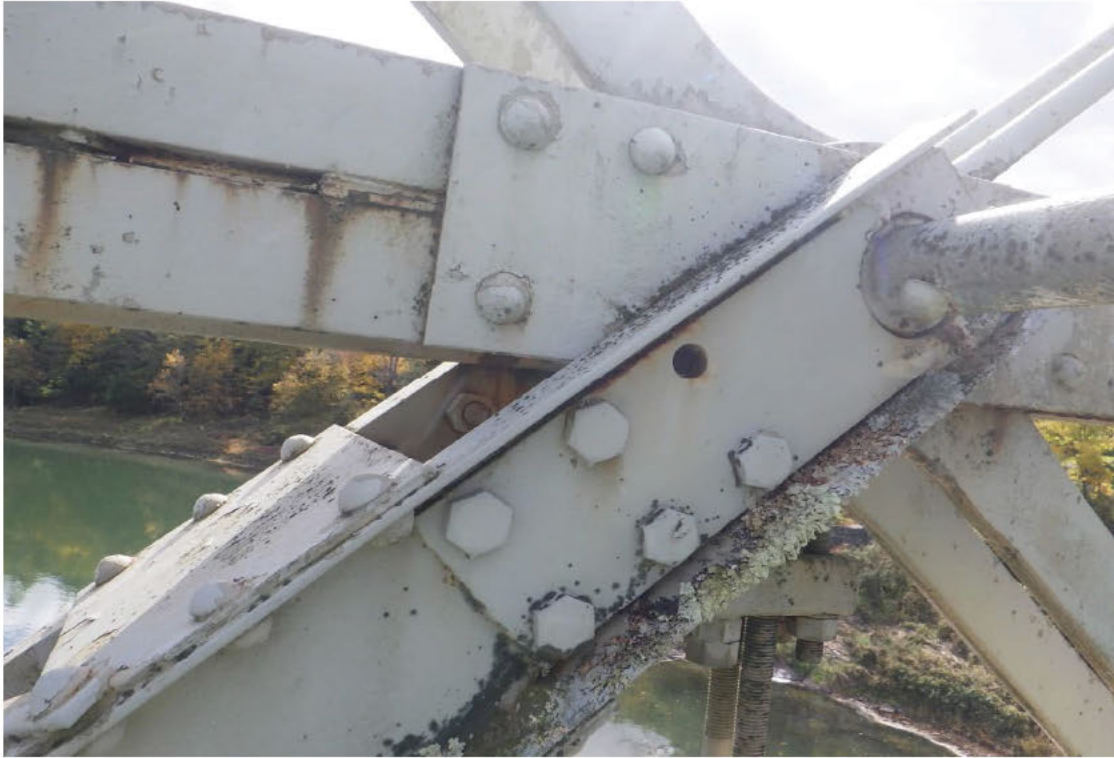
33. Mis-drilled hole, M7-L8 at M7, Right Truss, Span 1.

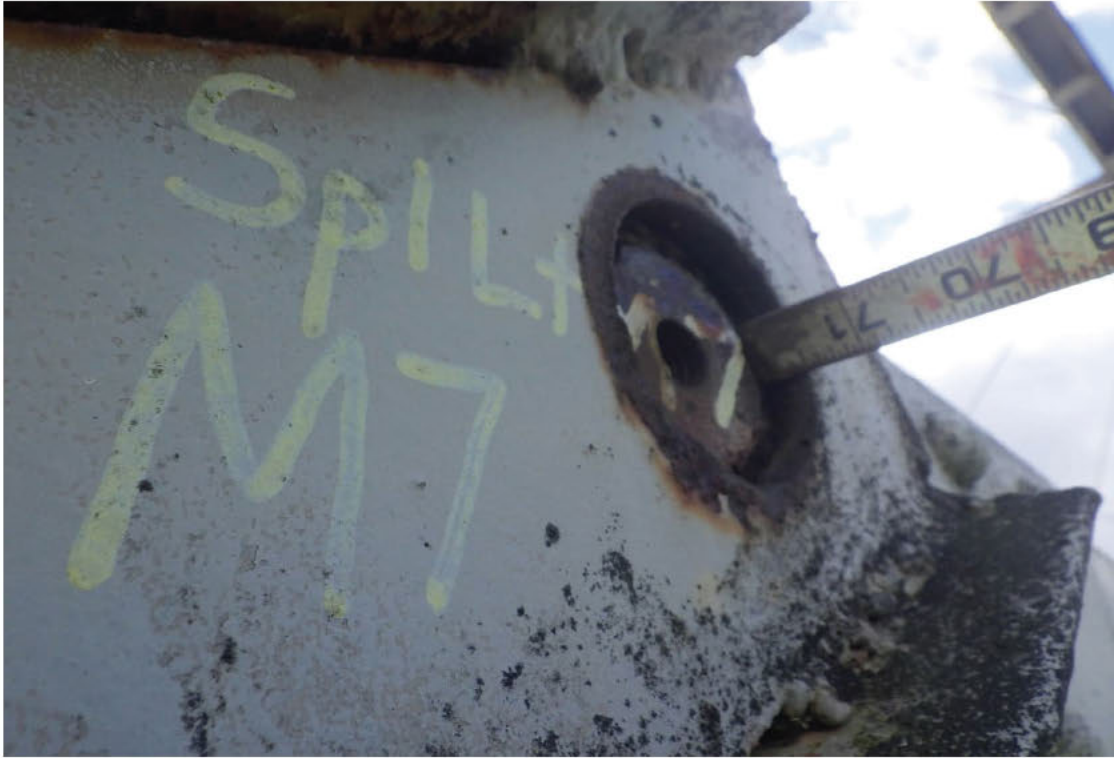
35. Pin plate not bearing on pin for M7-L8 at M7, Left Truss, Span 1.

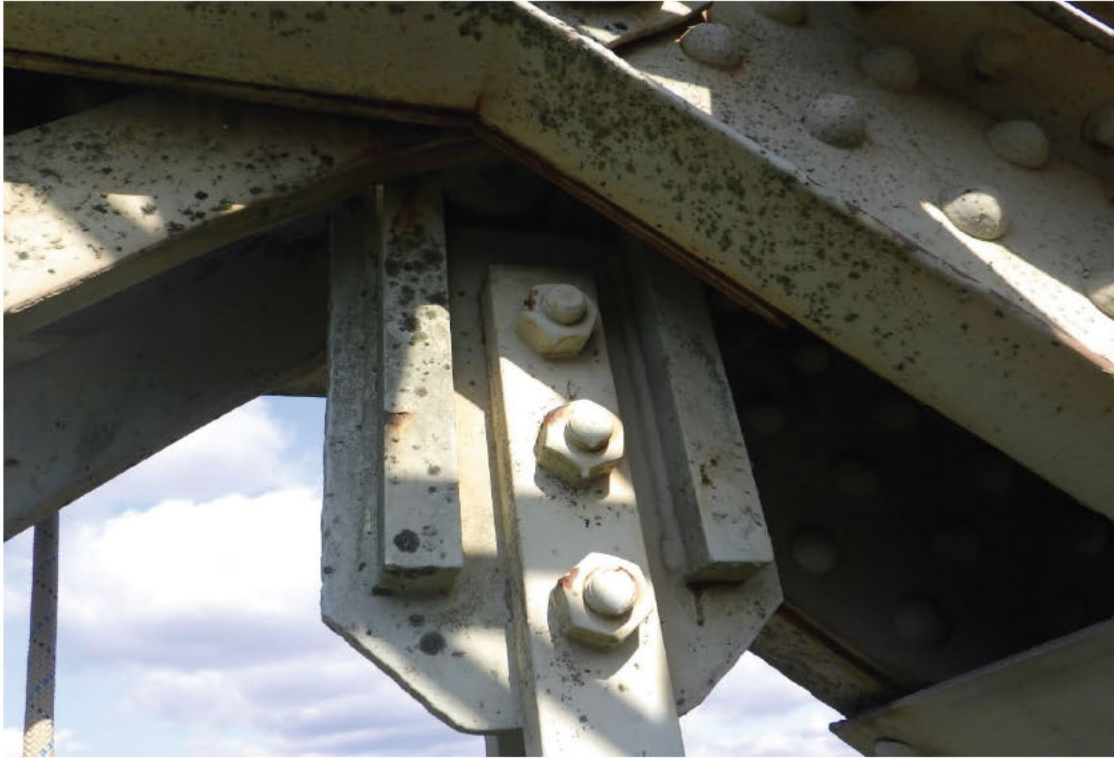
37. Retrofit vertical, L10-U10, Left Truss, Span 2.

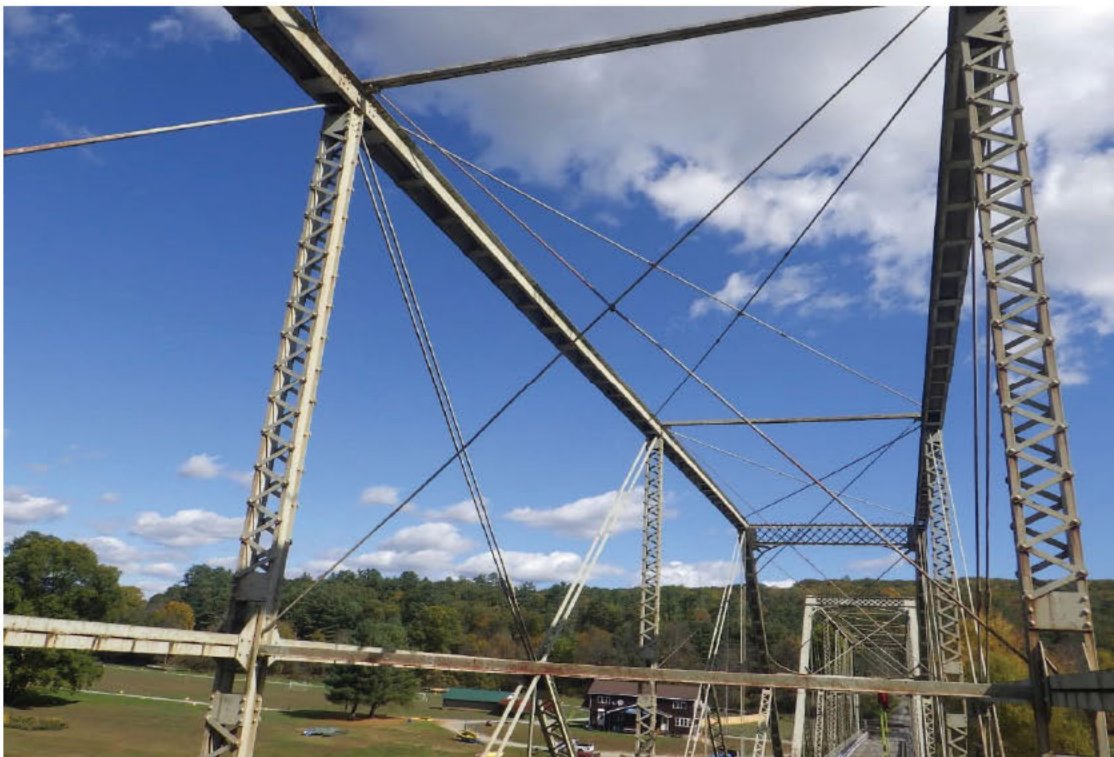
42. Typical sway bracing, M6-U6 in Span 1.

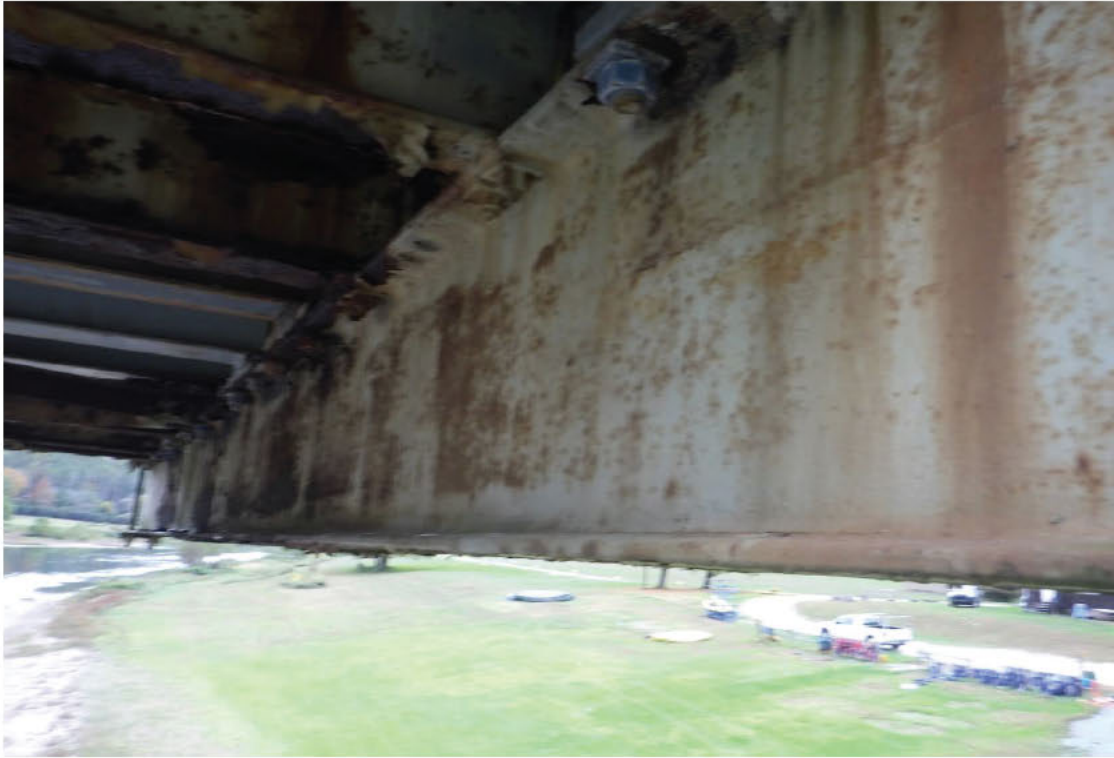
45. Typical view of Floorbeam 7 in Span 2, looking far left.

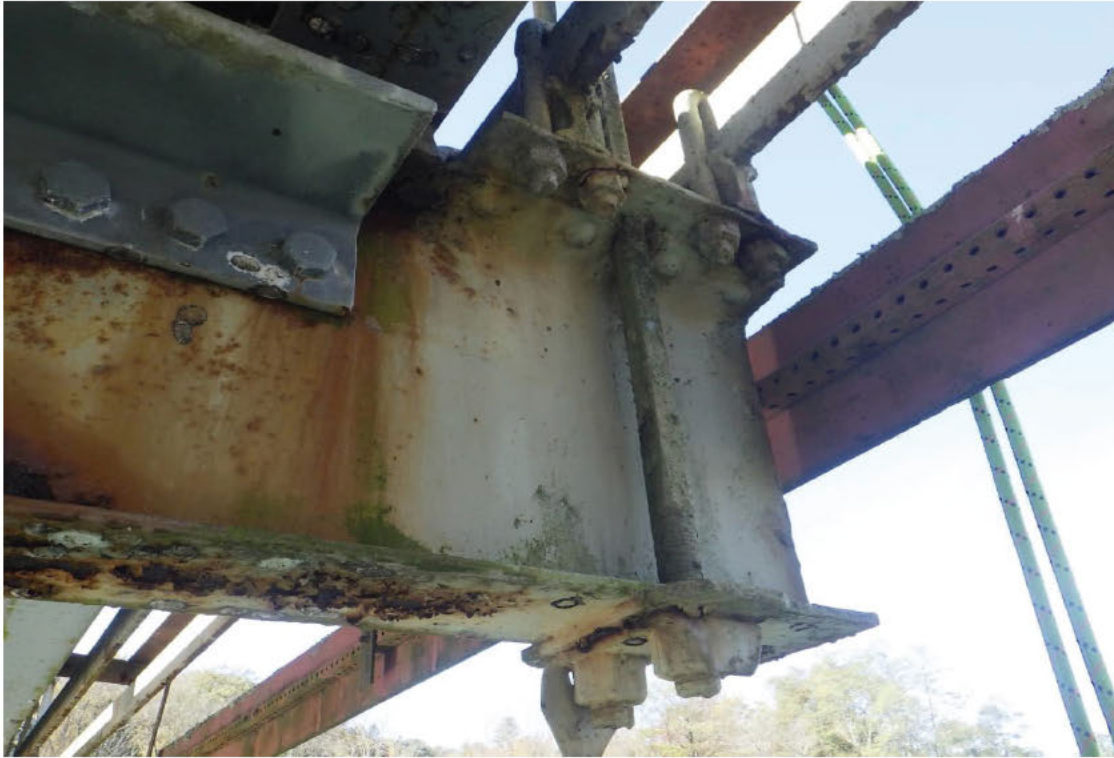
47. Typical floorbeam connection, FB9, Left Truss in Span 1, looking back.

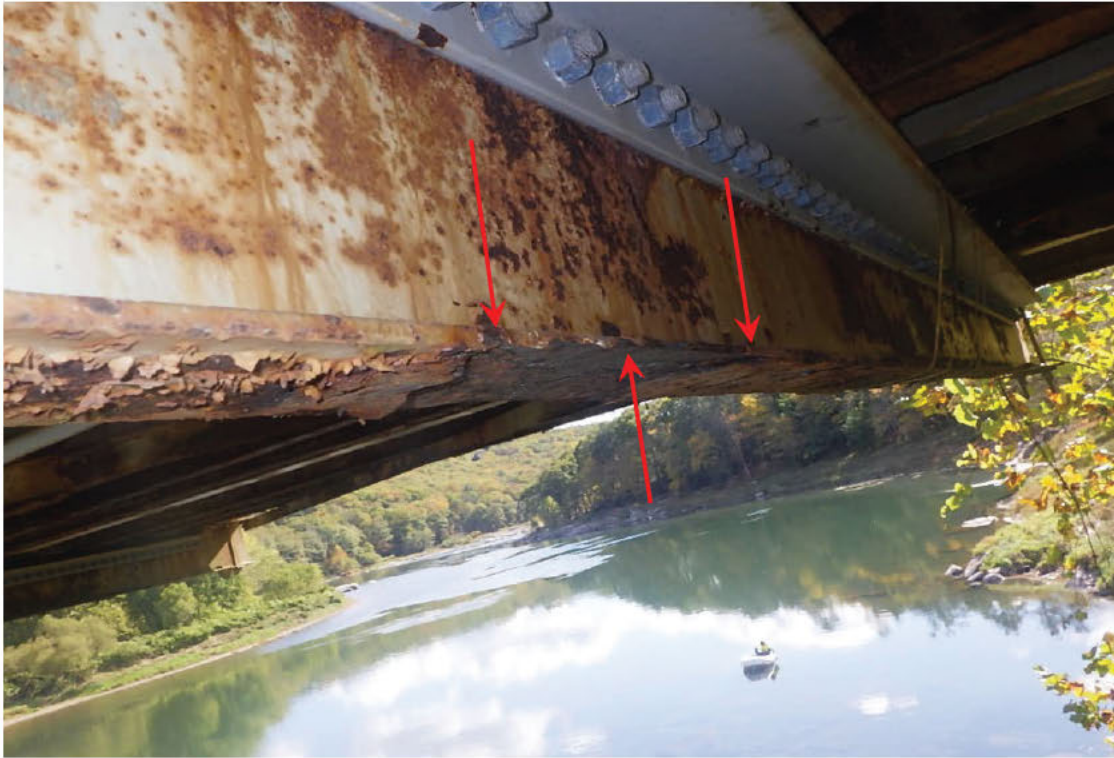
There are (11) steel floorbeams in each of the two spans. Several floorbeams have angle repairs in the top half of the web. There are widespread areas of active corrosion with minor to advanced section loss to the top and bottom flanges. The floorbeam webs have areas of minor to heavy corrosion with minor section loss throughout. The transverse plates at each end of the floorbeams, which connect the floorbeam to the truss vertical members, have active corrosion with minor section loss. The floorbeam top flange plates for the U-bolt connection to the truss bottom chord have moderate to severe corrosion with up to 100% section loss.

49. Section loss to bottom flange of Floorbeam 1, Span 1, looking right.

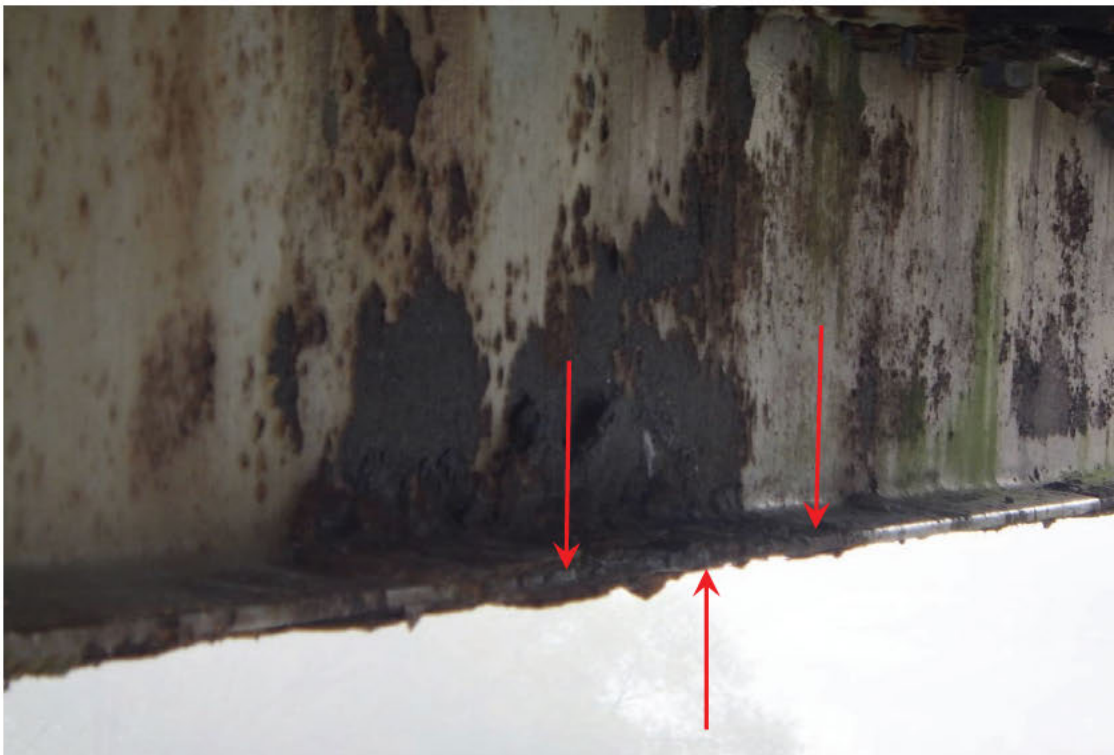
50. Section loss to bottom flange of Floorbeam 5 in Span 2, looking right.

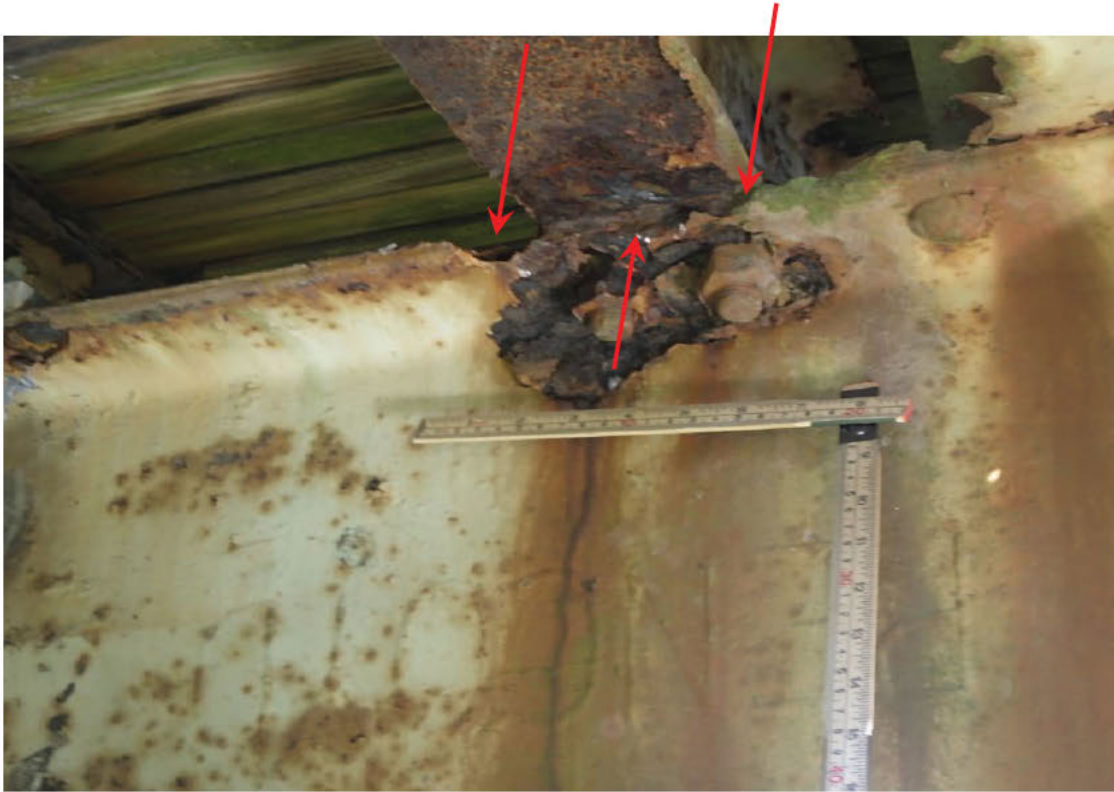
51. Section loss to top flange of Floorbeam 10 in Span 2, adjacent to Stringer 11.

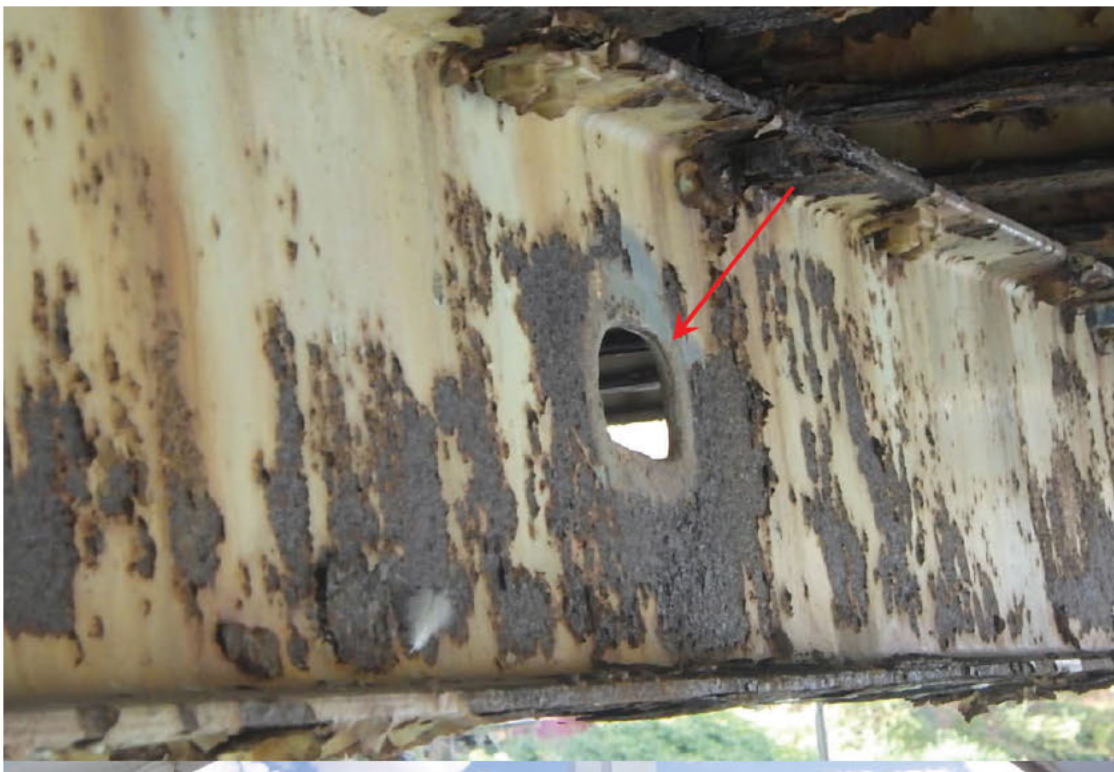
52. Flame cut hole in web of Floorbeam 4 in Span 1.

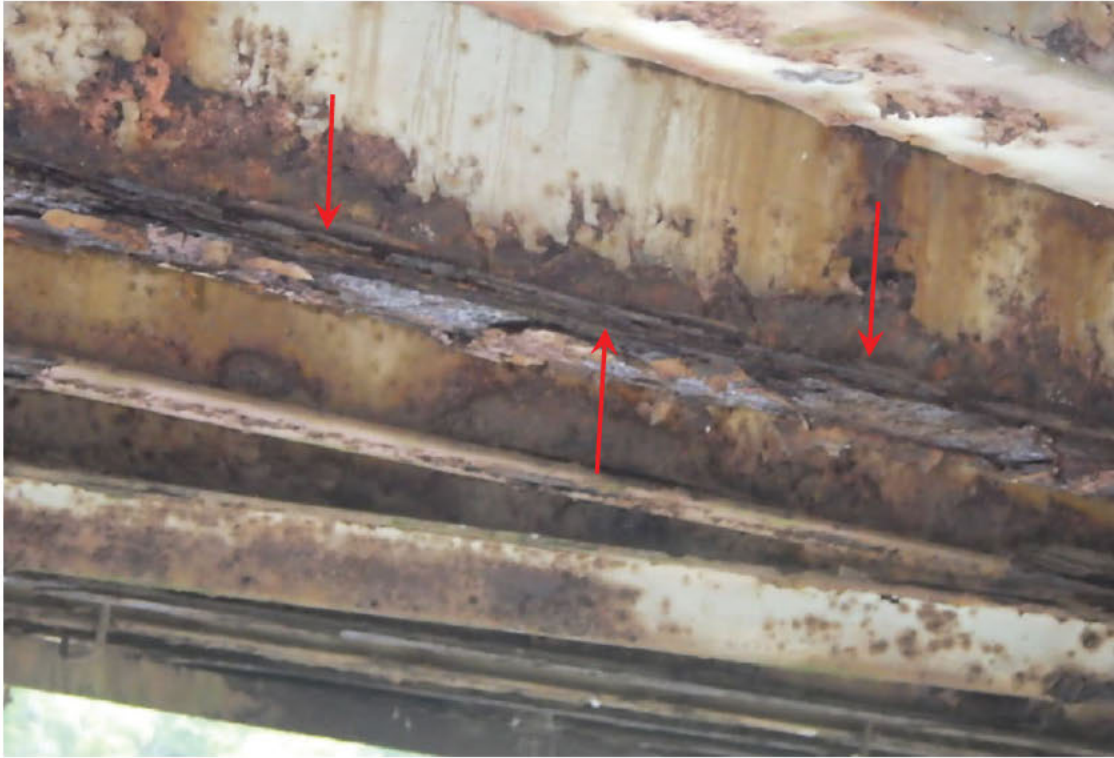
There are (11) steel stringers in each floorbeam bay. Several stringers were replaced during the 1980 rehabilitation, which display minor peeling paint. The remaining original stringers have moderate to severe corrosion with minor to advanced section loss throughout.

55. Section loss to bottom flange of Stringer 8 in Floorbeam Bay 4 of Span 2.

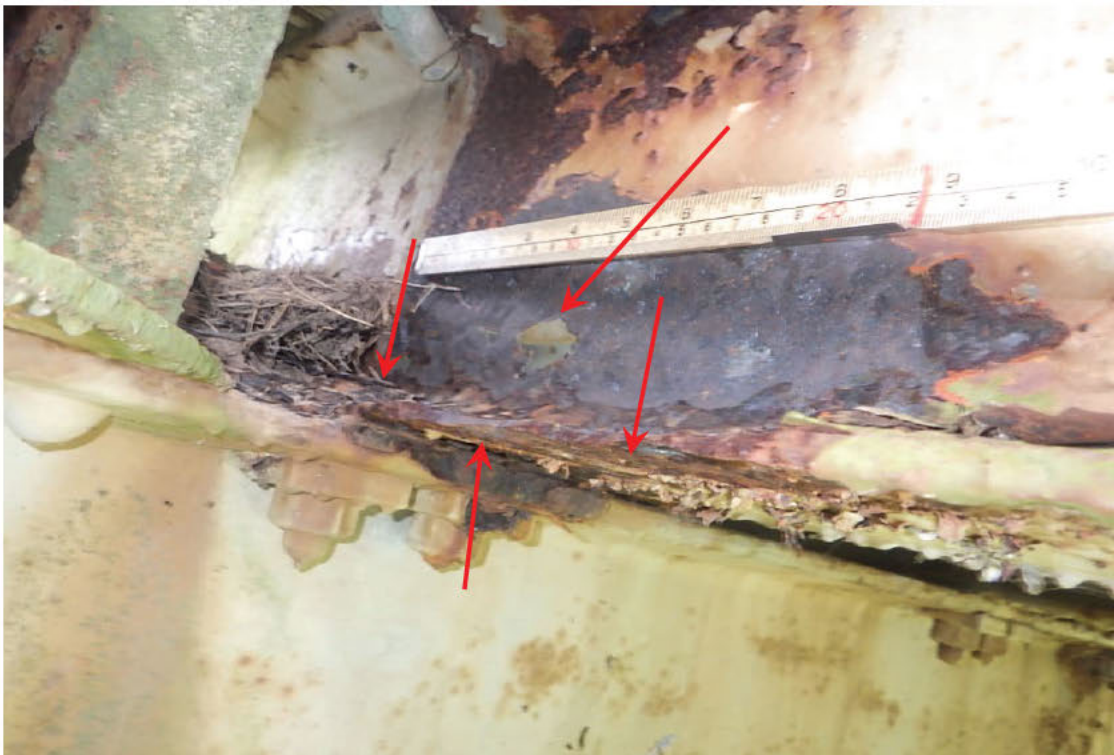
56. Section loss to web and bottom flange of Stringer 11 at Floorbeam 8 in Span 2.

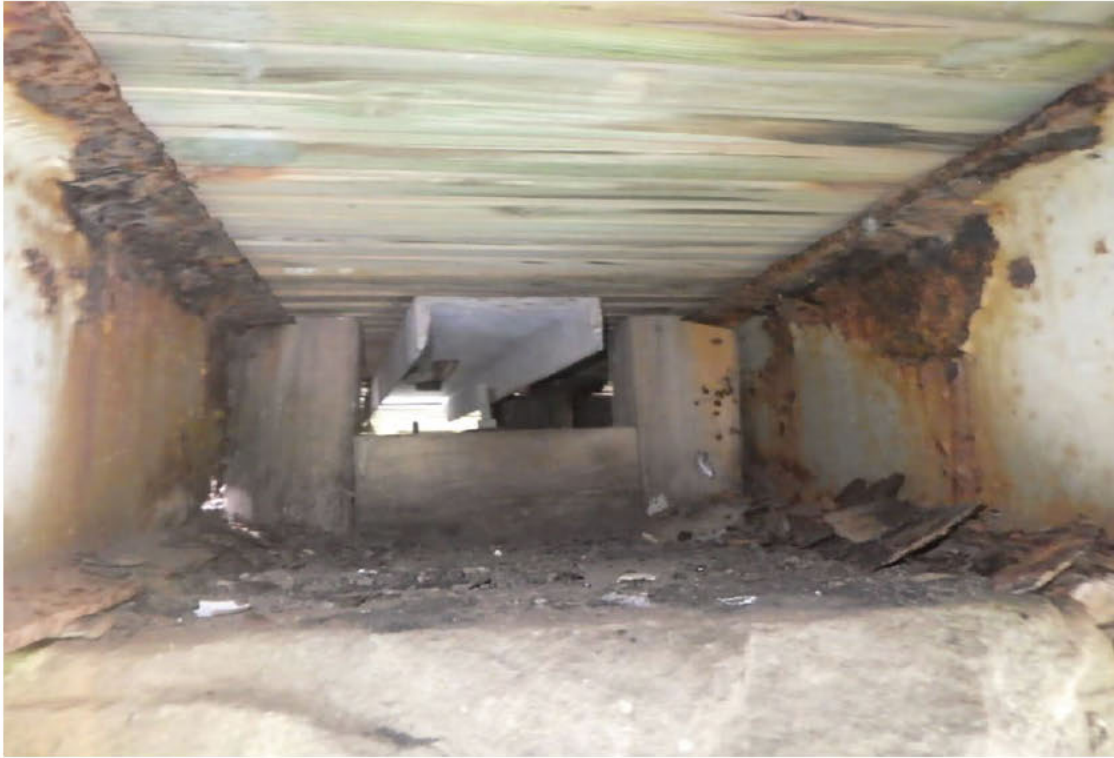
57. Timber cribbing in Bay 10 over Pier 1, looking back.

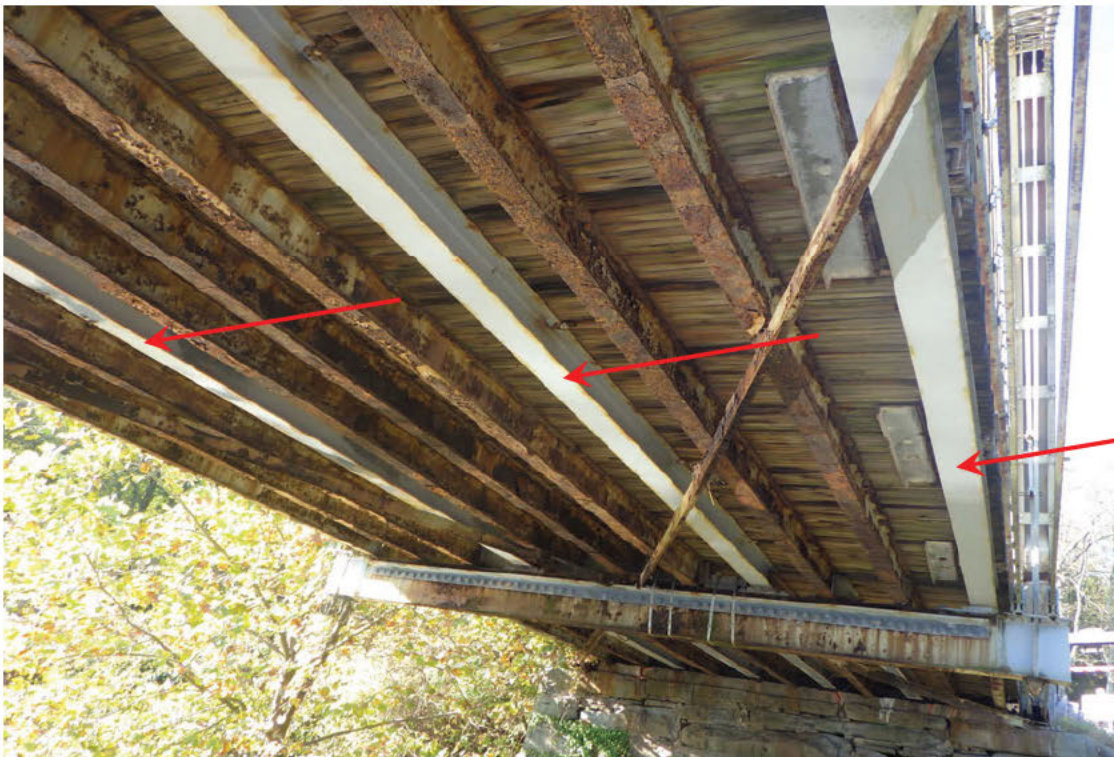
58. Typical newer stringer in Floorbeam Bay 2 of Span 1, looking back
