# 2024 Routine Bridge Inspection Report - District 4-0

BMS ID: 63 1002 0230 0739  
BRKEY: 35588  
Feature Carried: SR 1002  
Feature Under: Delaware River

**2024 ROUTINE BRIDGE INSPECTION REPORT  
SR 1002 over DELAWARE RIVER**

**BMS No. 63 1002 0230 0739**

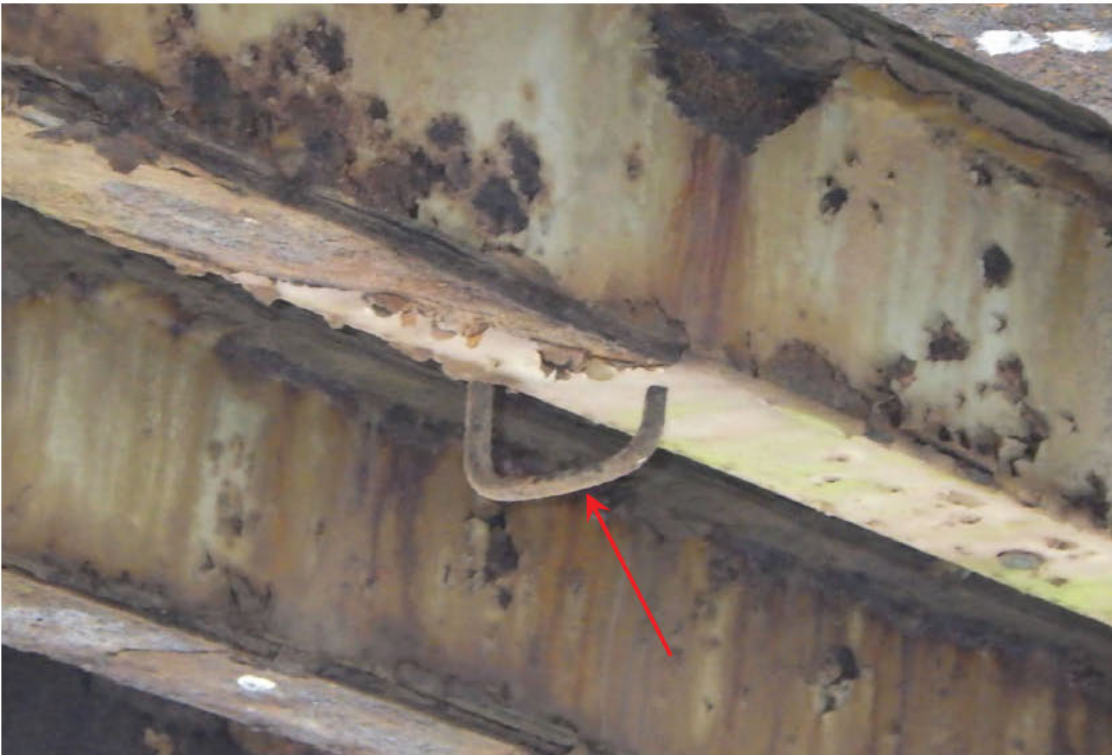
60. Loose "J" hook not engaging stringer bottom flange, Stringer Bay 5 in Span 2.

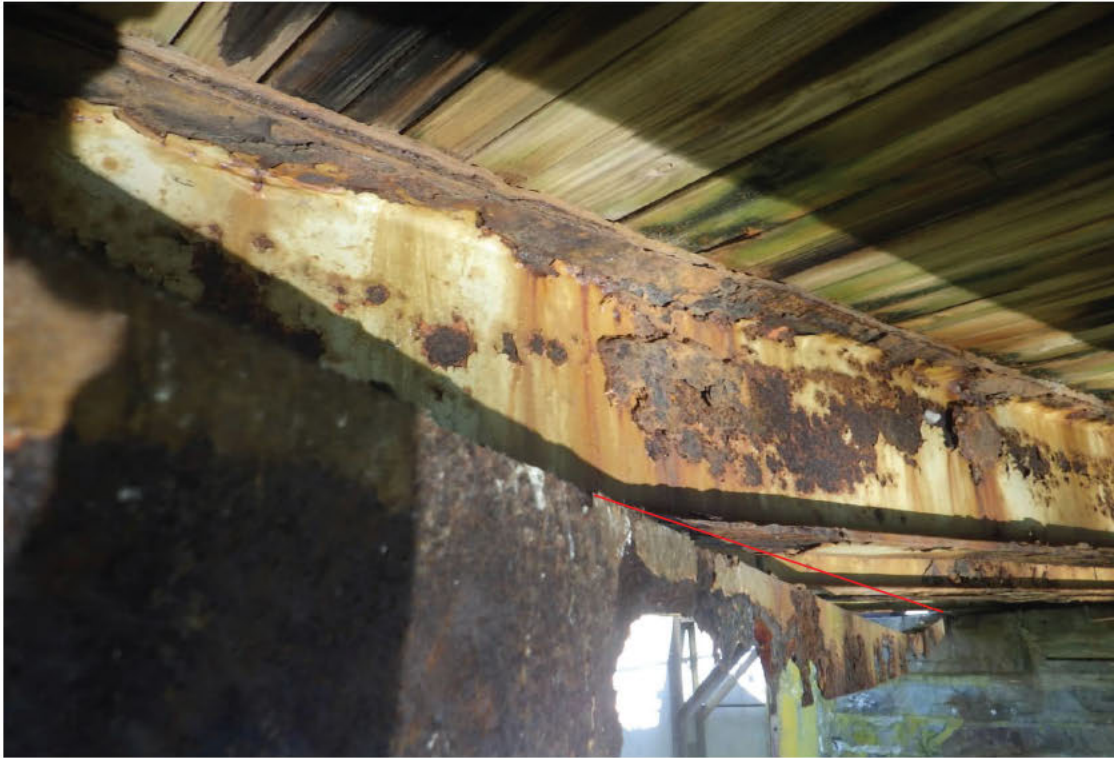
The steel angle and HSS lateral bracing above deck is typically has peeling paint and a few areas of 100% section loss. The steel angle lateral bracing below deck has severe corrosion with 100% section loss, exhibits severe sagging, and is missing or broken throughout. Additionally, the gusset connection to several lateral bracings exhibit 100% section loss, loose bolts, and exposed bolt threads throughout. The inspection team removed two sections of lateral bracing during the routine inspection and identified several others as fall hazards.

63. Sagging lower lateral bracing on left side, Bay 12 in Span 1.

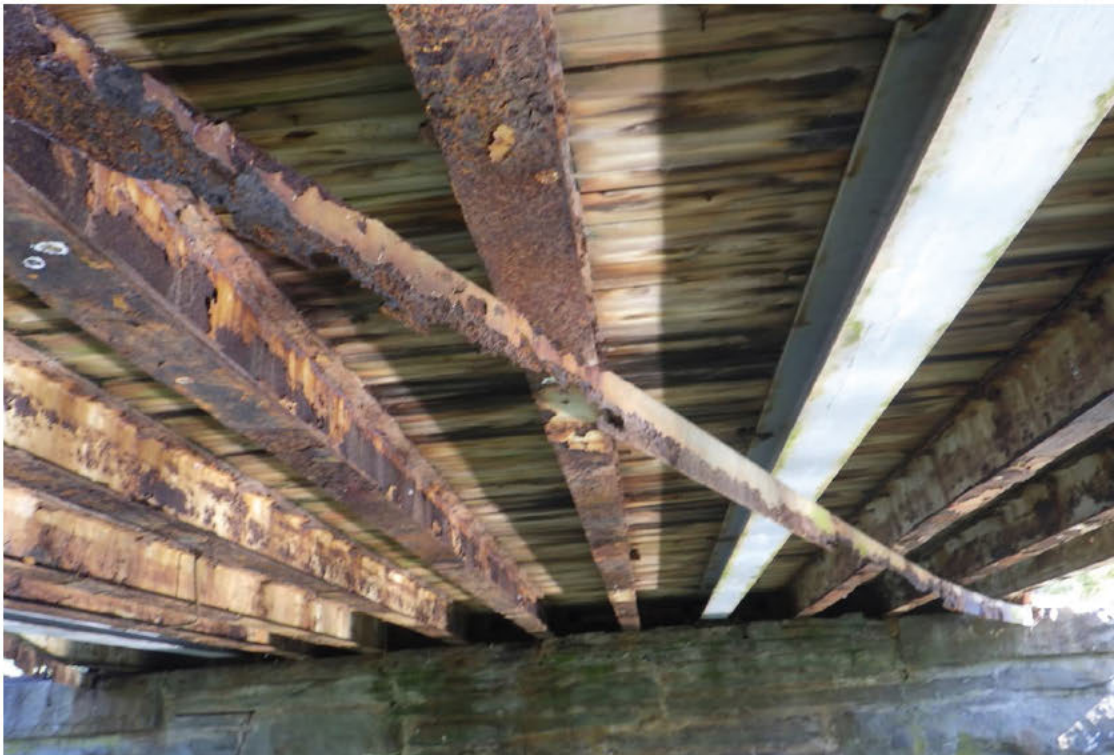
66. Sagging right lower lateral brace, Bay 12 in Span 1. (Removed during inspection)

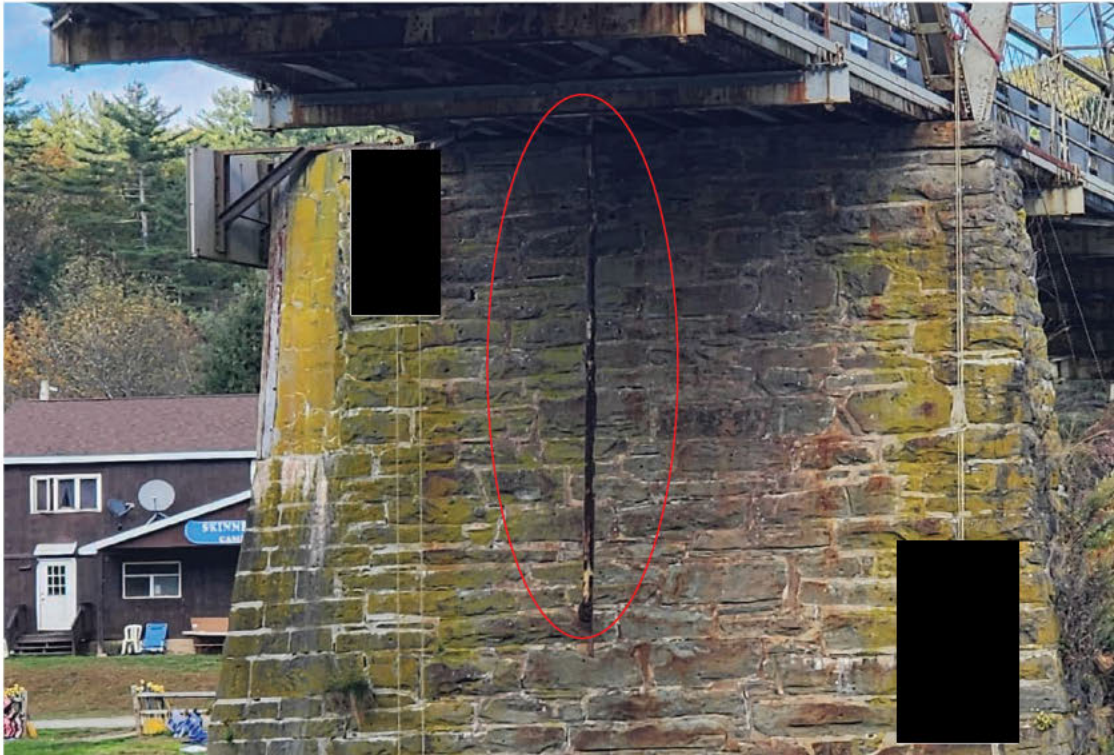
67. Disconnected right lower lateral brace, Bay 12 in Span 1. (Removed during inspection)

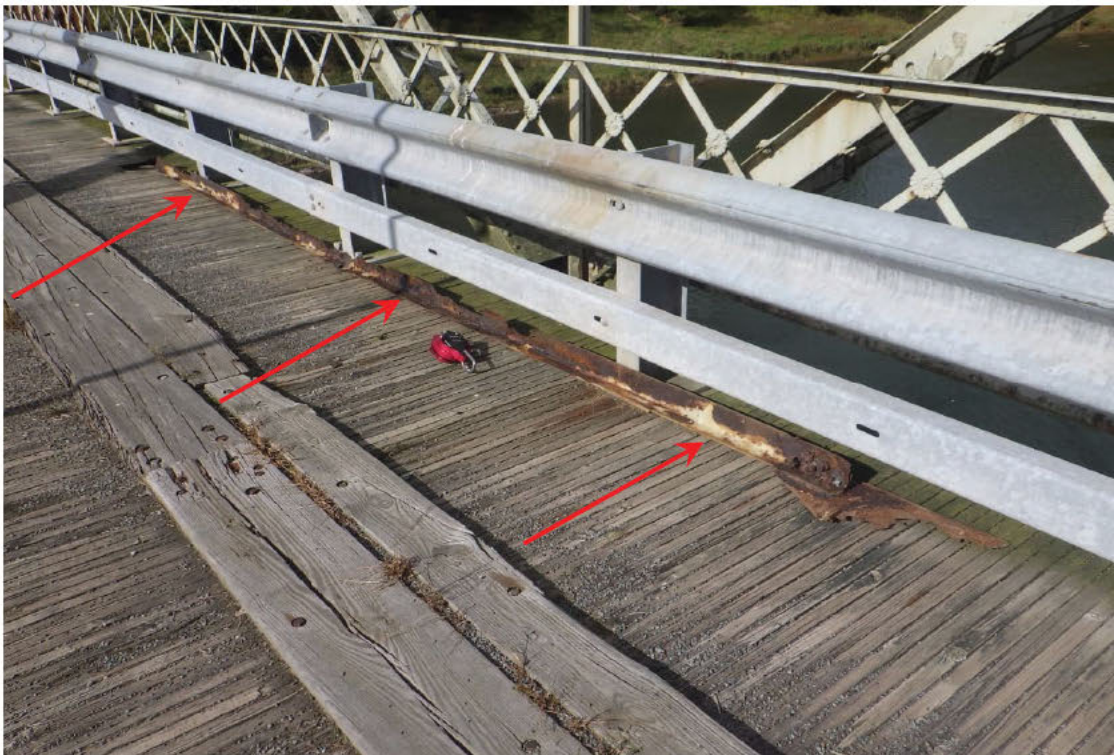
68. Removed right lower lateral brace, Bay 12 in Span 1.

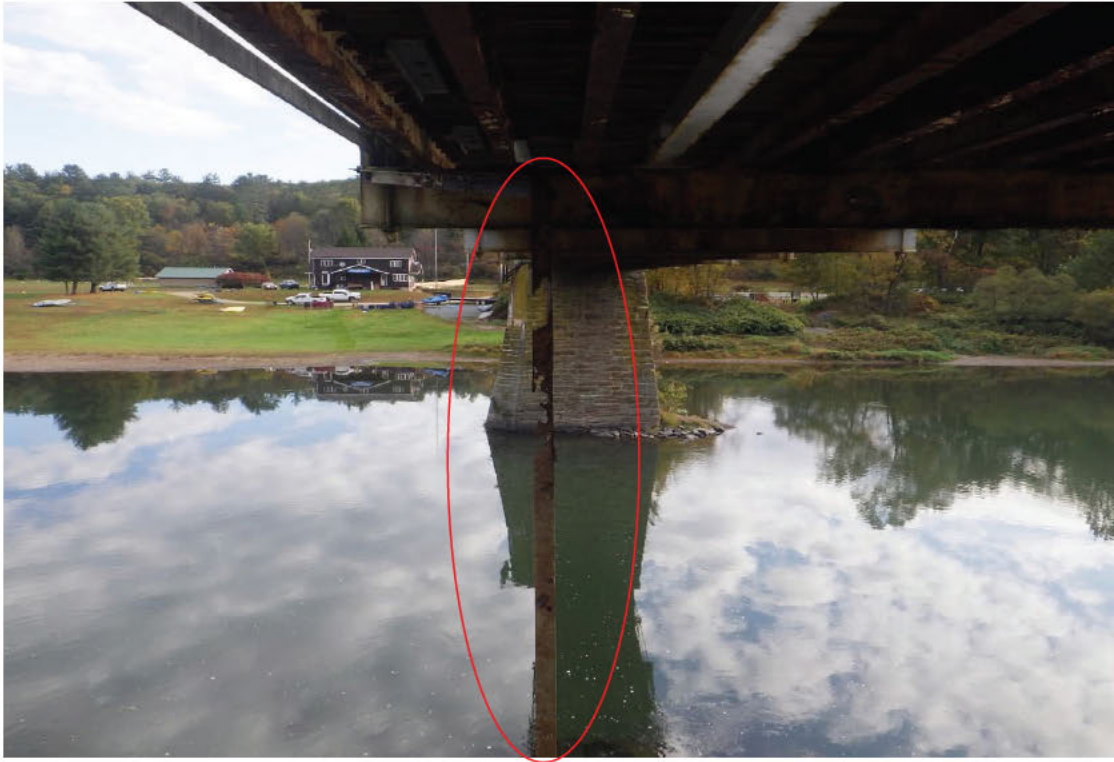
69. Disconnected left lower lateral brace, Bay 4 in Span 1. (Removed during inspection)

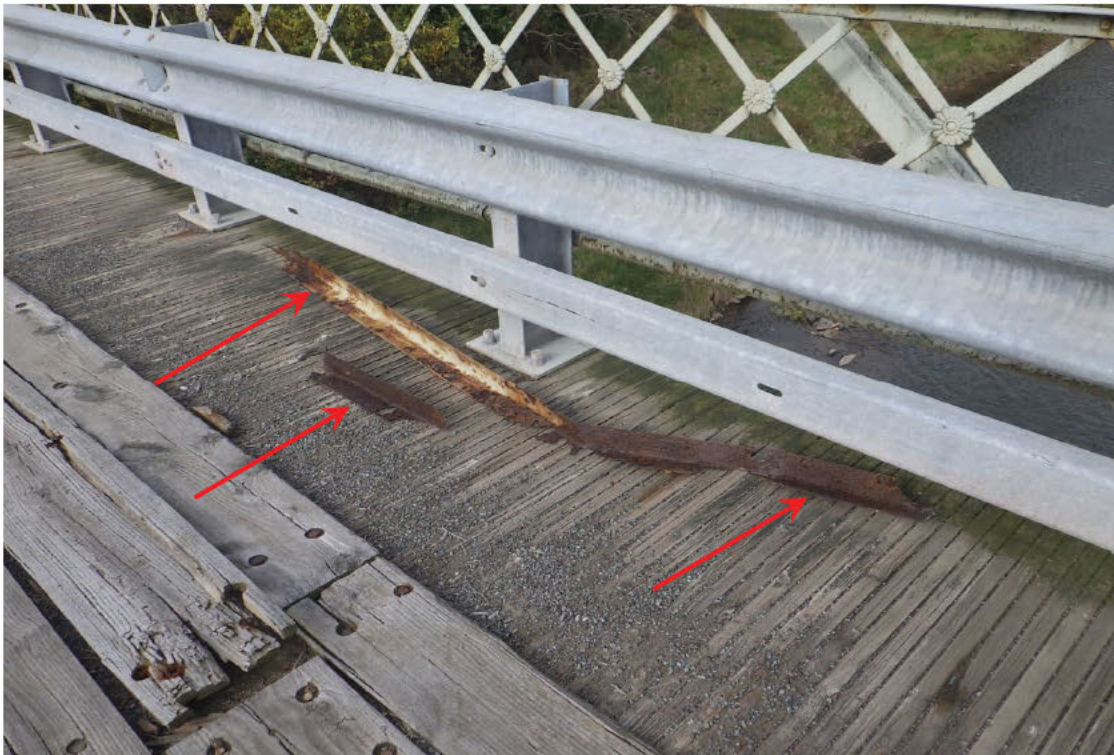
70. Removed left lower lateral brace, Bay 4 in Span 1. (Removed during inspection)

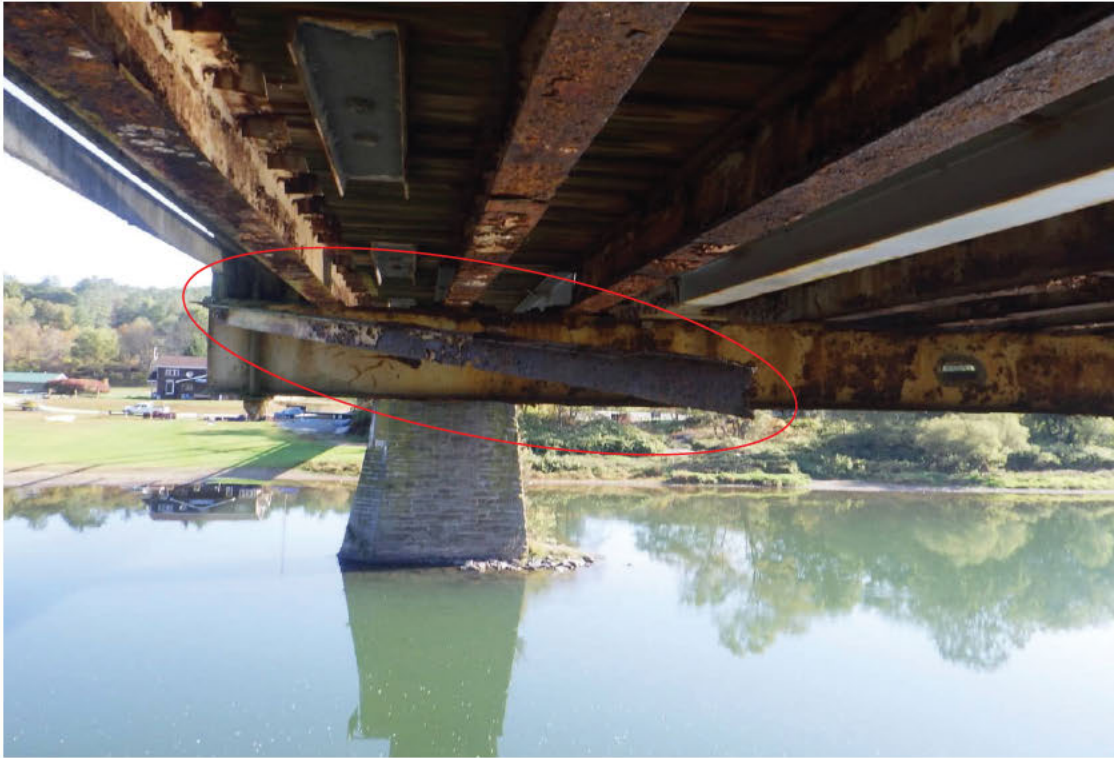
71. Remaining cantilevered section of left lower lateral brace, Bay 4 Span 1.

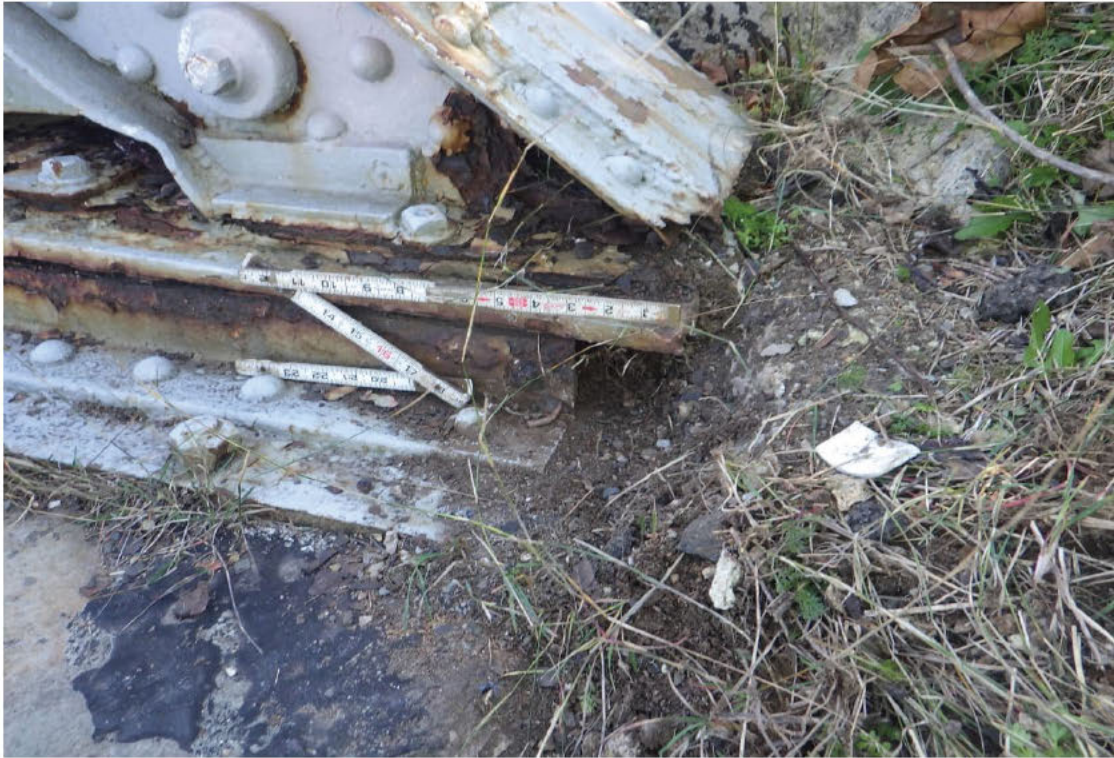
73. Left Truss bearing sole plate overhanging nested rollers at the Near Abutment.

74. Close-up of previous photo.

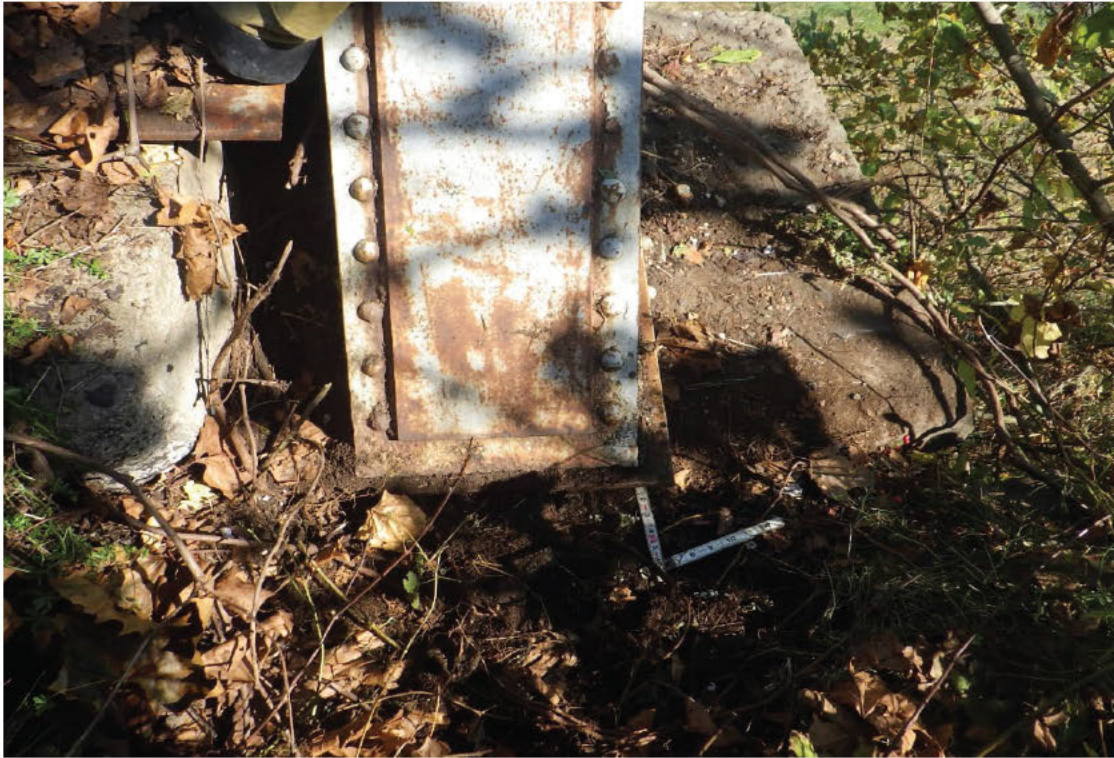
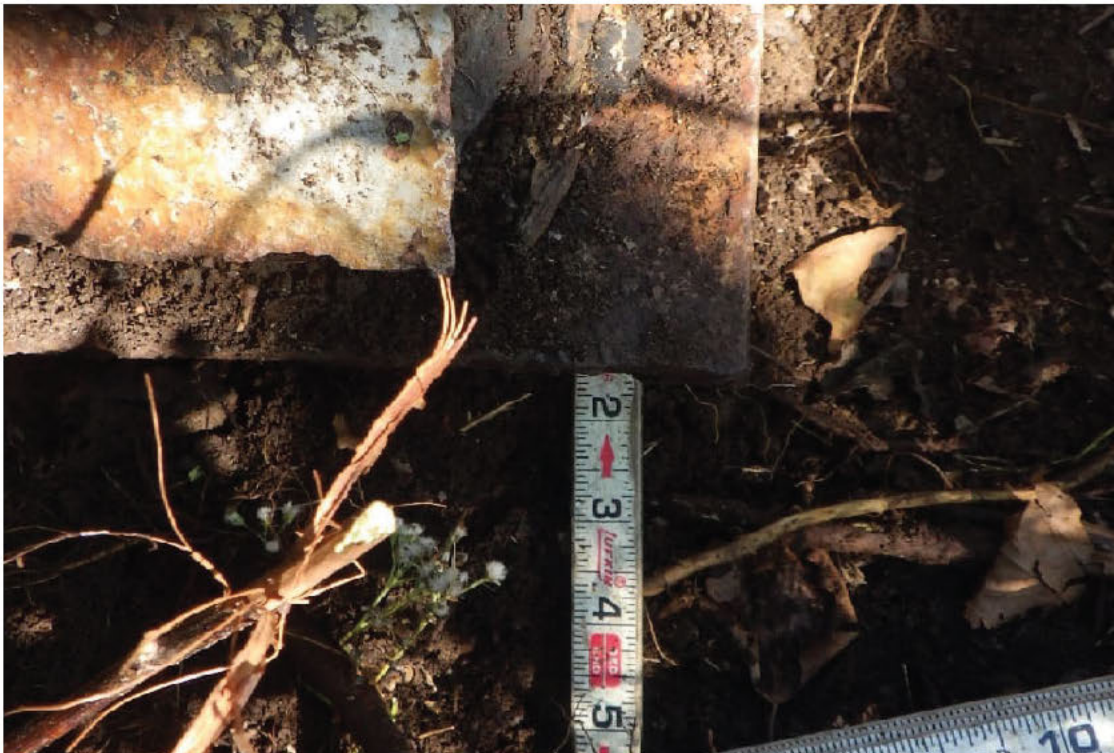
75. General view of the Right Truss bearing at the Near Abutment.

76. Close-up of previous photo, showing sole plate overhanging the nested roller bearings.

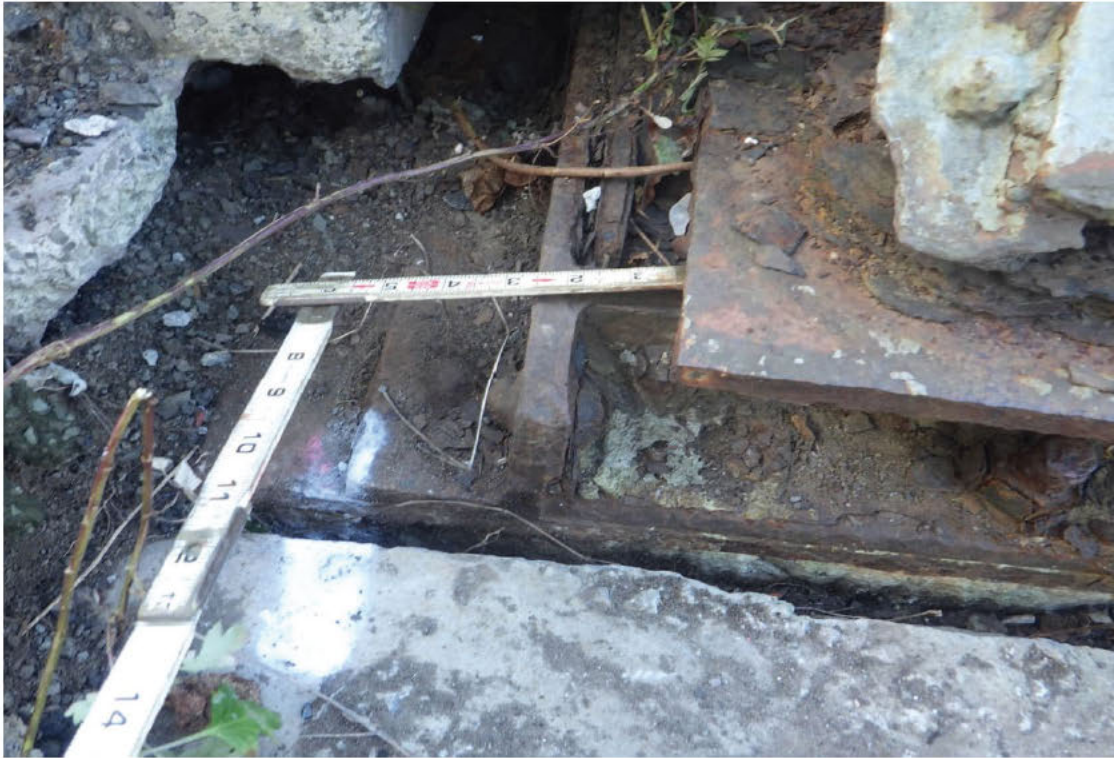
81. Sole plate shifted left on the left truss bearing at the Far Abutment.

82. Close-up of previous photo.

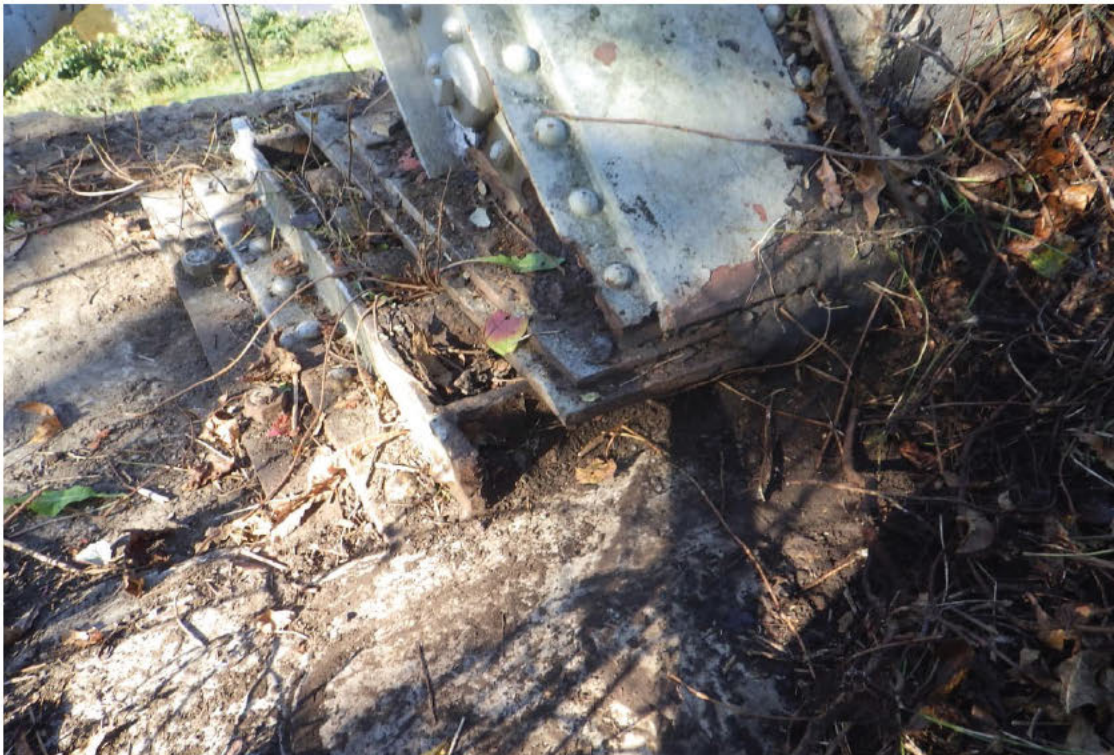
84. Superstructure shifted left with exposed rollers at the Right Truss bearing on the Far Abutment.

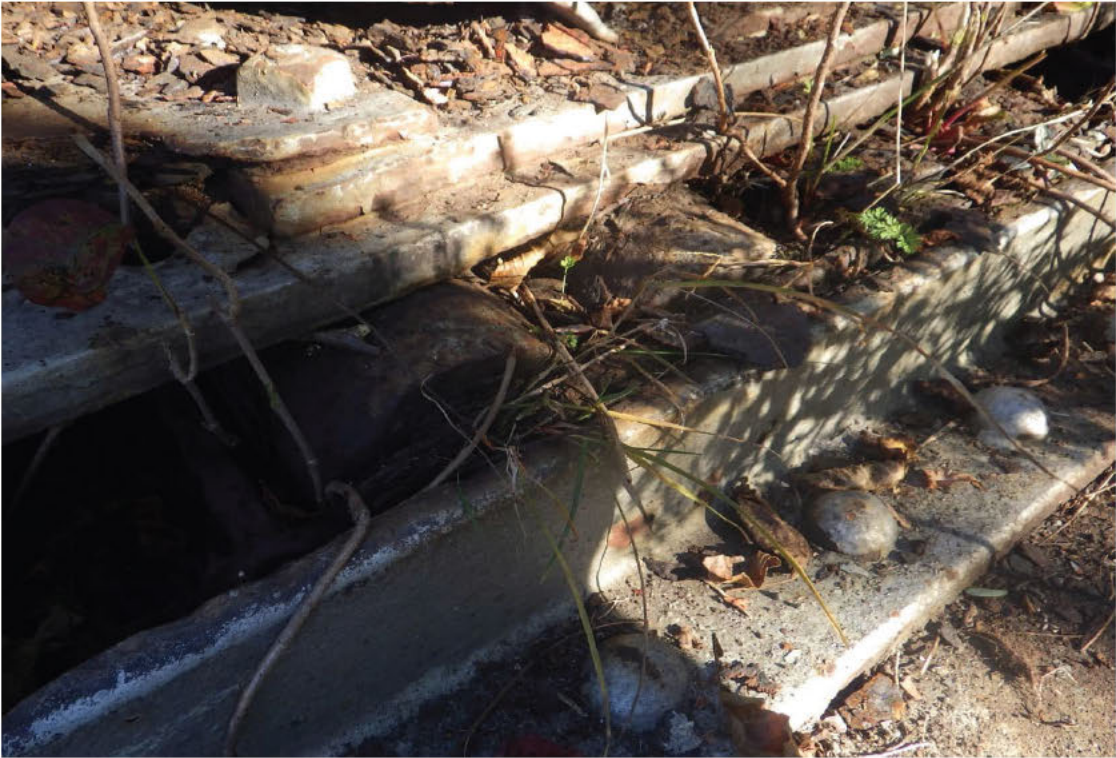
85. Exposed rollers with debris impacting movement of the Right bearing at the Far Abutment.

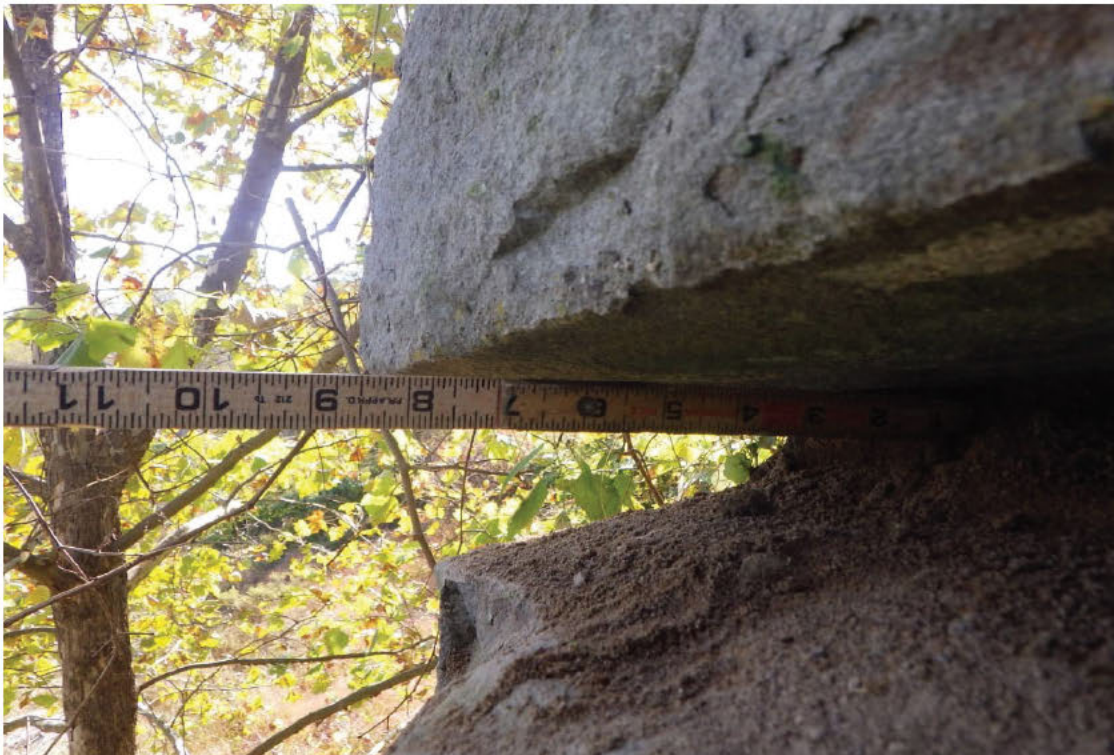
92. Close-up of previous photo showing undermining of the capstone.

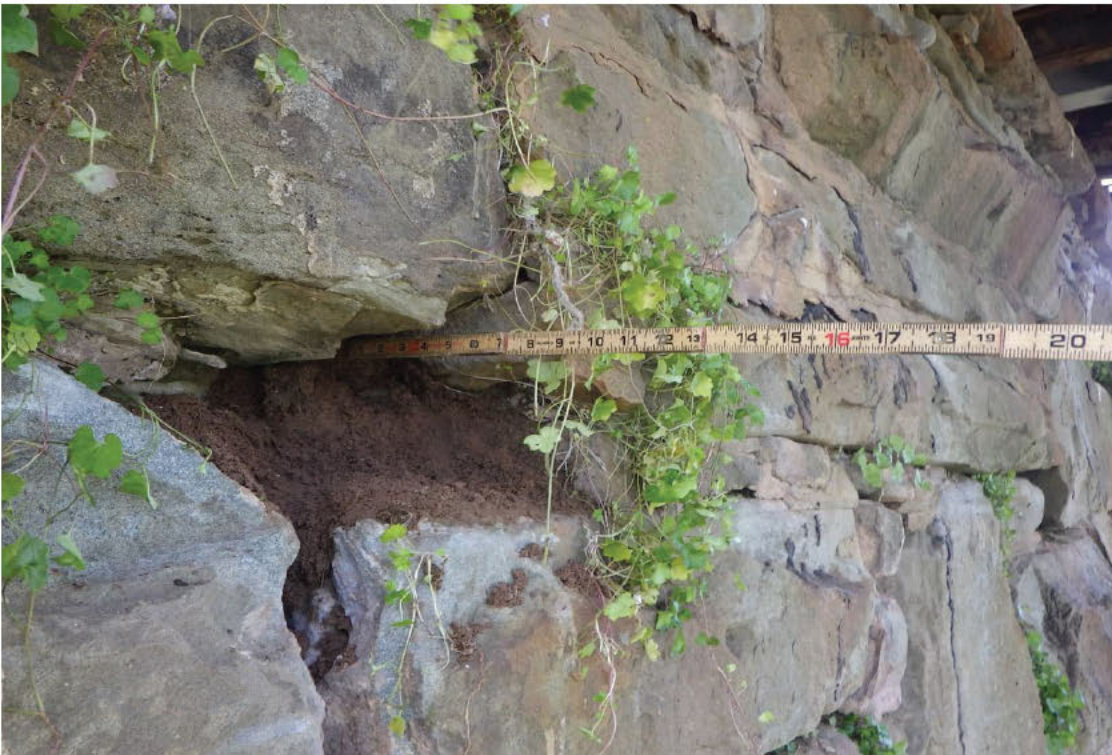
94. Missing stone below Stringer 10 at the Near Abutment.

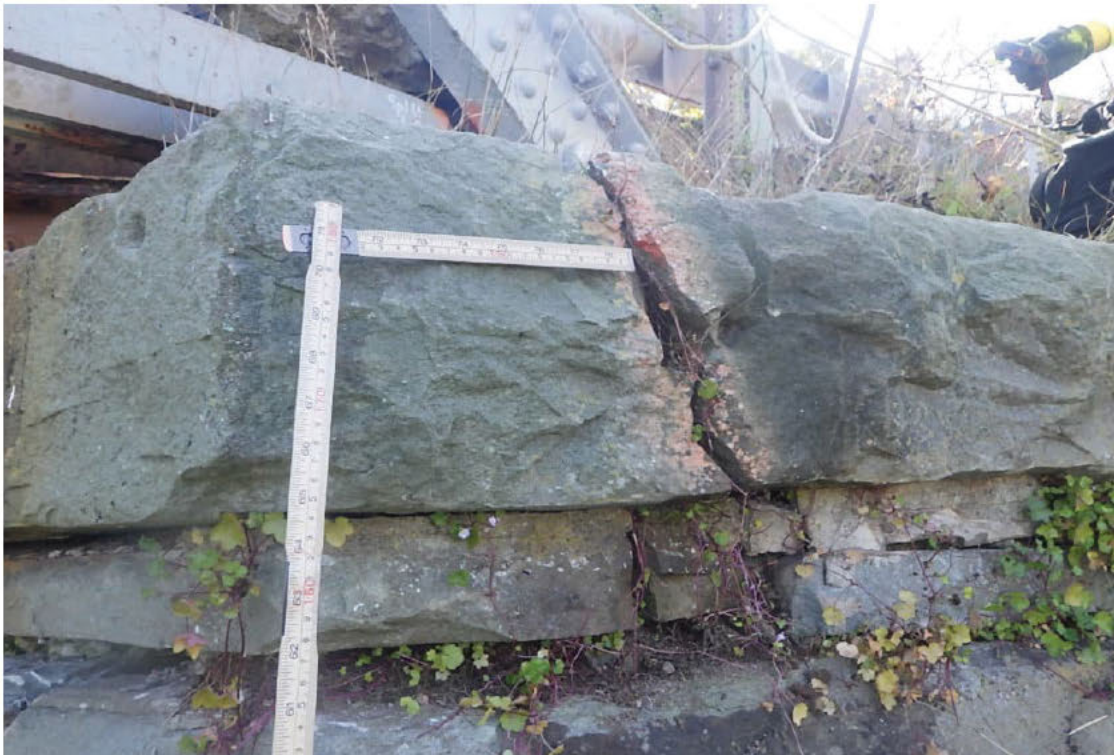
96. Fractured cap stone at the left end of the Near Abutment.

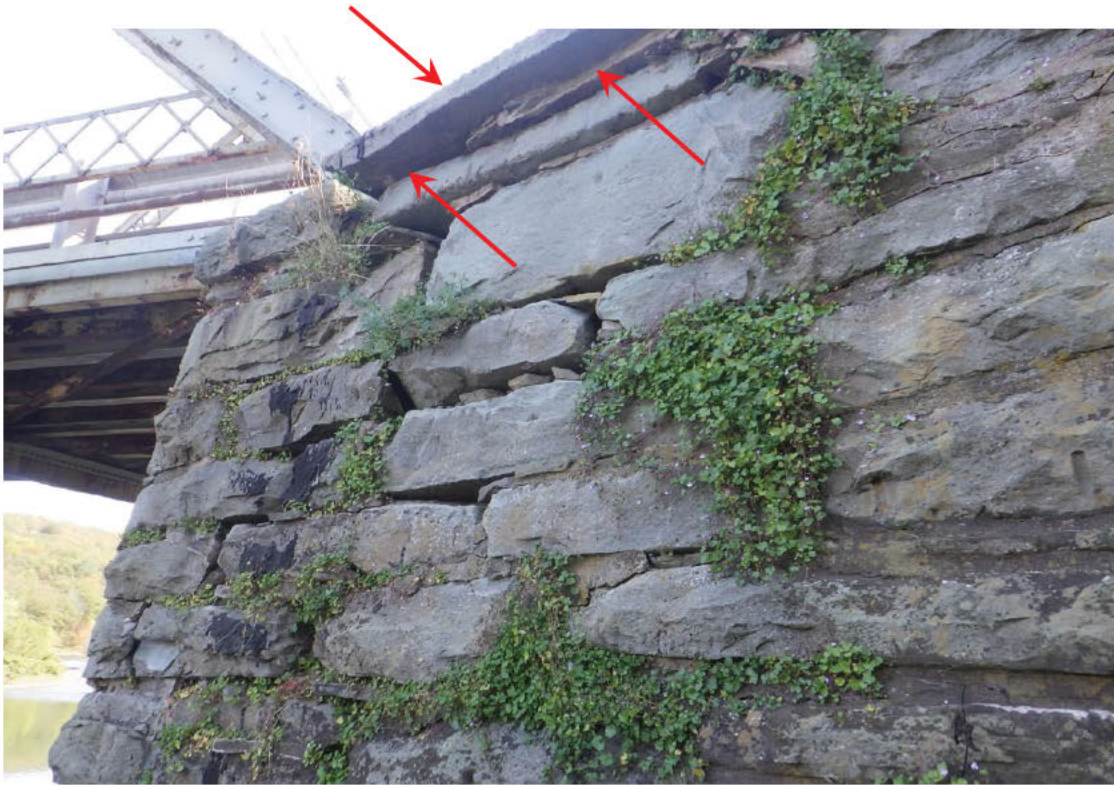
97. Shifted cap stone at the Near Left wingwall.

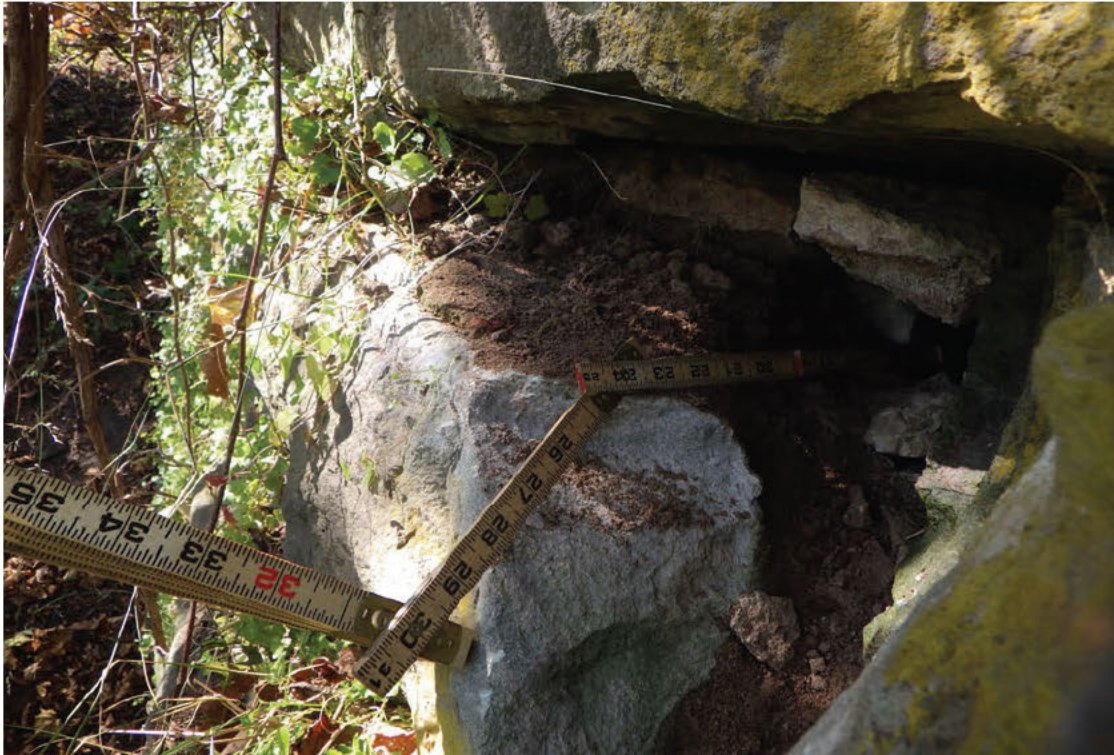
101. Missing stone with void in the Near Right wingwall.

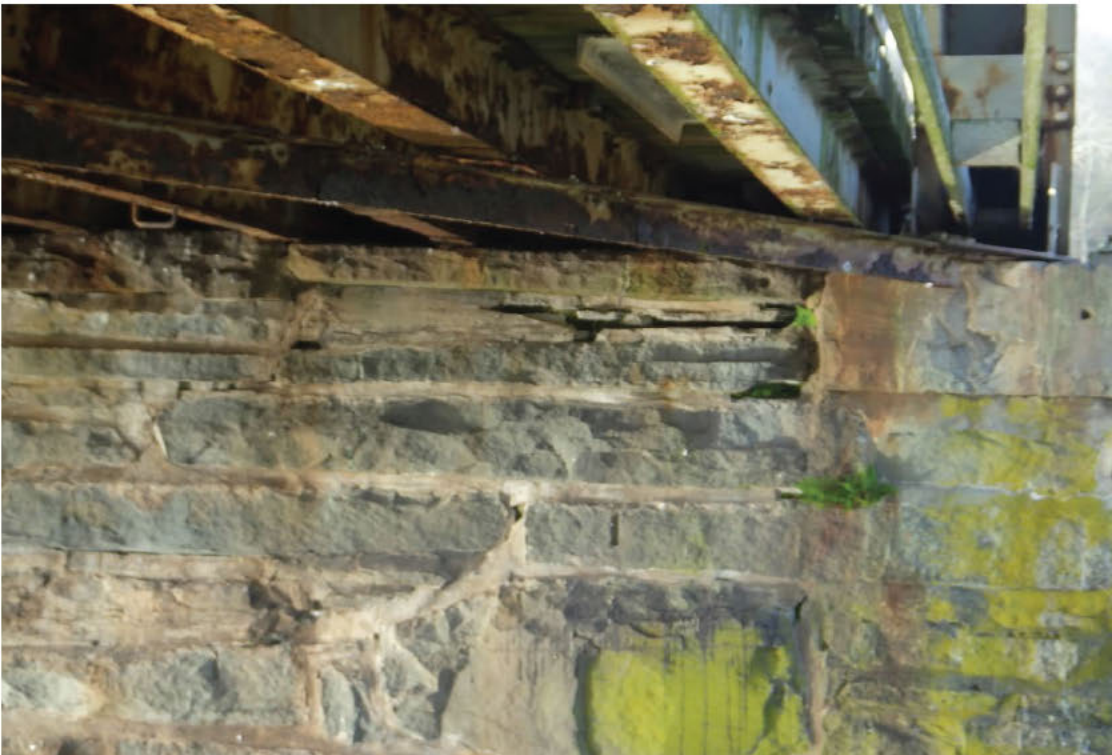
106. Area of missing mortar on the far face of Pier 1.

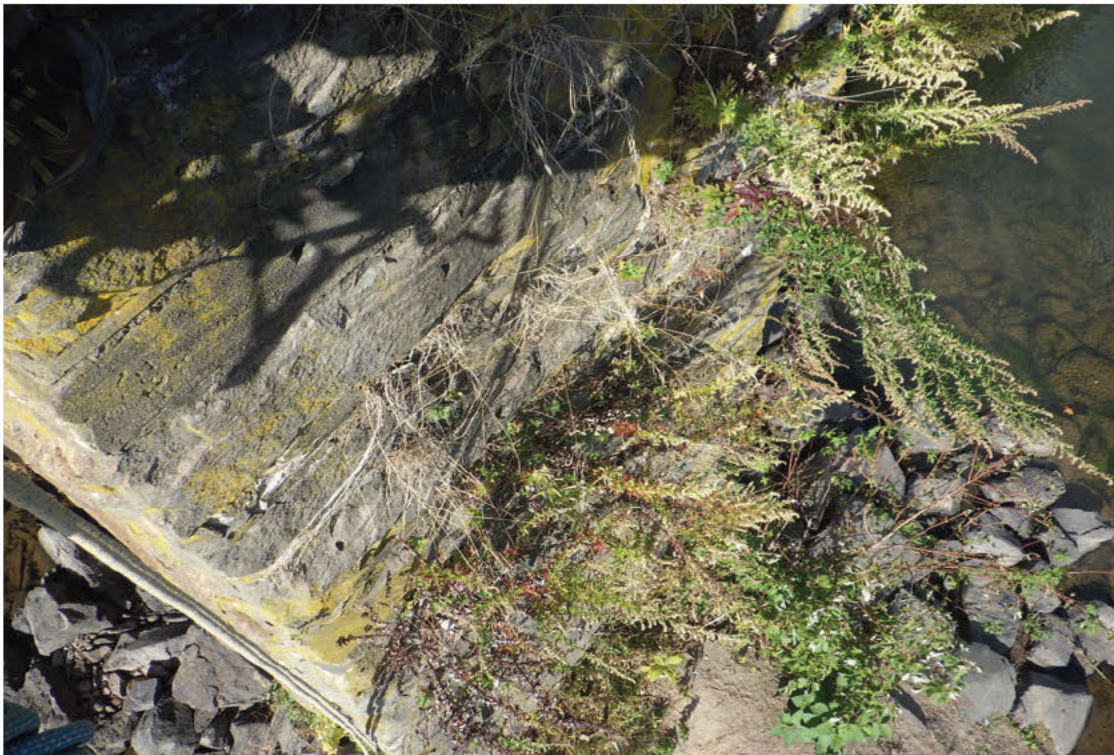
108. Vegetation growth on the right nose of Pier 1.

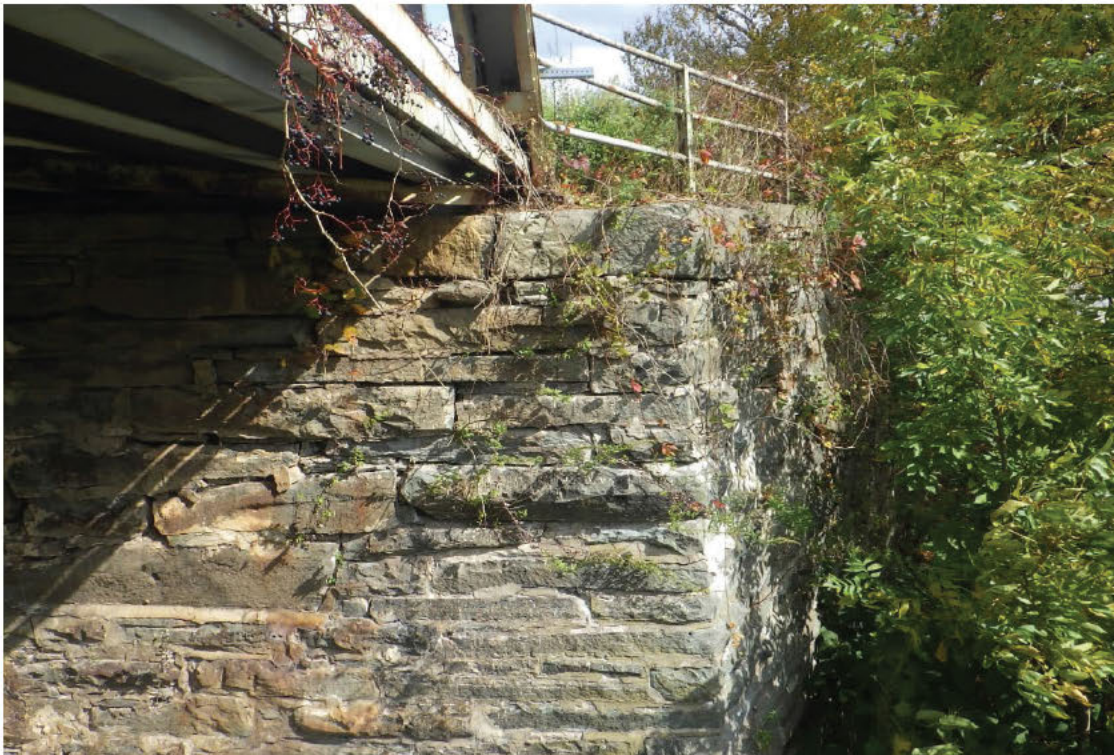
110. Missing mortar and displaced stones on the right side of the Far Abutment.

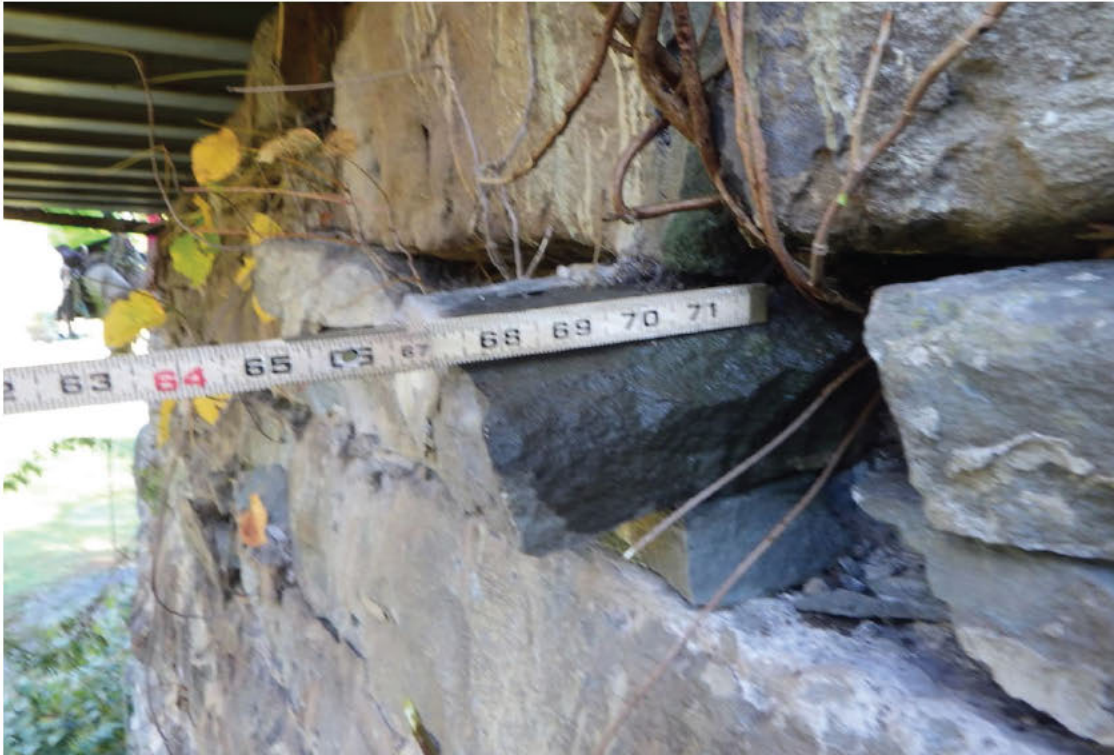
111. Displaced stone and missing mortar at the Far Abutment.

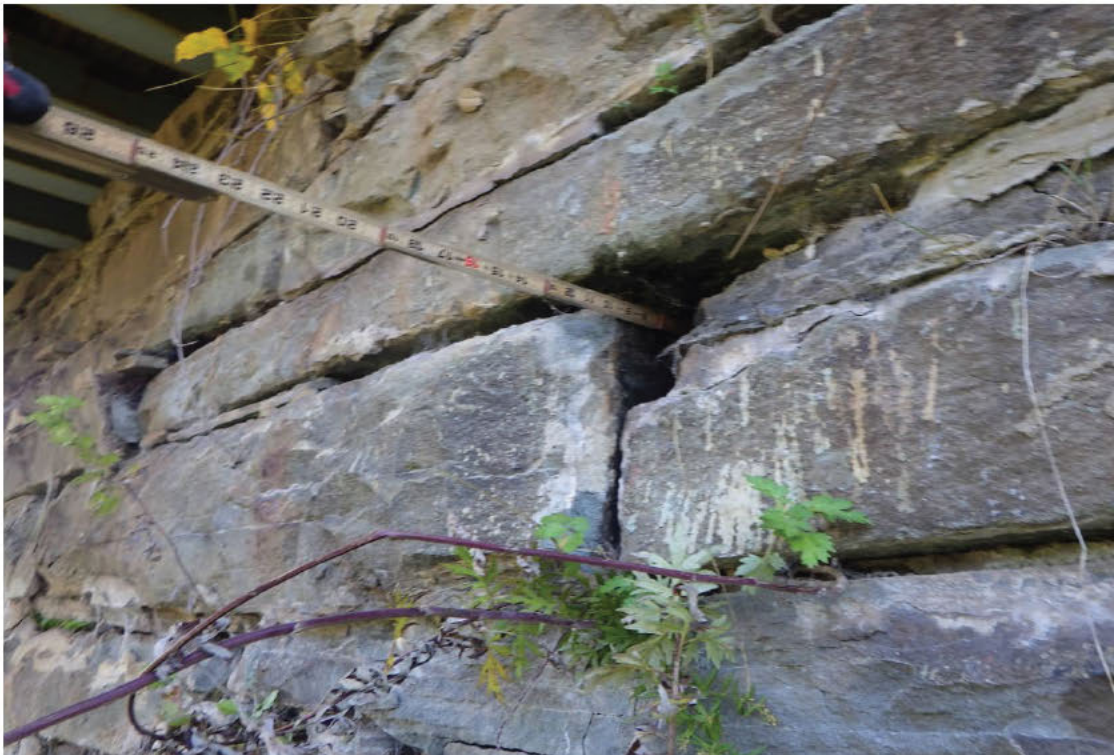
112. Missing mortar and deep voids at the Far Abutment.

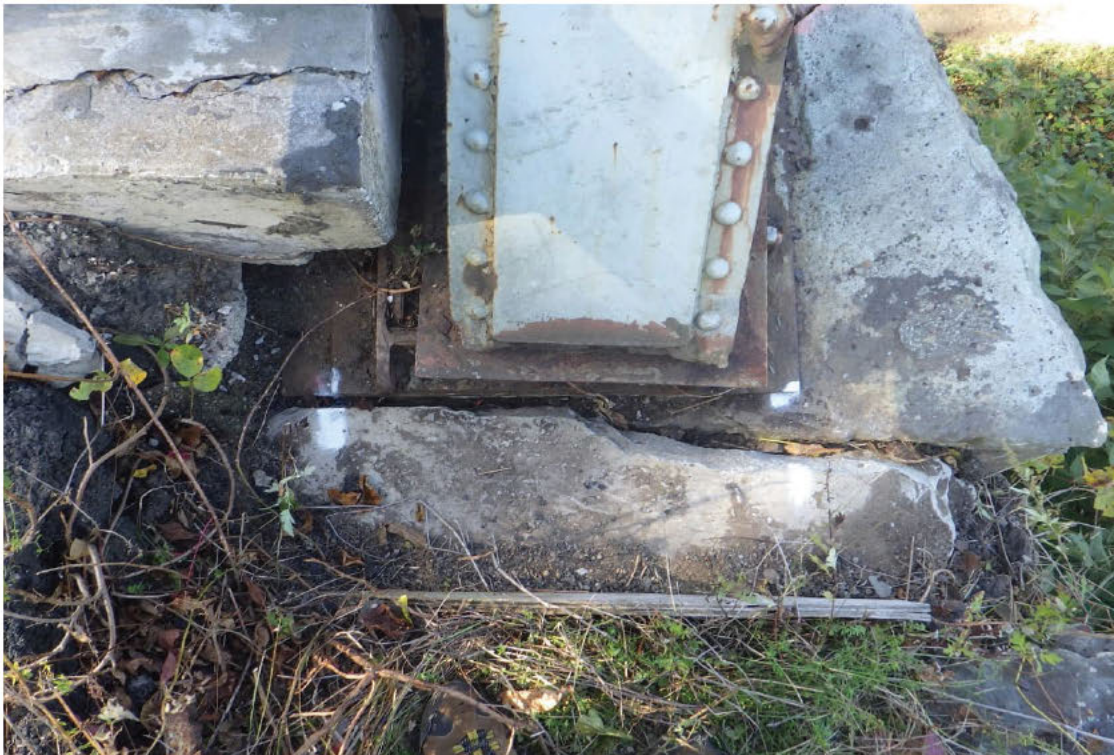
114. Repair adjacent to the left truss bearing at the Far Abutment.

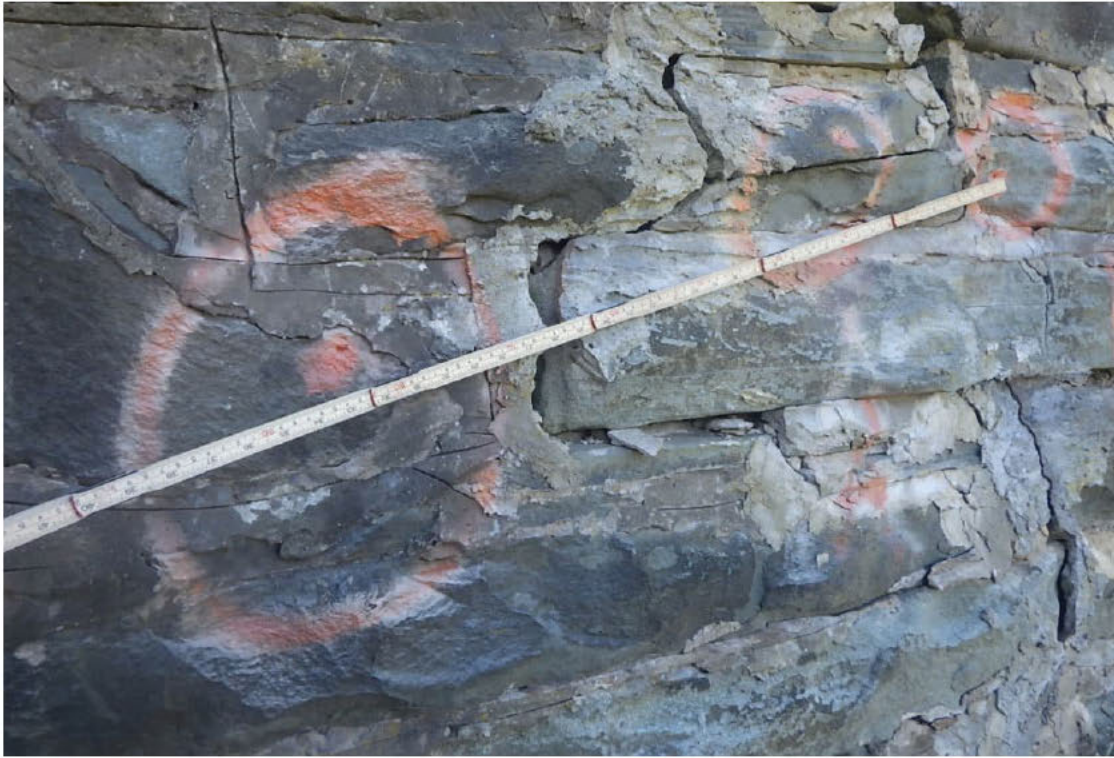
121. Monitoring point A' to B at the Far Left wingwall.
