# 2024 Routine Bridge Inspection Report - District 4-0

BMS ID: 63 1002 0230 0739  
BRKEY: 35588  
Feature Carried: SR 1002  
Feature Under: Delaware River

**2024 ROUTINE BRIDGE INSPECTION REPORT  
SR 1002 over DELAWARE RIVER**

**BMS No. 63 1002 0230 0739**

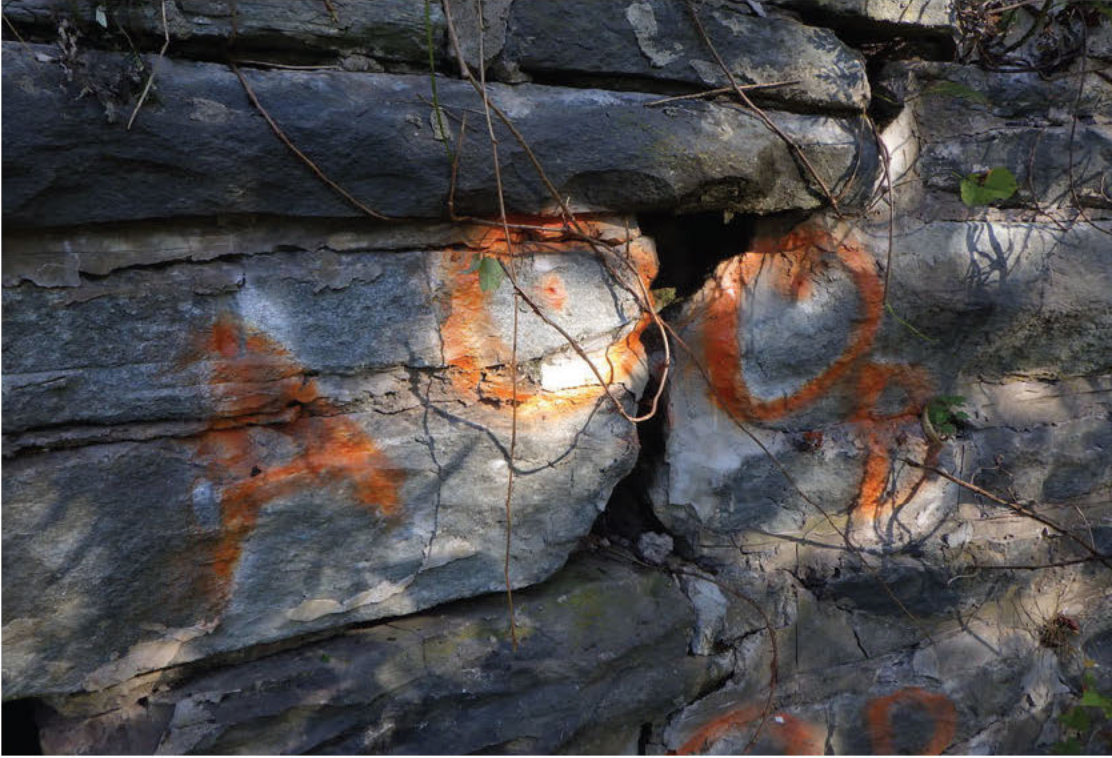
123. Far Right wingwall monitoring point A-B, no change from previous inspection.

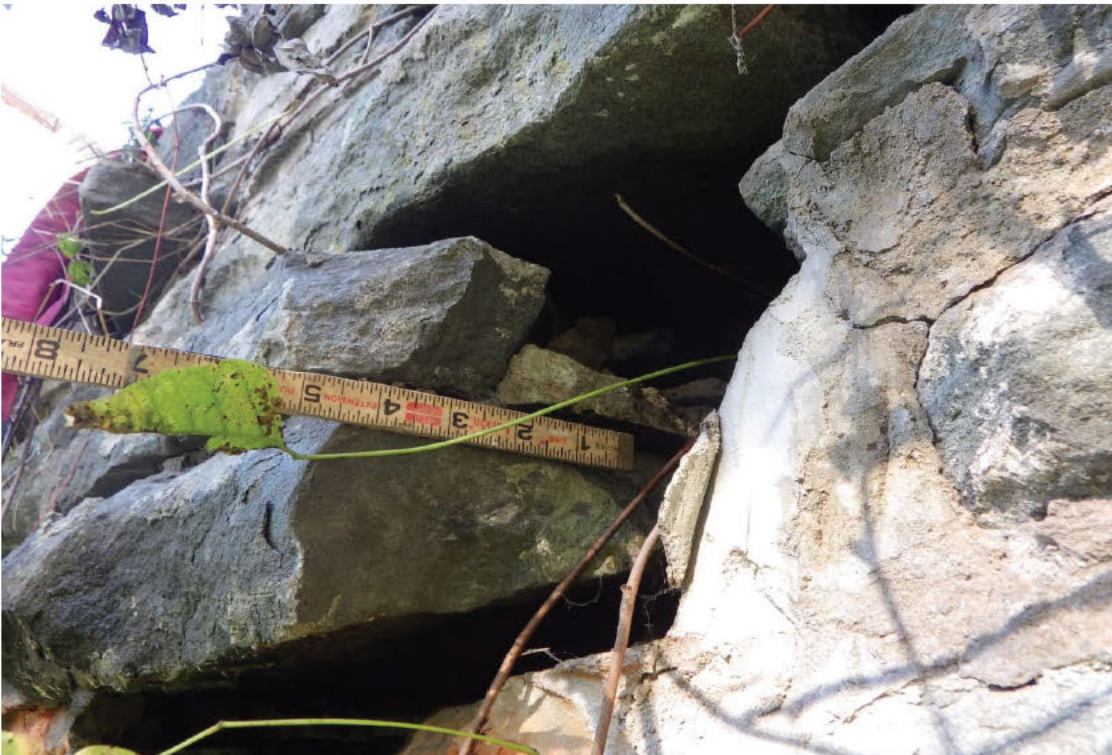
124. Displaced stones above monitoring point A-B at the Far Right wingwall.

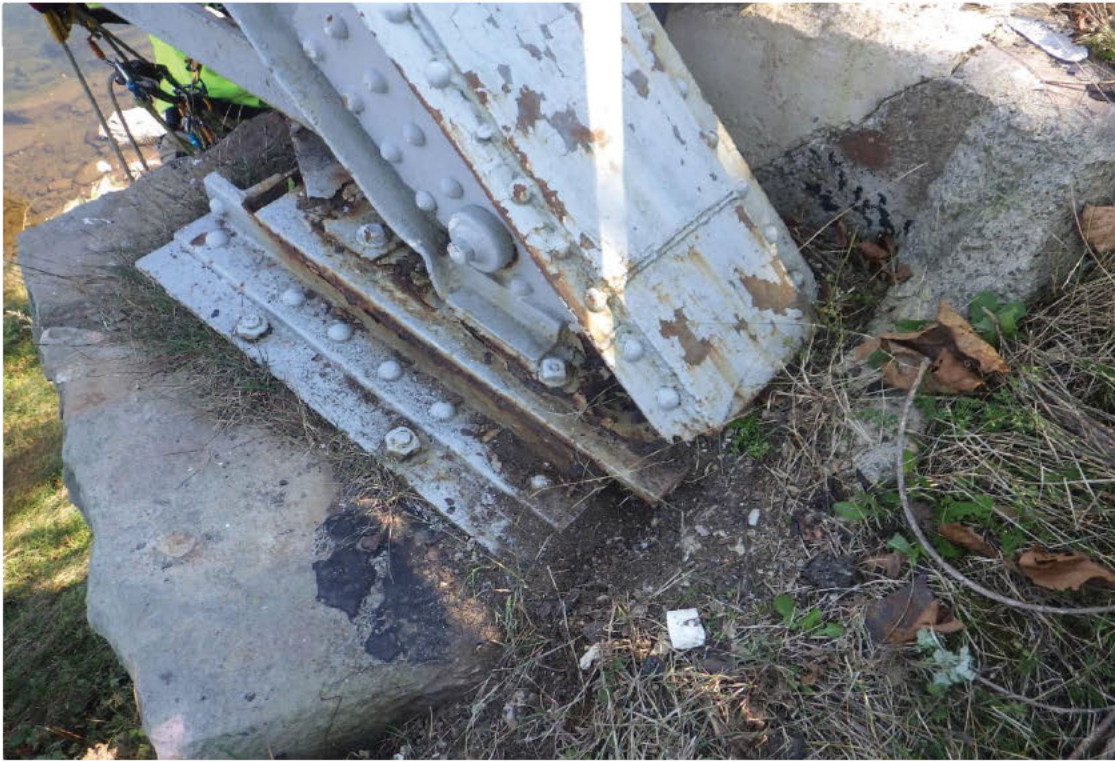
1. Overexpanded Left Truss Bearing at Near Abutment.

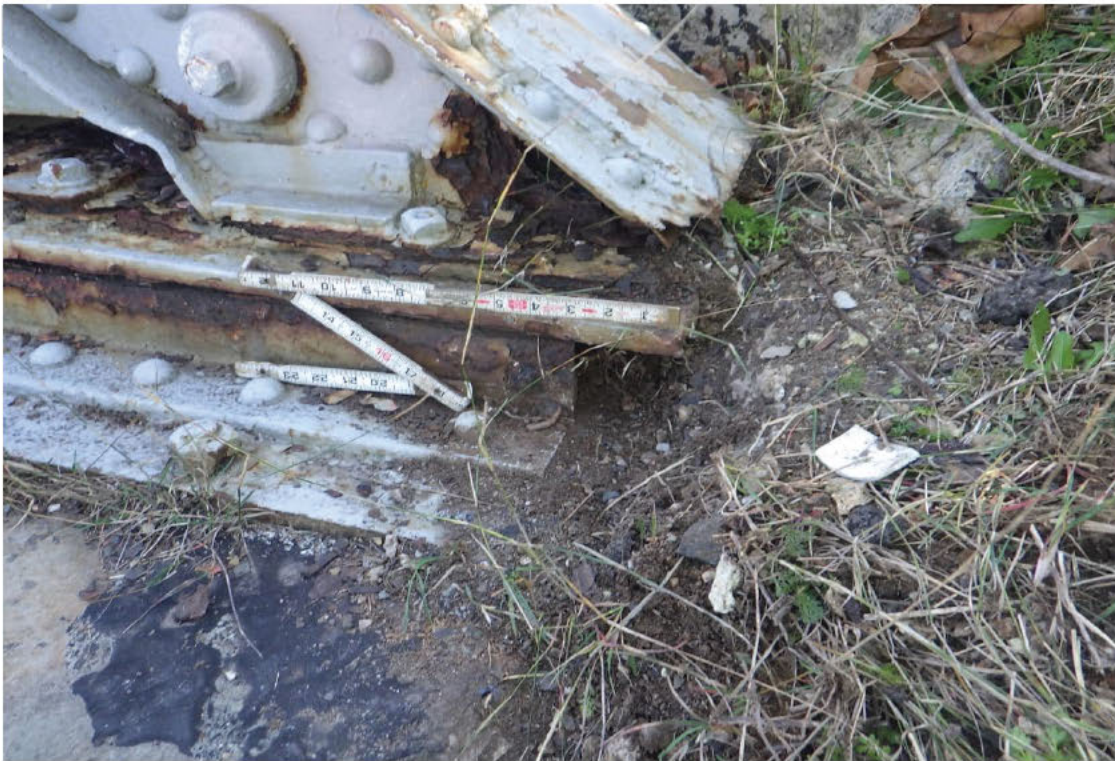
2. Close-up of previous Photo showing sole plate overhanging nested rollers.

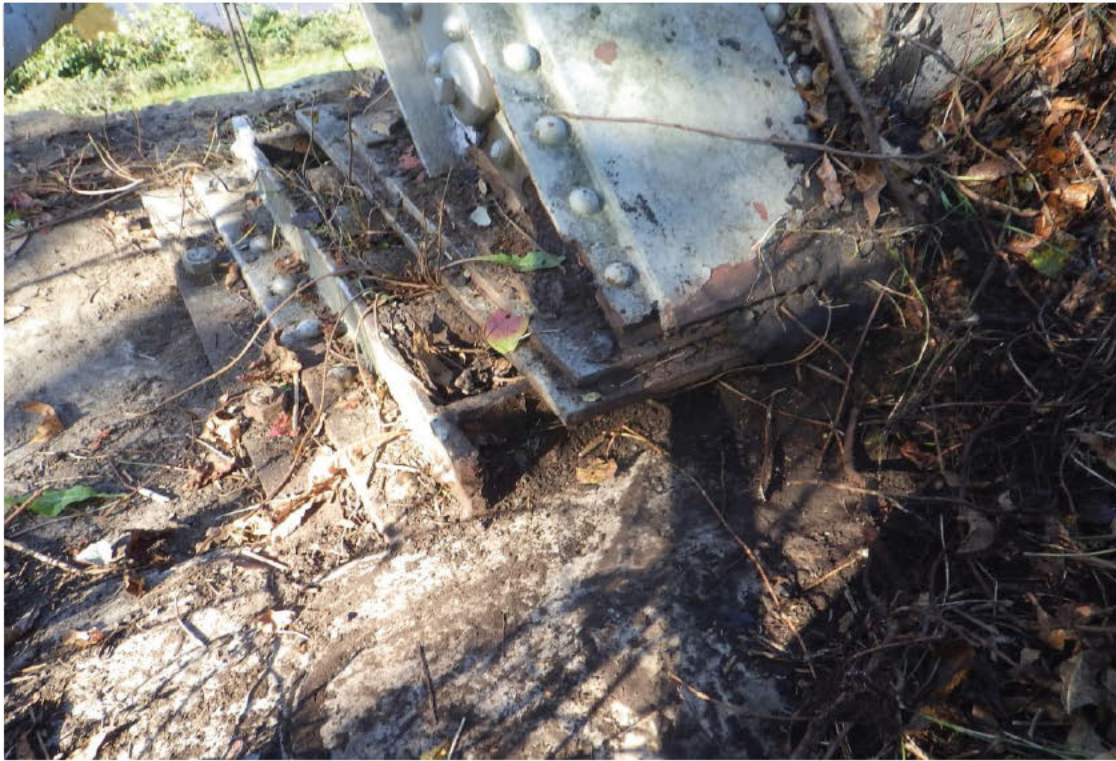
10/7/2024 Routine: A routine inspection was performed by AECOM utilizing rope access to achieve hands-on of all necessary members. The condition rating of the Superstructure was reduced from '4-Poor' to '2-Critical' due to the continued deterioration of bottom chord eyebars, missing/cracked retaining nuts, severe corrosion to original stringers, corroded/detached lateral bracing, and severely misaligned/frozen truss bearings. The condition rating of the Substructure was reduced from '2-Critical' to '0-Failed' due to severe shifting in the stone masonry abutments, which has caused the superstructure to shift as well.

3. Far Abutment bearing shifted to left on the Right Truss.

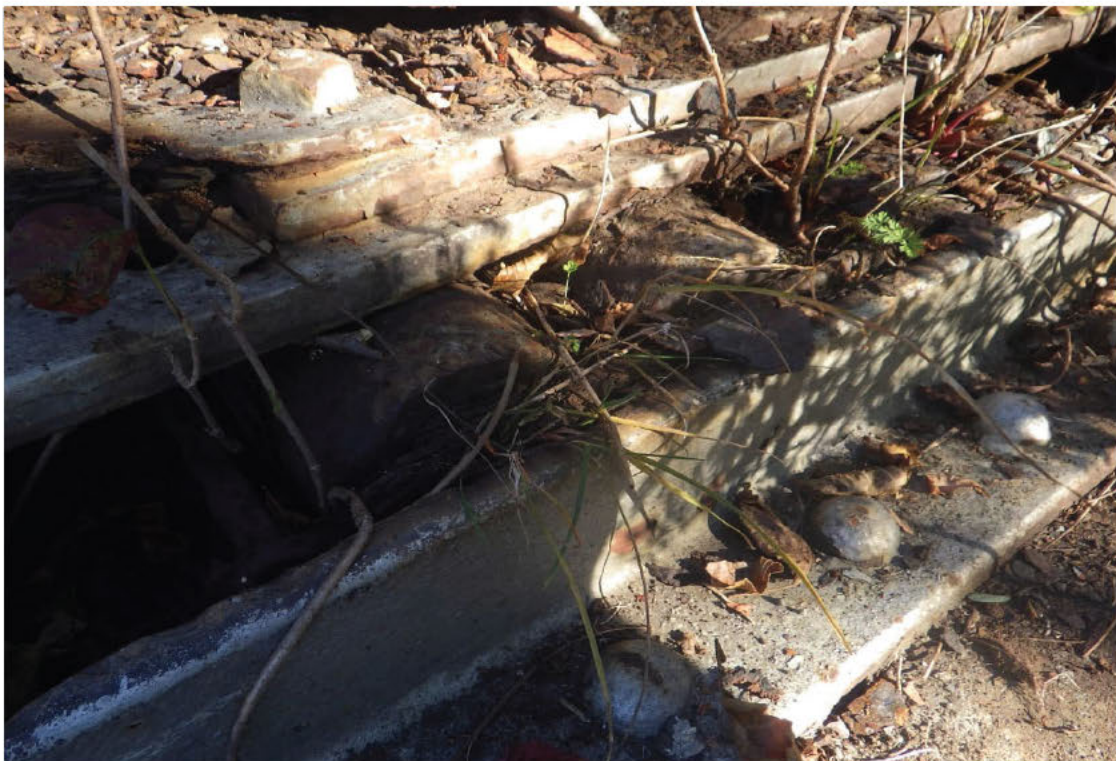
4. Close-up of previous photo showing exposed rollers.

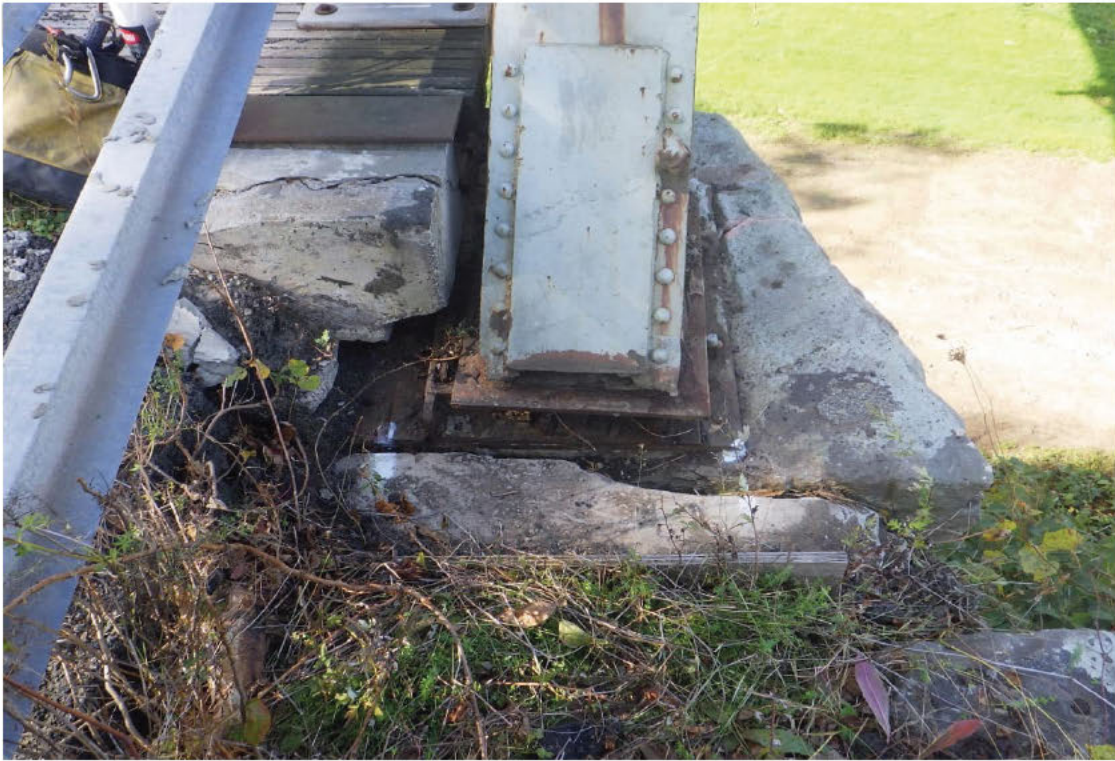
5. Far Abutment bearing shifted to left on the Left Truss.

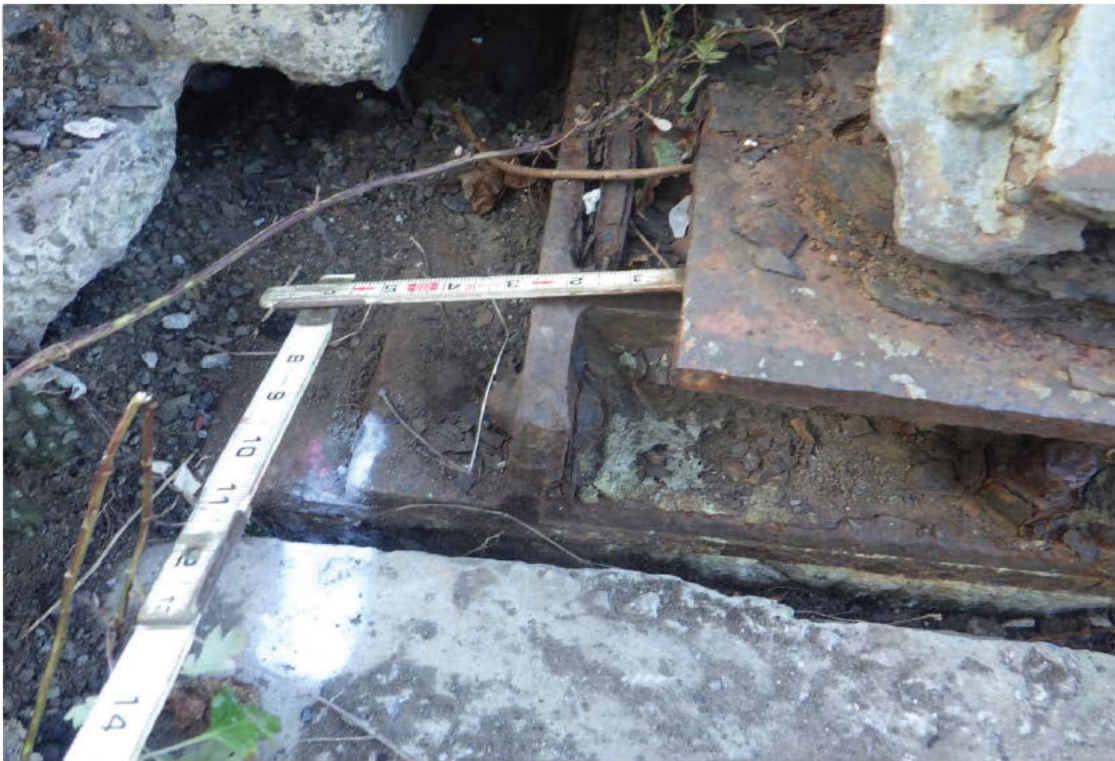
6. Close-up of previous photo showing exposed rollers.

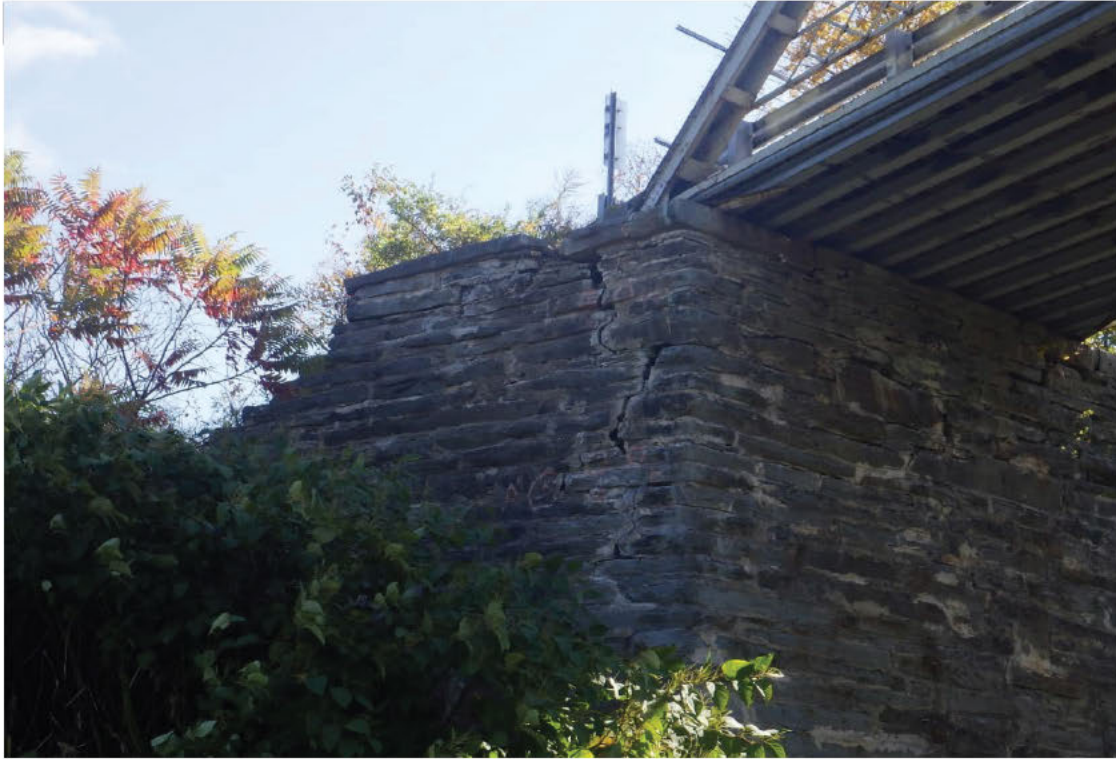
17. General view of the Far Left Wingwall.

4/14/2022 Problem Area Inspection Notes: Bridge remains closed to traffic. Inspection focused on the far stone masonry abutment, specifically the far left wingwall, to monitor the stone masonry condition following the freeze/thaw cycle. Minor increases were noted at the far left wingwall monitoring points. New cracking was observed in the grout/concrete repair to the far left truss bearing capstone which was completed in the summer of 2018. A priority notification email was sent to the district on 4/15/2022. Problem Area inspections to be completed in April of every year to monitor the NY Abutment.

4/5/2024 Interim Inspection Notes: Bridge remains closed to traffic. Inspection focused on the far stone masonry abutment, specifically the far left wingwall, to monitor the stone masonry condition following the freeze/thaw cycle. Minor increases were noted at the far right wingwall monitoring points. Interim inspections to be completed in April of every year to monitor the NY Abutment.

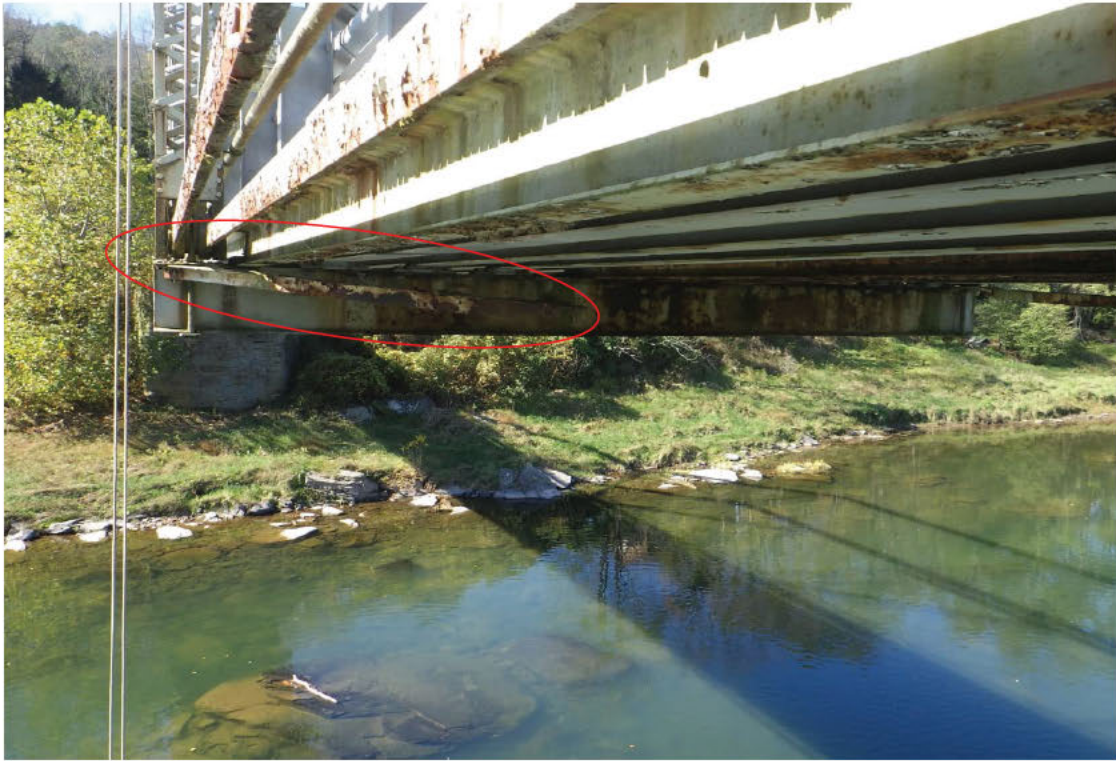
19. Partial length lower lateral bracing, Span 1 between FB 8 & 9. looking back.
