# 2024 Routine Bridge Inspection Report - District 4-0

BMS ID: 63 1002 0230 0739  
BRKEY: 35588  
Feature Carried: SR 1002  
Feature Under: Delaware River

**2024 ROUTINE BRIDGE INSPECTION REPORT  
SR 1002 over DELAWARE RIVER**

**BMS No. 63 1002 0230 0739**

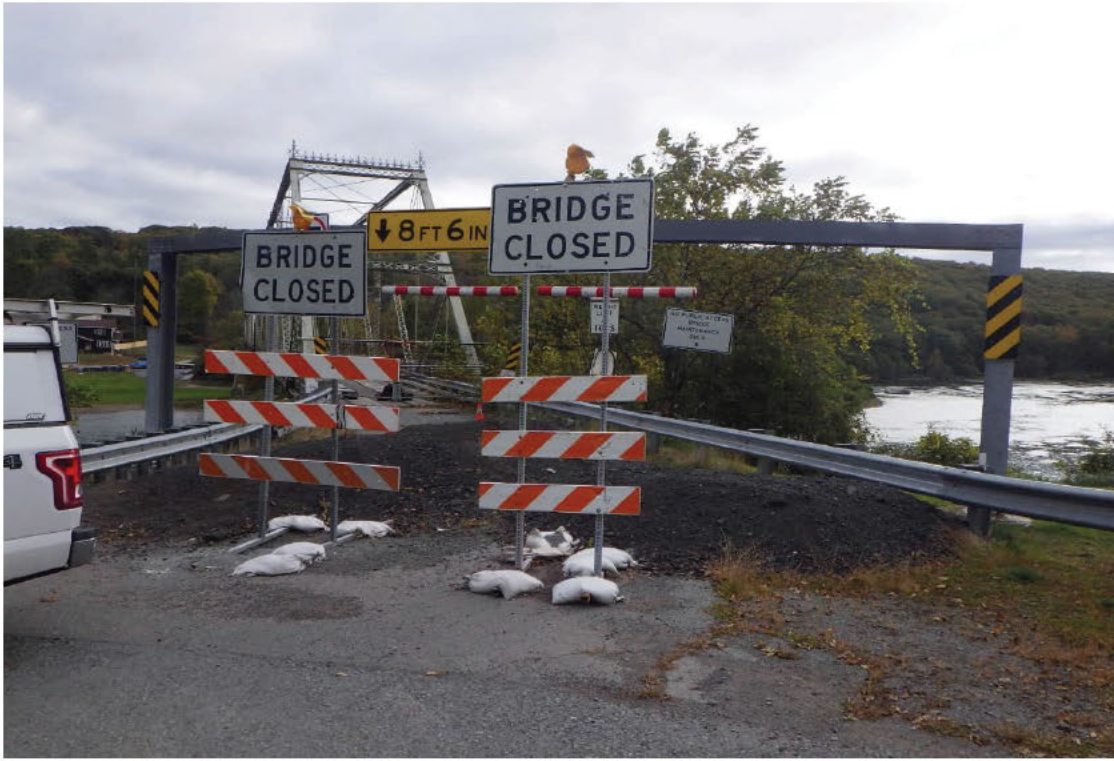
The asphalt approach roadways exhibit transverse and longitudinal cracks, up to 3/4" wide, and minor settlement along the roadway edges. The near left approach corner has an asphalt swale drainage system with a wide crack along the back edge of the top course of stones for the near left wingwall, allowing water penetration into the wingwall fill. The other three approach drainages are natural with no significant defects.

3. Near approach, looking ahead.

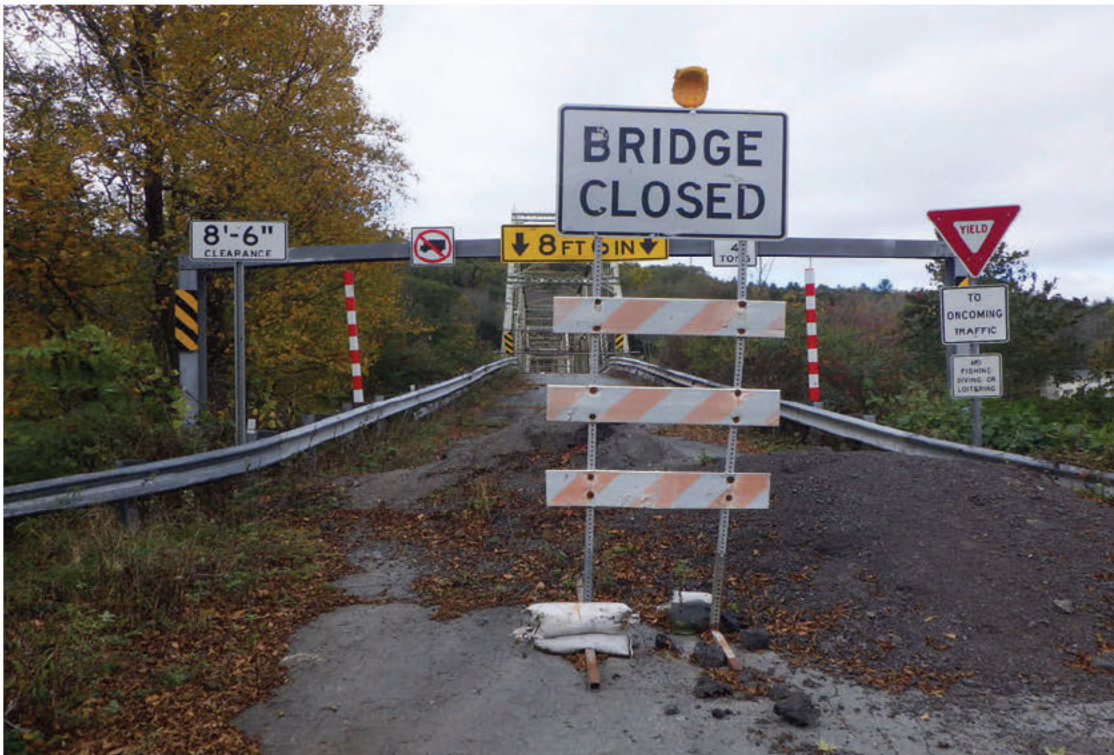
4. Far approach, looking back.

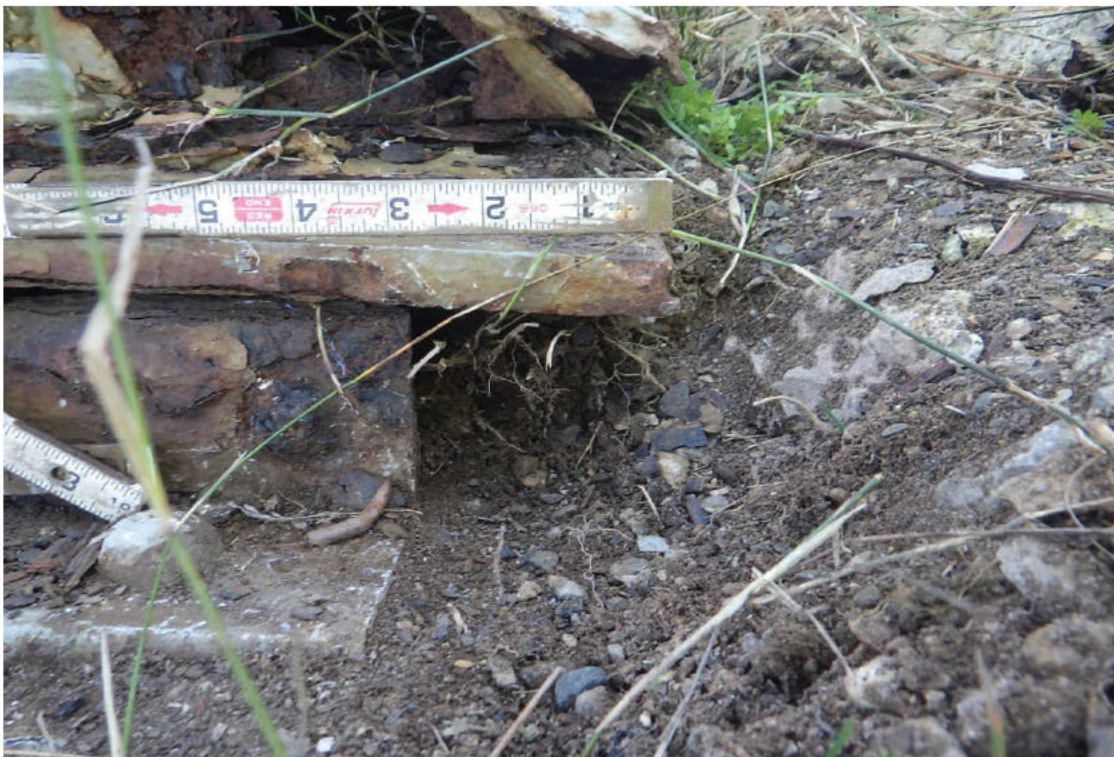
73. Left Truss bearing sole plate overhanging nested rollers at the Near Abutment.

74. Close-up of previous photo.

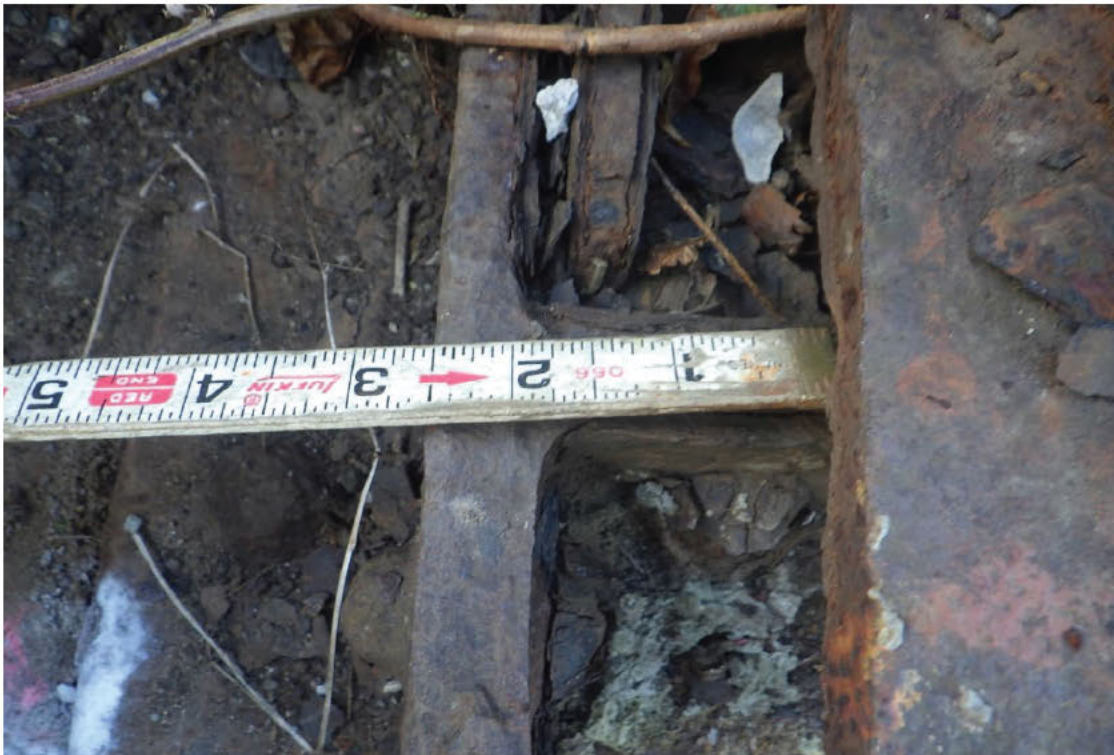
81. Sole plate shifted left on the left truss bearing at the Far Abutment.

82. Close-up of previous photo.

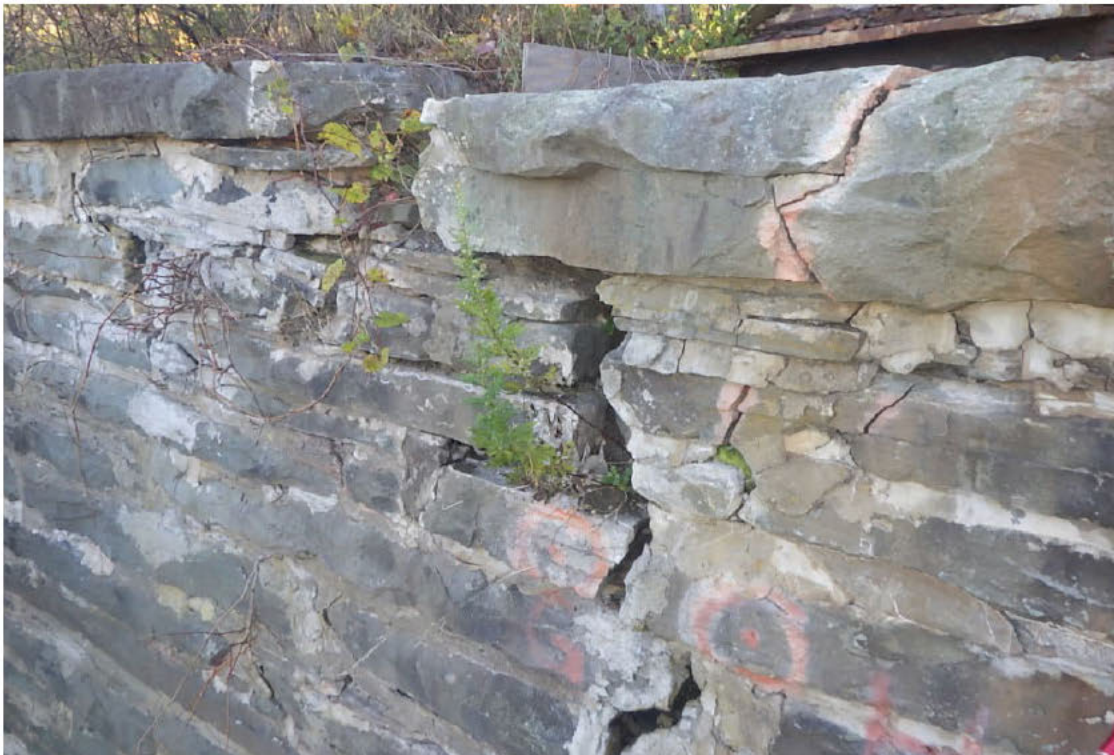
118. Close-up of previous photo.

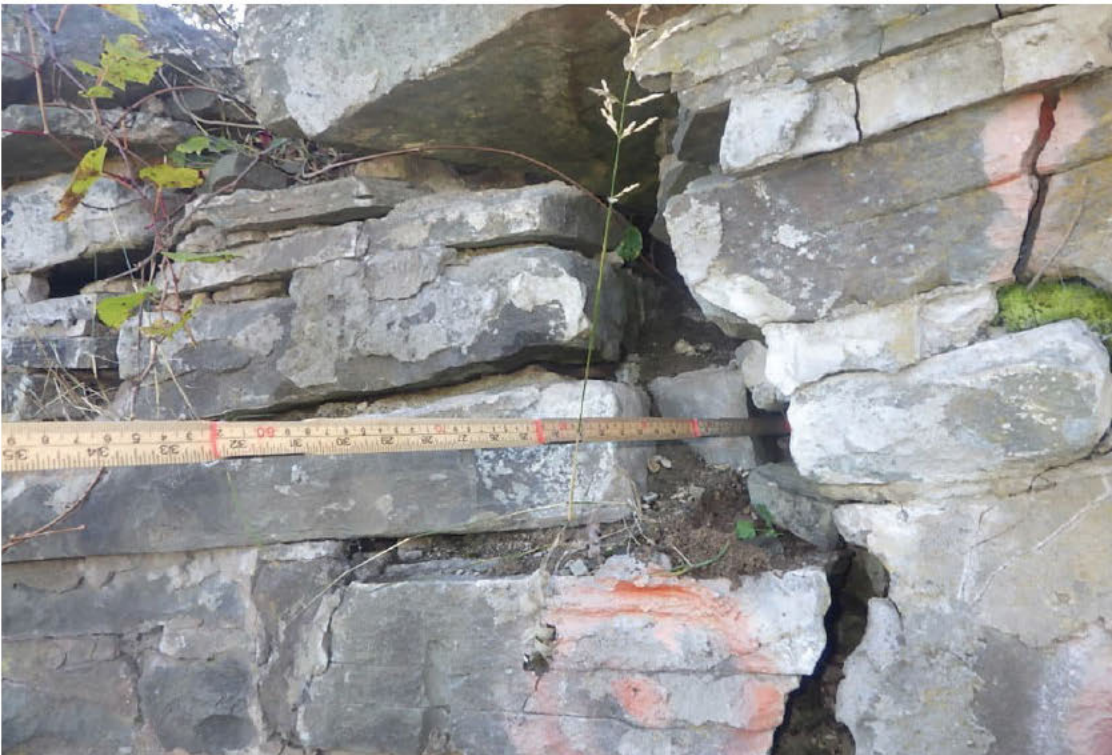
120. Close-up of previous photo.

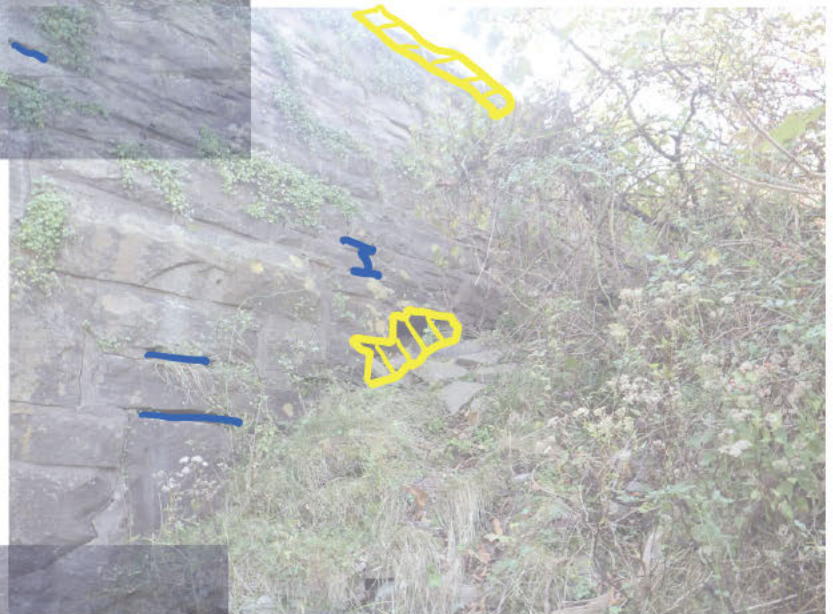
# NEAR LEFT WING WALL:

- MISSING MORTAR & VOIDS
- CRACKED STONES
- MISSING/DISPLACED STONES

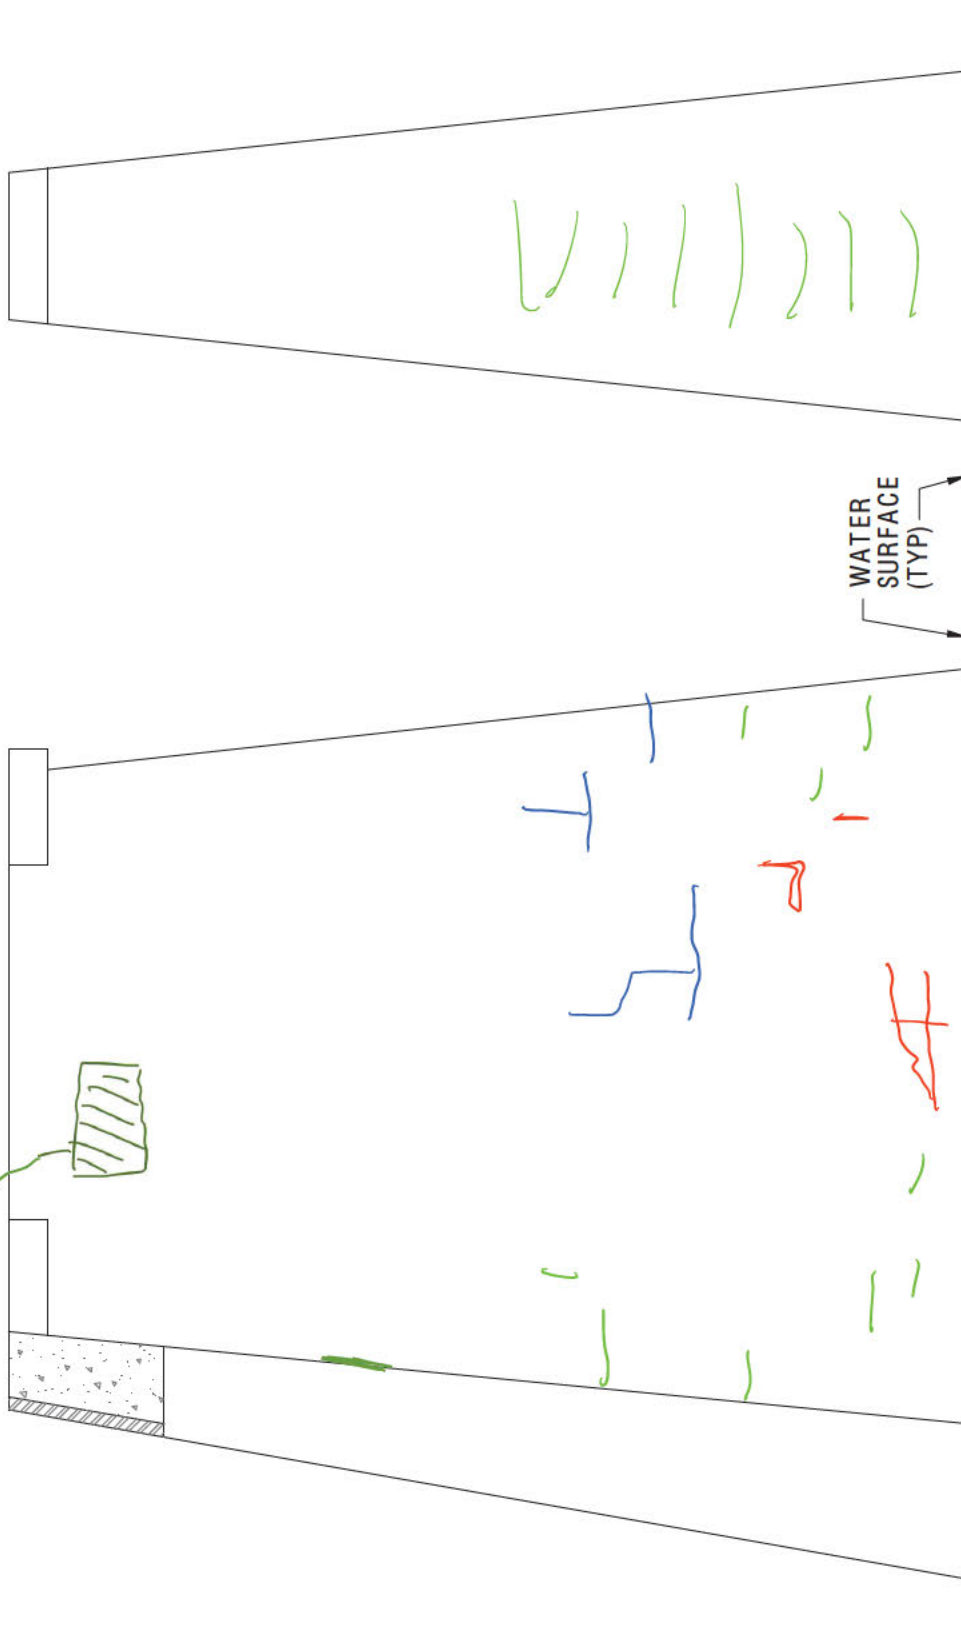
RIGHT FACE - PIER  
(DOWNSTREAM NOSE)

Typ: Random gaps in mortar w/ moss accum. or voids

105F area of Rt efflo
